# Conservation Management Plan

## **FORMER TRANSPORT DEPOT**

Prepared by  
**Philip Leeson Architects Pty Ltd**

*Issue for*  
*Submission to ACT Heritage*  
**April 2021 (Approved June 2023)**

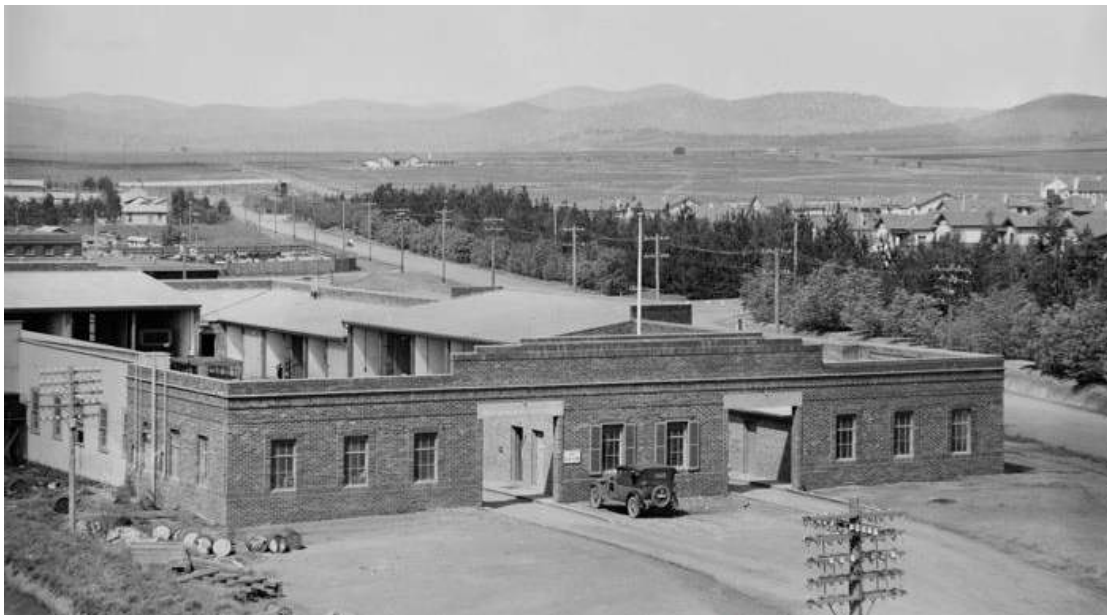
The 1928 photographs below show the original Kingston Transport Depot. The brick building was constructed around a vehicle turning courtyard. A brick parapet to the external walls concealed the skillion roofs that sloped inward to the unroofed turning area. The parapet stepped up in the centre of the south-east and north-west elevations.

*Transport Depot from Kingston Power Station (March 1929)*  
(Source: National Archives of Australia, A3560, 5128)

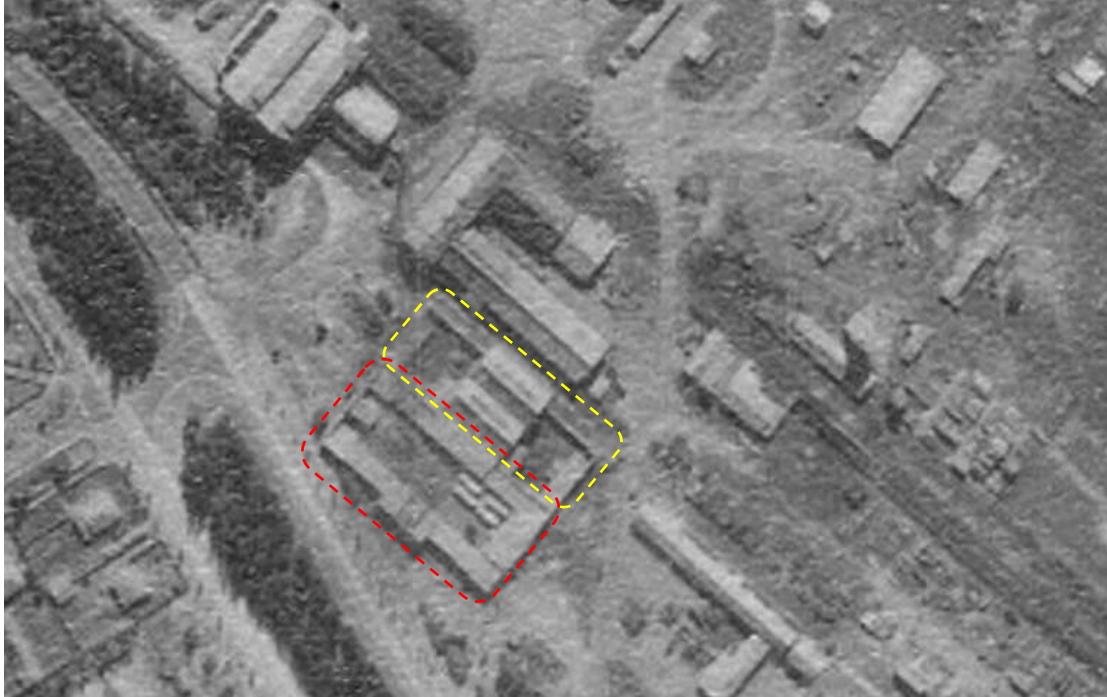
The 1936 workshop addition was designed by the Commonwealth Department of Works Branch and consisted of a new lower level covered workshop to the north-east of the original Depot and additional enclosed courtyards with roofed areas to the south-east and north-west sides of the addition. Freestanding walls were erected along the railway line to separate the workshop from the line and to enclose the unroofed yards at either end.

*Aerial of Canberra area with 1927 Transport Depot indicated in red and 1936 addition in yellow (1940)  
(Source: National Library of Australia, MAP Aerial Photograph Collection 55 16 451)*

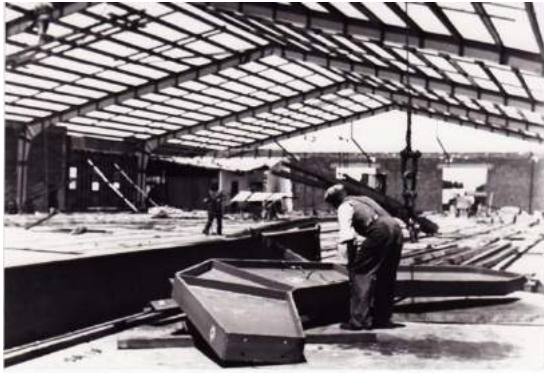
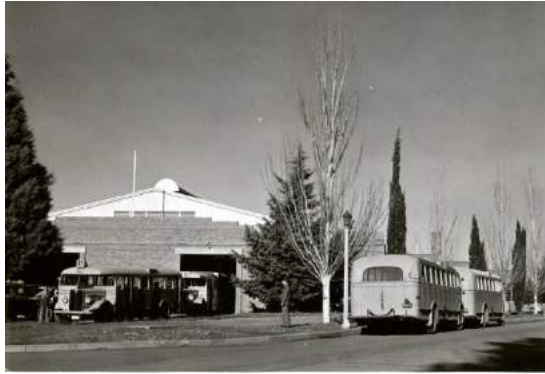
Left: portal frames being erected over the original open garage (circa 1941). Right: 1940s roof to original open garage (circa early 1940s)

The additions, alterations and steel framed roof drawings detailed the construction of two main structures consisting of an attached single storey brick administration and management office located to the Wentworth Avenue frontage and a new roof over the original 1927 building, including the central vehicle circulation area. Both structures were designed by the Department of the Interior in early 1940 with the addition to Wentworth Avenue to include a goods store, general office and executive offices. The works also involved alteration of the parapet (partially increasing its height) and enlargement of the vehicular openings to the north-west elevation as well as extension of the garage (upper hall) to the south-east and construction of a mess room addition to the east corner (refer to physical assessment for a plan showing the location of these additions).<sup>33</sup>

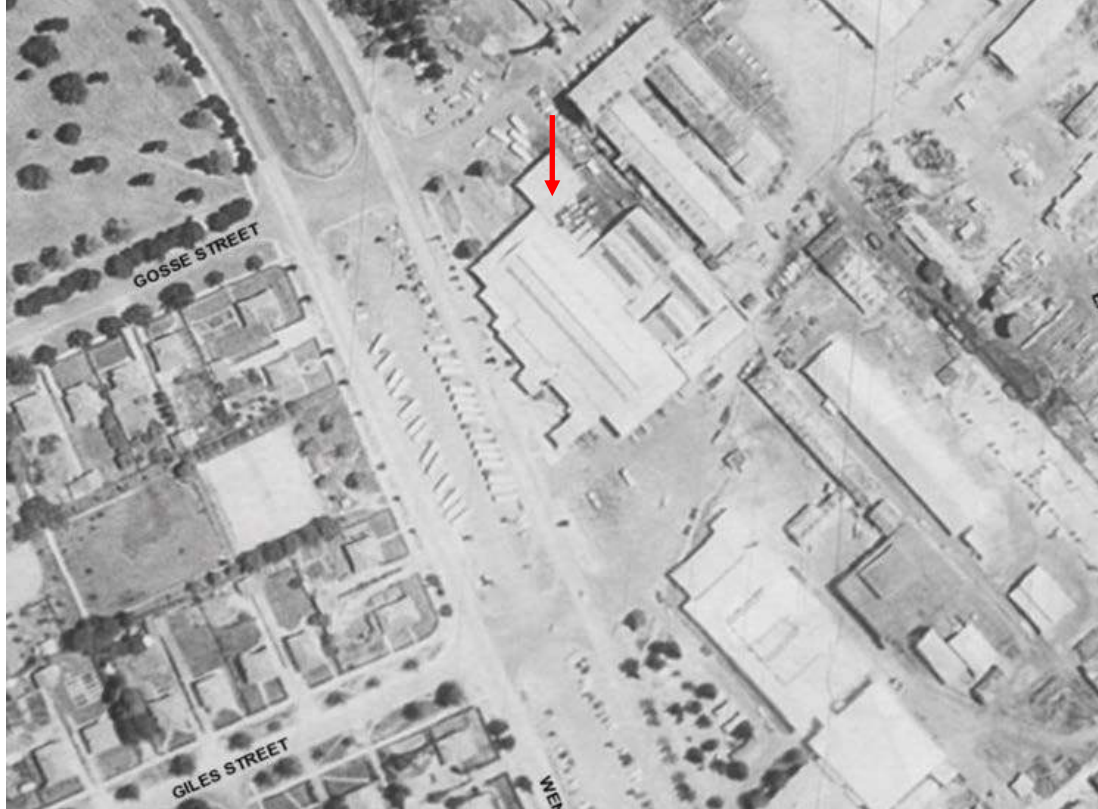
Shortly after the completion of these additions, in 1942, it was reported that an annex (now demolished) was being erected at the Depot by day labour. The addition was to include a greasing bay with hoist capable of supporting the heaviest busses in use by the Department, an engineering machine shop and a carpenter's shop where general coachwork will be undertaken (in addition to repairing furniture containers).<sup>36</sup> This annex is shown on a 1952 plan as being located to the north-west end of the building, adjacent to the north-west yard of the 1936 addition (refer to aerial photograph below).

1955 aerial photograph with the 1942 annex indicated. Note the buses to the Wentworth Avenue median strip (Source: ACTmap*i*)

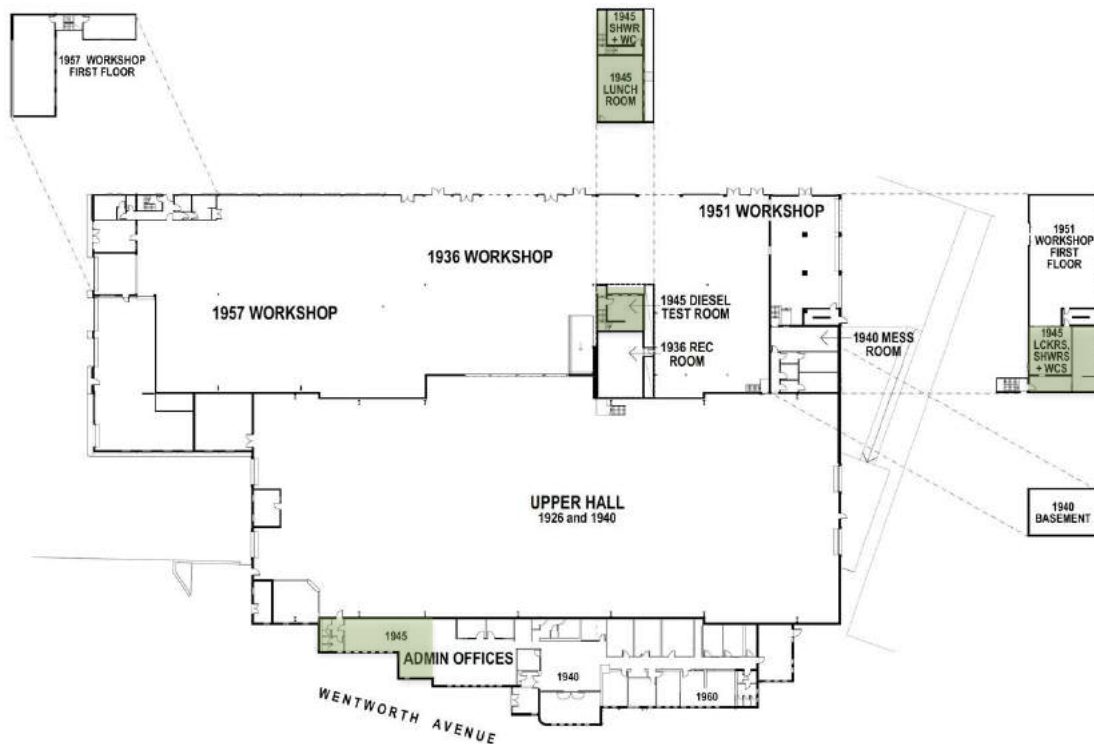
*Floor plan showing the location of 1945 additions (green) to the ground and first floors*

In 1945, the Chairman of the Capital Territory Advisory Council noted that there were certain works which were urgently required, including luncheon rooms and other amenities for employees in the transport section, joiners' shop and electrical and mechanical workshop at the Kingston Depot.<sup>43</sup> Plans for two separate amenity additions to the Transport Depot were prepared in 1945. This included additional lockers and toilets above the existing 1940 mess room and a diesel test room to the ground floor adjacent to the 1936 workshop with additional lunch room and toilets above (refer to plan below).<sup>44</sup> The following year, the paper reported on the pending opening of amenities at both the Transport Depot and the Government storeyards and workshops. These facilities were reported to be 'modern brick buildings' and included 'luncheon rooms where men may eat in comfort'. Lockers for individuals were also provided as well as hot and cold shower rooms.<sup>45</sup>

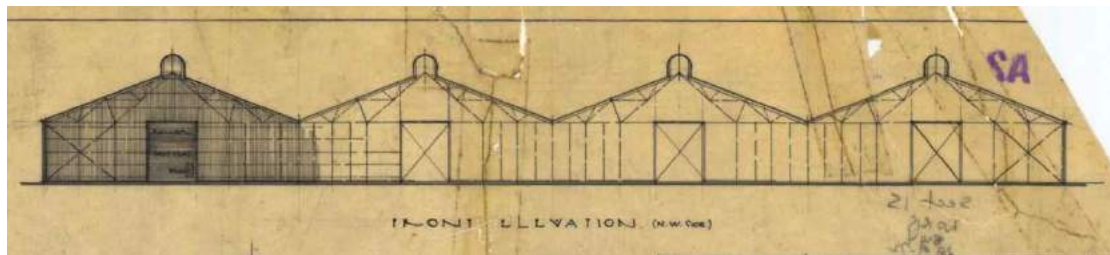
*Front (north-west) elevation of proposed new Vehicle Park for Transport Depot (1945)  
(Source: National Archives of Australia, A 2617 Section 15/15587)*

In October 1945, it was noted that a vehicle park (now demolished) would be constructed at Kingston as part of the Advisory Council's Works Programme for that year.<sup>48</sup> Drawings from January 1945 show that the building, which was located further to the south-east on Wentworth Avenue, consisted of a large shed that was square in plan and was divided into four bays each with a gable roof.<sup>49</sup>

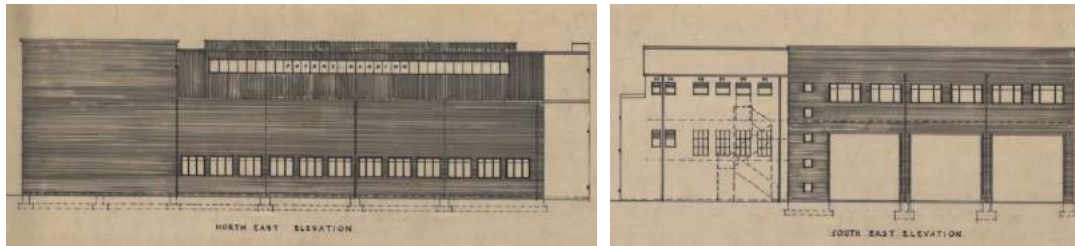
North-east (left) and south-east (left) elevation of two storey addition to east corner of Depot (1951)  
(Source: National Archives Australia, A2617 Section 15/20844)

The Kingston Transport Depot however continued to undergo expansion. Designs for the part single storey part two storey east workshop were drawn up in 1951. Drawings show this addition was to include a workshop with overhead crane and tyreing floor with tyre store above. This building was constructed over the south-east courtyard of the 1936 addition and is indicated on the aerial photograph below.

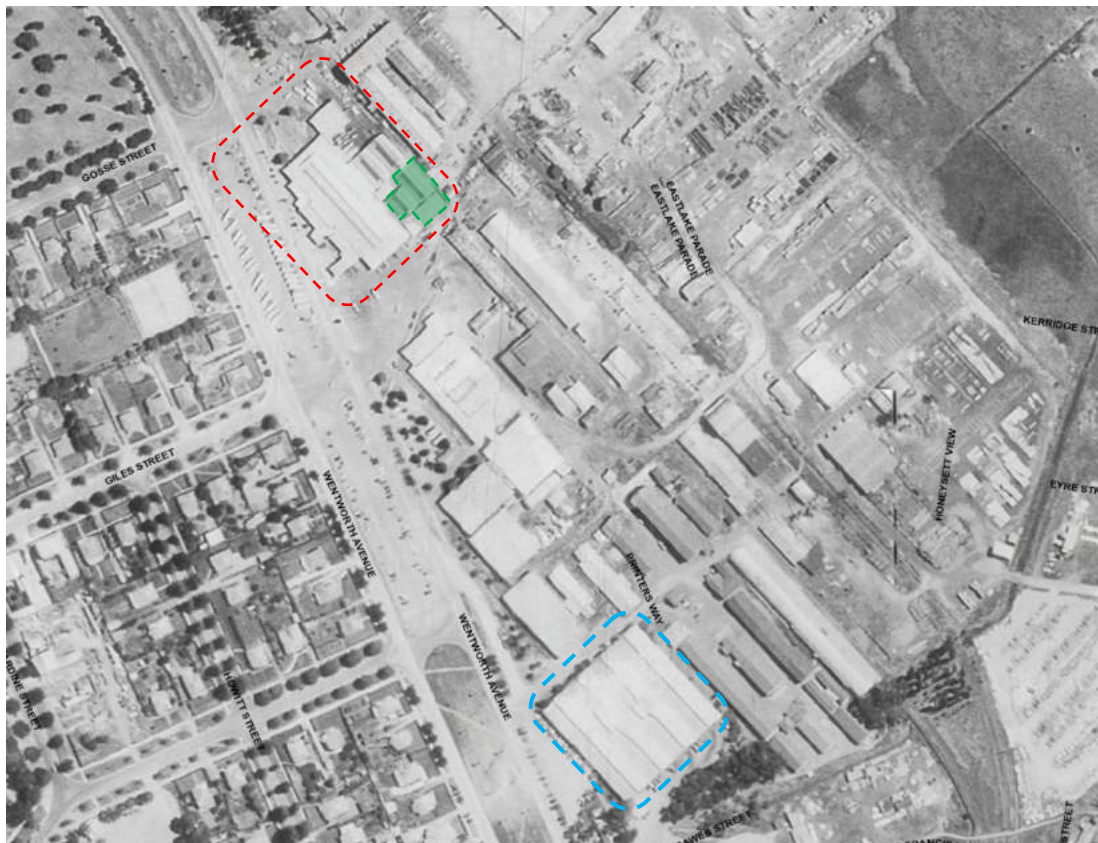
1955 aerial photograph showing the Transport Depot (red) and Vehicle Park (blue).  
The 1951 workshop is indicated in green  
(Source: ACTmap*i*)

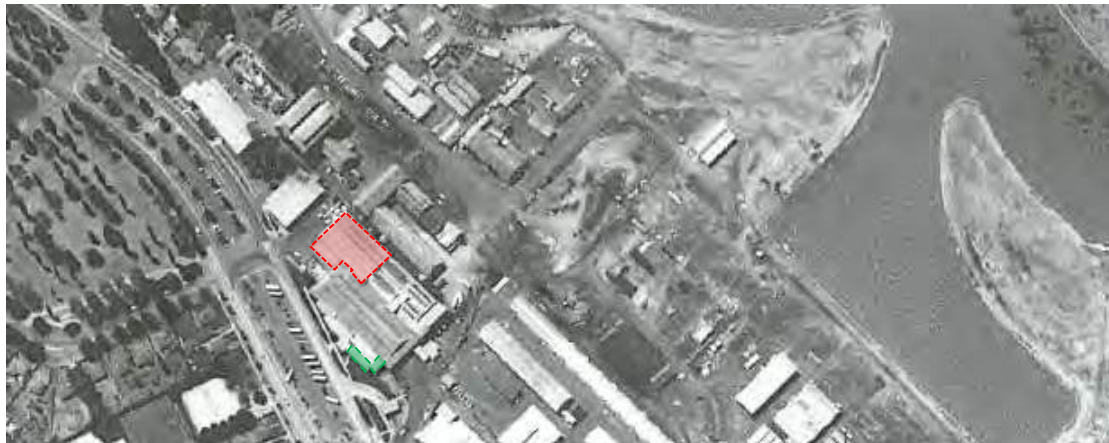
An addition to the south-east end of the Wentworth Avenue administrative offices wasn't constructed until 1960 (refer to aerial photograph below) and was much smaller than that shown on the 1957 plans. It was designed by Moir and Slater Architects in 1960 in a similar mode to the 1945 office addition. At this time, the chimney to the 1940s part of the office, which was originally a flue for the heating of hot water, was converted to a clock tower.<sup>56</sup>

1965 aerial photograph showing the 1957 workshop (red) and the 1960 addition to the administration offices  
(Source: Kingston Section 49 Heritage Strategy, Lovell Chen, 2013)

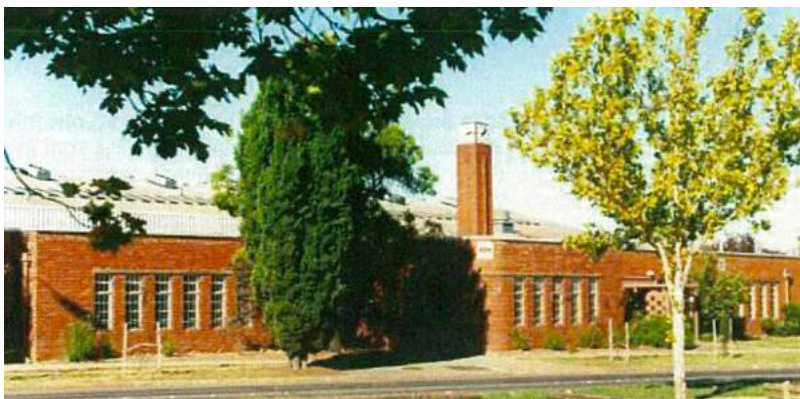
In the early 2000s, the administration block was refurbished. This involved a new interior fit out, painting of the red face brick, replacement of several original steel-framed windows with glass blocks and construction of a new entry porch. In 2013, further works were undertaken to the administration block to convert it to the Megalo Print Studio and Gallery. This involved reconfiguration of the internal spaces, rectifying damp, upgrading services and replacement of unsympathetic glass block windows and bricked-up openings with new windows.<sup>63</sup>

*The administration offices before the face brick was painted (2001)  
Note that glass bricks had been installed in the window openings  
(Source: 2010 ACT Heritage Register nomination report, J Camall and AIA)*

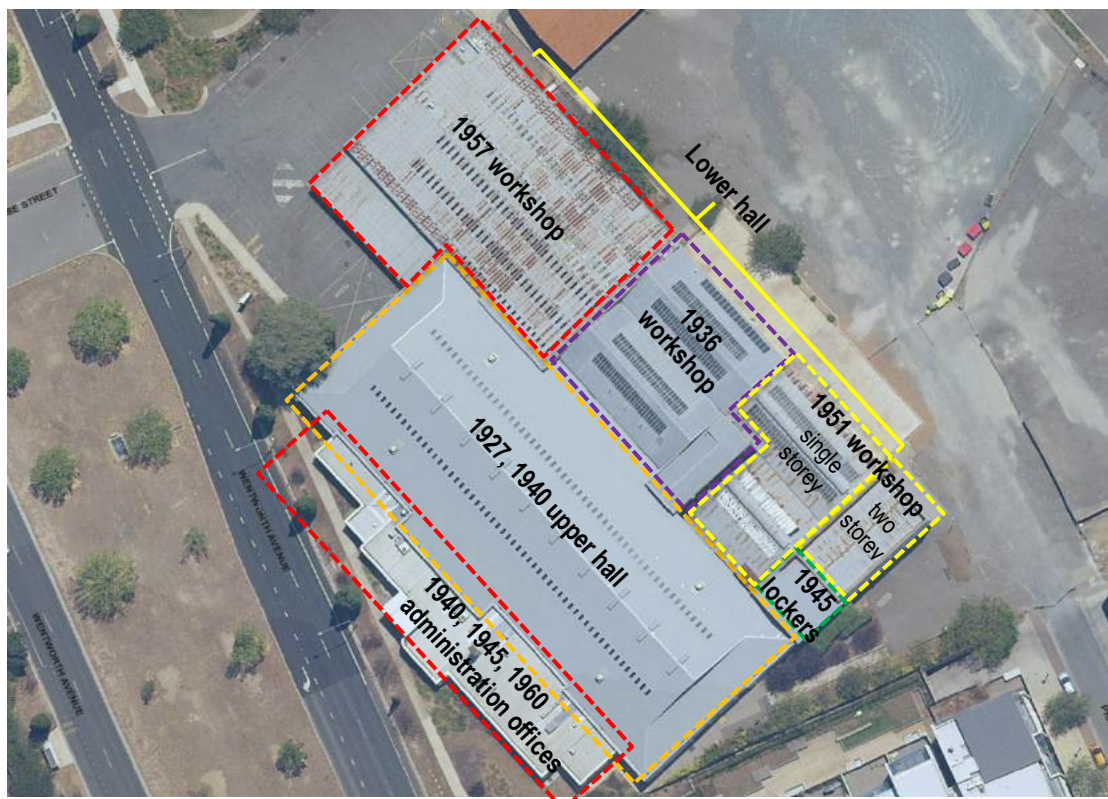
Each of the above are indicated on the aerial photograph below. The 1936 workshop and single storey parts of the 1951 and 1957 (excluding the skillion part) workshops are referred to collectively throughout this CMP as the lower hall.

Aerial photograph showing the location of the main parts of the Former Transport Depot (2020 aerial)  
(Source:ACTmap)

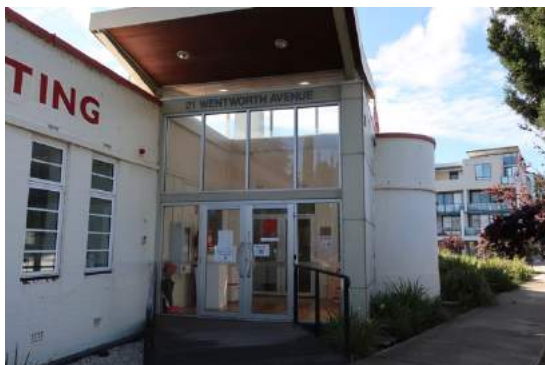
Left: Original, central part of the administration offices (yellow box) with the flue that has been converted to a clock tower and 1960 addition (orange box) with original steel framed windows. Right: Original part with curved corner and 2000s entry structure

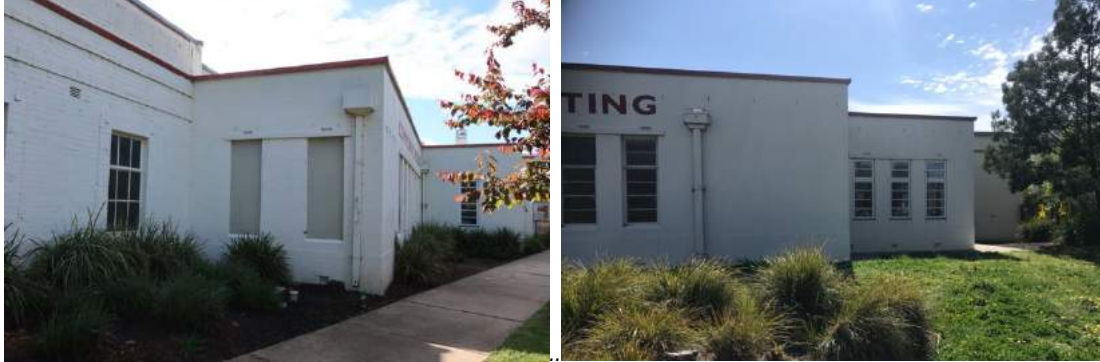
*Left: 1945 addition to administration office with infilled windows. Right: 1960 part of administration office to south-east end*

The building has a subtly projecting brick plinth which contributes to the horizontality of the composition. All sections have vertically oriented window openings which originally had steel-framed windows with horizontal glazing bars. These windows remain to the 1960 part (1 has been replaced), though most windows to other sections are now modern aluminium framed alternatives. Two of these windows to the 1945 addition have been bricked up and another is fitted with glass bricks. A modern entry structure with butterfly roof and ramp has been erected to the front of the original part. Original rectangular rainwater heads remain.

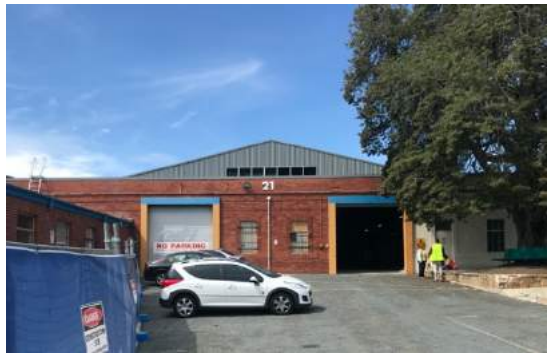
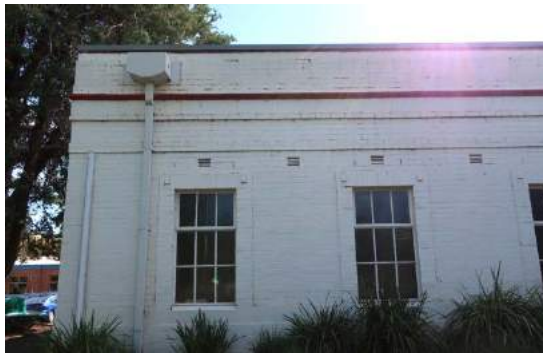
*Left: north-west elevation of 1927 depot building with 1940 roof clad in modern corrugated sheeting.  
Right: west end of south-west elevation, 1927 depot with original steel framed windows and overpainted brickwork*

Three original multi paned steel-framed windows remain to the north-west elevation as do the original vehicle openings this side, though these have been enlarged and fitted with modern roller doors. Another three original windows also remain to the south-west elevation. Original openings are framed by projecting brickwork incorporating a soldier course above the openings. The steel frame to one of the windows on the north-west elevation has been altered to accommodate air conditioning units and metal security grills have been installed over two of the windows to this side. Two original pedestrian doorways to the north-west elevation also remain and are fitted with modern flush panel doors.

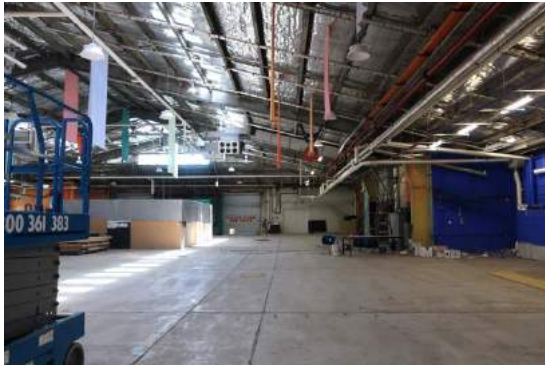
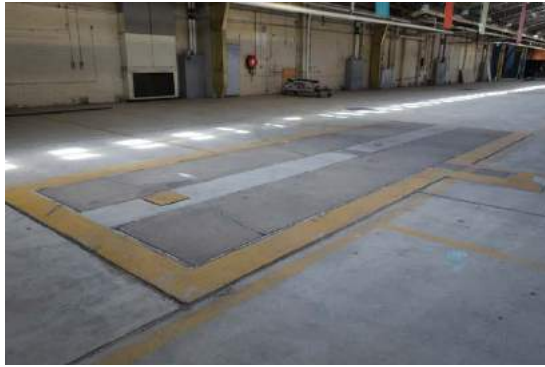
*Left: interior of upper hall, looking south-east. Right: previous service area*

The roof was originally clad in deep profiled corrugated asbestos sheeting though this has been replaced with a modern metal alternative. There are several raised sections of flooring and covered drainage pits within shallow spoon drains throughout the building that are trip hazards. These indicate the types of activities that were previously undertaken in the space. The ramps at either end of the upper hall to each of the roller are also trip hazards. A raised platform is located to the west corner adjacent to the fire services room. A more recent steel stair provides access to the gallery (former lunch room).

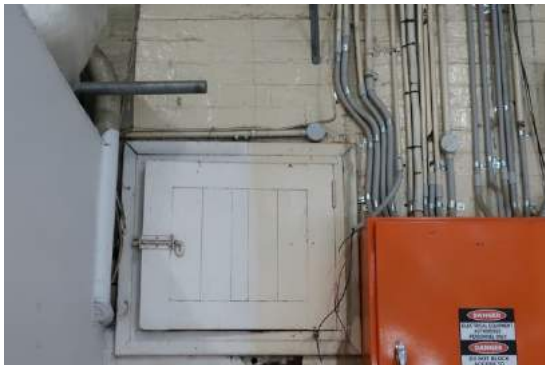
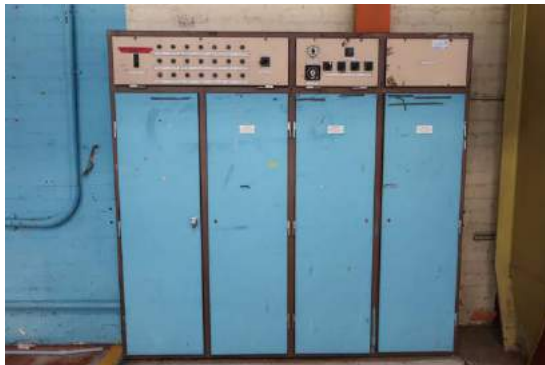
A small, hut with timber door is located to the south-east wall, though has been bricked over externally. An early metal tank supported on a timber deck that is suspended from the roof is also located to the south-east end. Galvanised metal vent covers are located to the south-west wall. It is not clear if the fuel/oil tank located below the floor at the eastern end of the building remains (shown on the original drawings).

*Left: Timber hut to south-east end. Right: circa 1950s mechanical plant control board*

A range of equipment and services have been installed over the years and give an indication of the types of activities that were undertaken. Some early items include a small control panel to the south-west side which includes a Venner time switch. A mechanical plant control board for the early mechanical systems is located to the north-east side and likely dates to the 1950s. Parts of an earlier heating system that includes hot water pipes (boxed out to the lower part with sheet metal) remain, as does a relatively modern air conditioning system that is no longer operational. This area, like the lower hall, is fitted with Nederman swinging arms, which were presumably used for fume extraction and likely date to the final years of the transport depot phase.

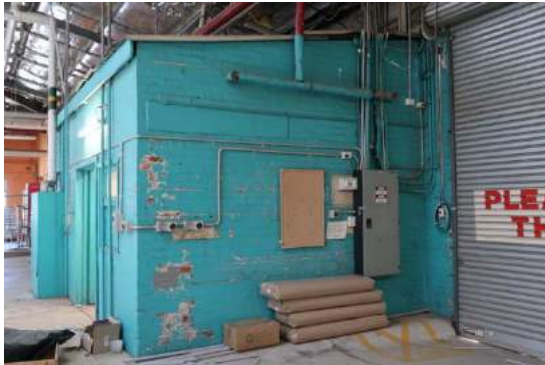
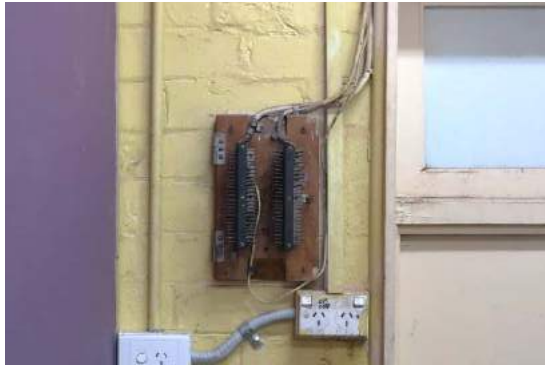
This space appears as the Transport room on the 1926 plans and is used as a storeroom by the markets. The walls are constructed of brick and it has a separate skillion roof under the portal roof of the upper hall. The skillion roof was likely rebuilt in 1940 when the portal framed roof was erected. An early braced and ledged timber door with vertical boards is located to the south-east side (in an enlarged opening) and likely dates to 1940 when a door was installed on this side following the demolition of the adjacent office. The concrete lintel to the original doorway is evident on the north-east side, though the opening below has been infilled with brick. The sheet linings to the ceiling are in poor condition and the floor is clad in modern non-slip sheeting. An early telephone distribution board remains in the office to the south-east wall.

*Left: north-east side of office. Right: telephone distribution board*

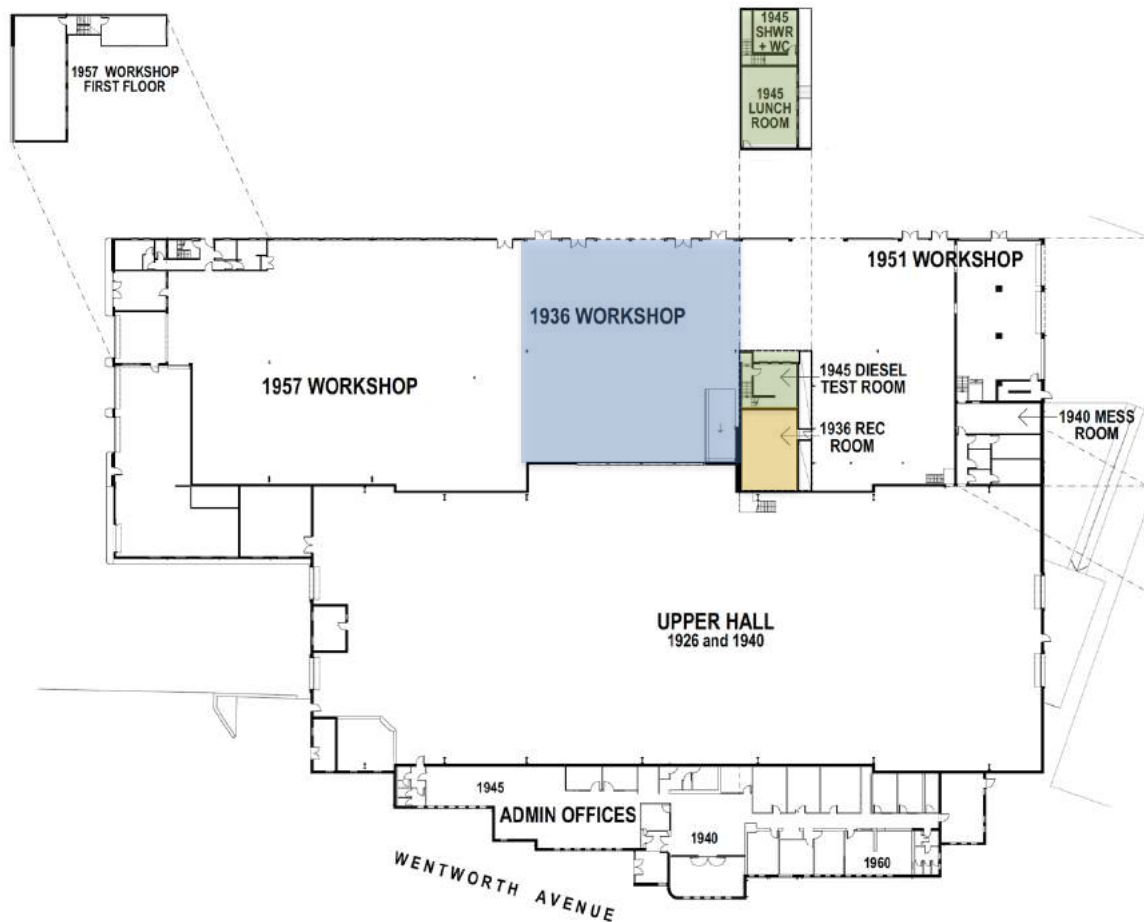
*Floor plan showing 1936 workshop (blue) with associated 1936 recreation room (orange), adjacent 1945 diesel test room and 1945 shower and lunch room addition to first floor (green)*

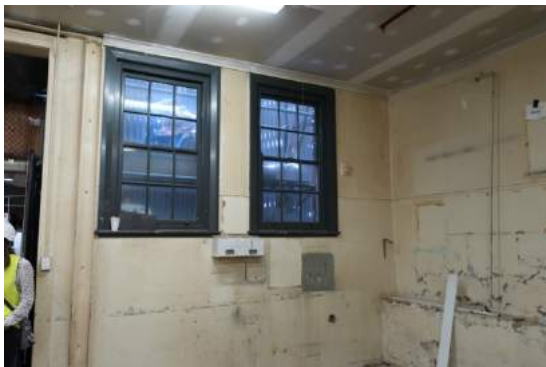
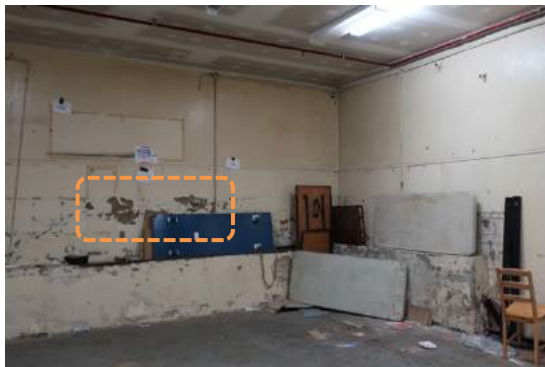
*Left: south corner of former recreation room. Right: west corner of former recreation room showing damage to the hard plaster*

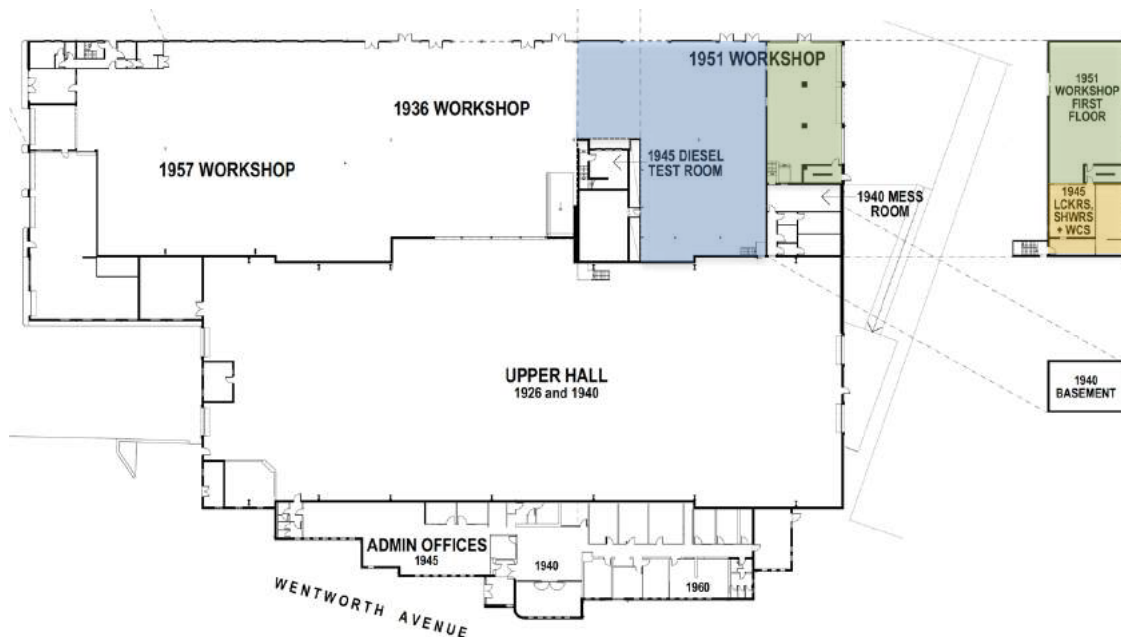
*Floor plan showing single storey part of 1951 workshop (blue), two storey part of 1951 workshop and adjacent 1945 locker room (green), showers and toilets (orange)*

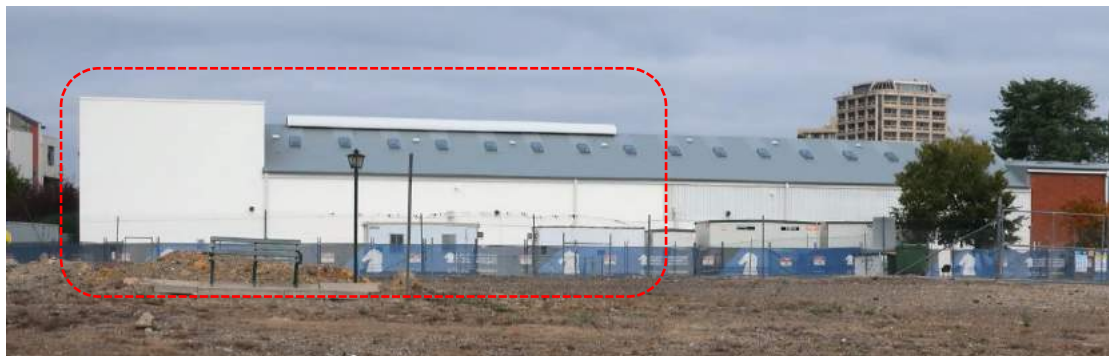
*North-east elevation with the 1951 workshop indicated*

The gable roofs originally had a row of wired glass skylights to each roof slope and continuous ridge vents. The original galvanised corrugated sheeting has been replaced with a Colorbond alternative and the skylights replaced with modern types in a different configuration.

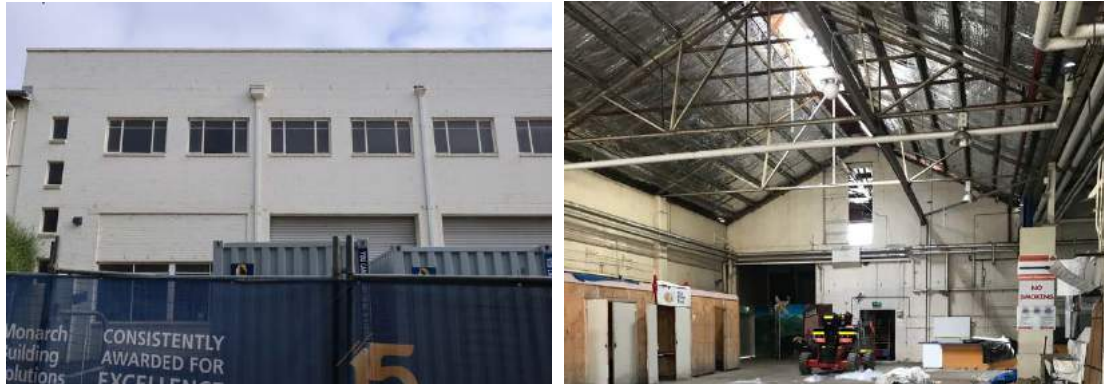
*Left: south-east elevation of 1951 workshop. Right: interior of 1951 single storey section looking east*

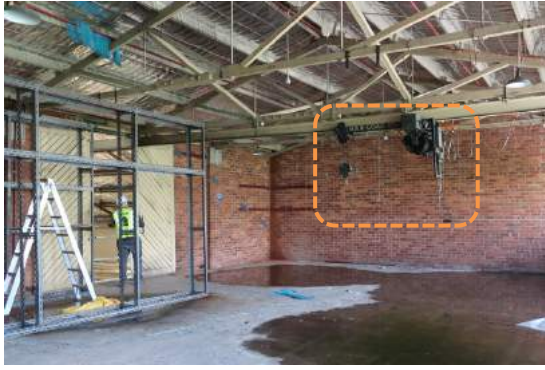
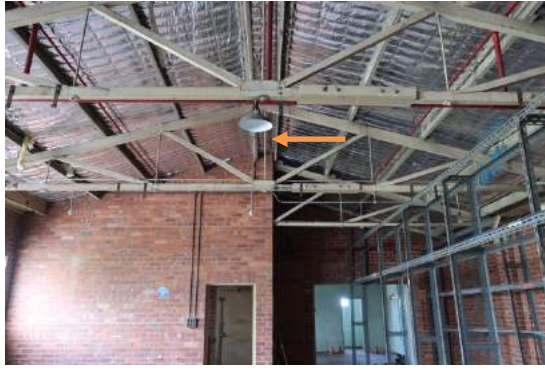
This area, now known as the loft, is not currently used. The space is intact and retains face red brick walls, steel framed windows with casement openings and composite timber and steel (rods) roof trusses. The underside of the box gutters are lined with timber boards. An overhead monorail with electric hoist remains to this area. Steel angles have recently been installed to tie the north-east wall to the adjoining walls.

*Left: Upper floor of 1951 workshop with original hoist (indicated) and timber doors.*

*Right: Upper floor of 1951 workshop looking south-west with original light shade indicated.*

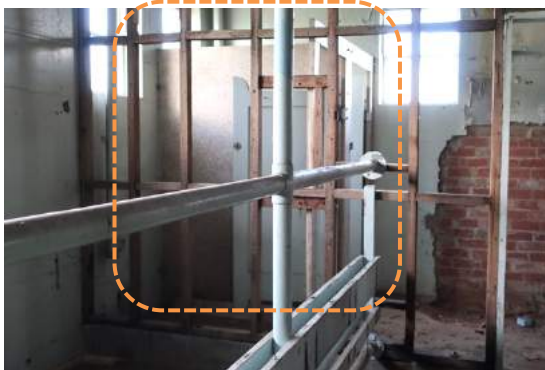
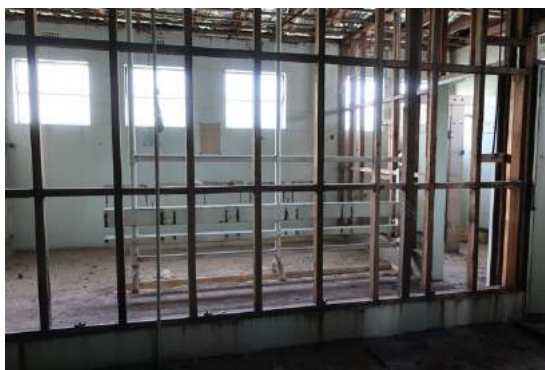
*Left: original terrazzo partitions and timber doors to toilet cubicles (indicated). Right: dressing area with spoon drains*

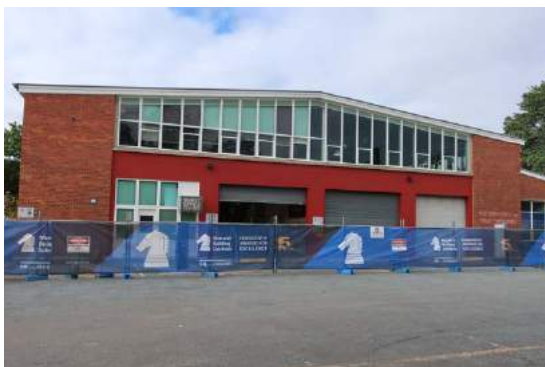
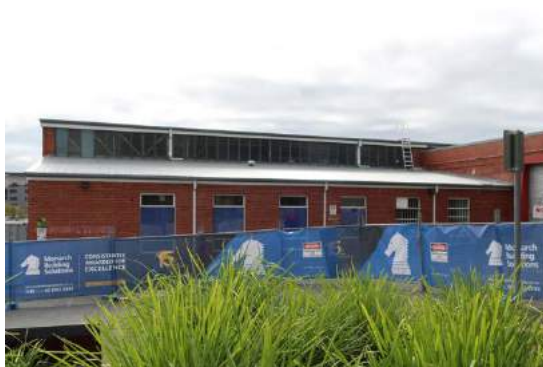
The main part of this building has a broad gable roof which originally included rows of two skylights to each roof slope. A skillion section, constructed at the same time as the gable part, is located to north-west of the original transport depot. The skillion part originally consisted of a special duty car bay at the same level as the upper hall and a trimming shop located at the height of the lower hall.

*Left: north-west elevation of 1957 workshop showing two storey gable part with skillion section to the right.  
Right: south-west elevation of south-west workshop with the skillion section in the foreground*

The roof of the gable section is supported on steel angle trusses and is clad in corrugated metal sheeting. There are steel trussed stanchions to the south-west side of this part. This section incorporates a second storey in the north corner which has a concrete frame with brick infill walls. There is a proprietary glazing system to the north-west gable end which incorporates green coloured glass to the upper part (much of it now overpainted) and has awning openings.

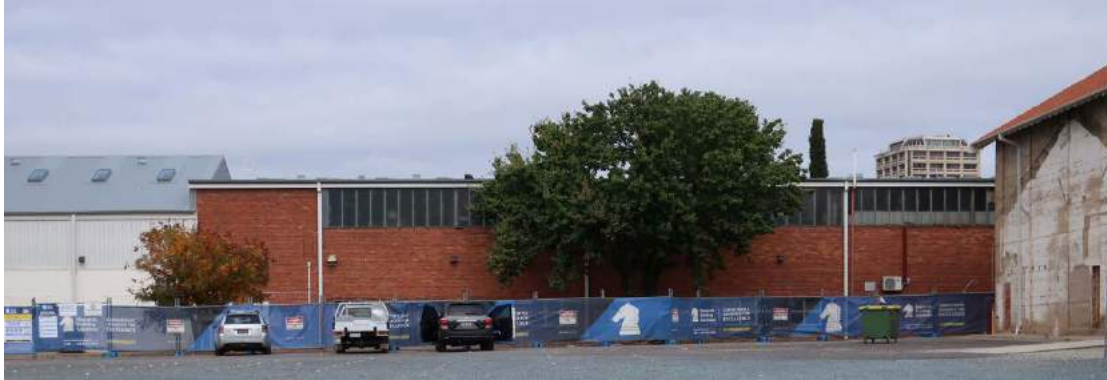
The north-east and south-west elevations of the gable part has a continuous strip of high level windows with wired glass that abuts the fascia. Windows to the lower part of the north-east elevation are steel framed hopper types. Vehicular access to the workshop was provided by three large roller doors to the north-west elevation with one door for the large workshop, one door for the former wheel alignment bay and one door for the former joinery shop (now part of the foreshore space). An original timber framed window wall, with central timber door provides pedestrian access to the former traffic office.

*North-east elevation of 1957 workshop*

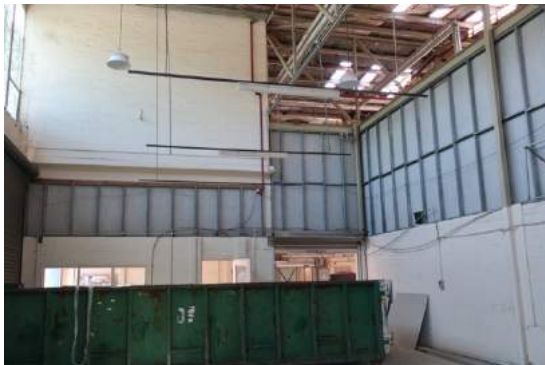
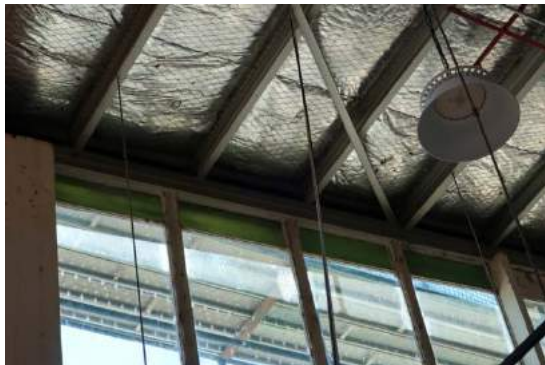
The joinery shop and wheel alignment bay are divided from the workshop by low brick walls. Modern sheet linings on steel studs have been installed between earlier, more substantial steel framing located on top of the brick walls to provide greater separation between the Foreshore space and the workshop.

*Left: modern partition above original brick walls. Right: green glazing to upper part of north-west gable end*

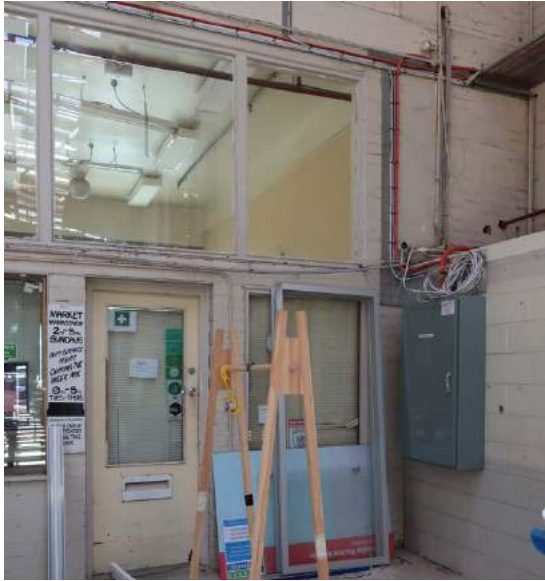
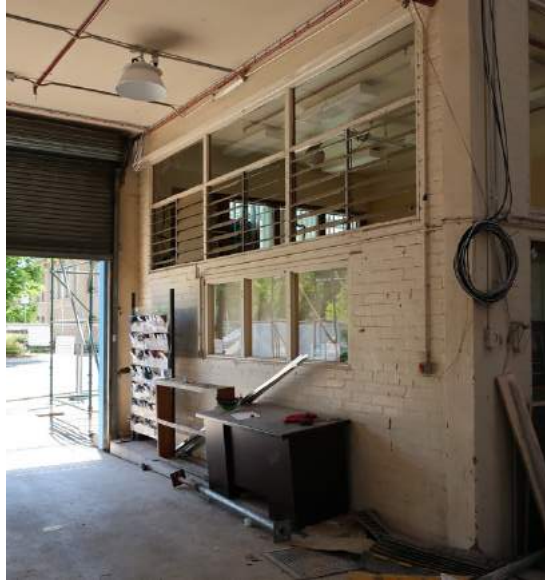
The office has a strip of high level windows that face the workshop (south-east and south-west sides). These have been fitted with modern fixed glass, though earlier louvers remain to the south-west side. A later window is located to south-west side of the office whilst two fixed windows and an early timber door with glazed upper part are located to the south-east side.

*Left: south-east side of traffic office. Right: south-west side of traffic office with early glass louvers to the upper part*

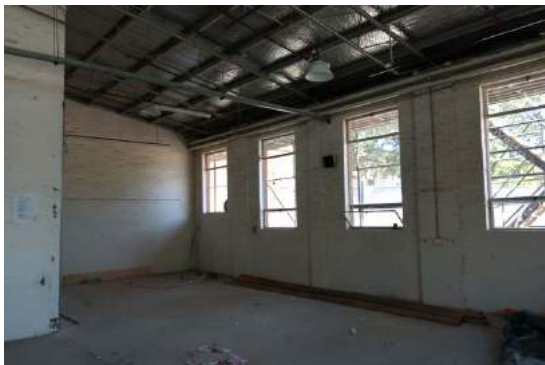
The skillion section is constructed on two levels with the upper part opening onto the main hall and the lower part level with the workshops. This section has a raked steel truss and timber purlins with roof that was originally clad in short lengths of galvanised corrugated metal sheeting. Windows are steel framed with hopper openings to the top and bottom. A large metal roller door to the north-west elevation provides access to the former trimming shop. Above this door and the adjacent steel framed window is a continuous rendered hood.

*South corner of trimming shop*

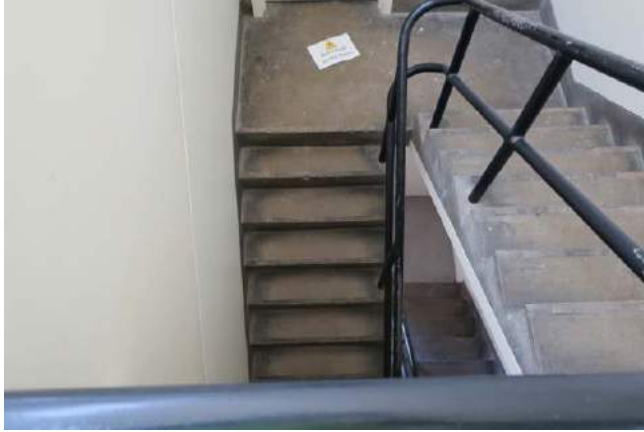
The original concrete stair with plain galvanised steel pipe handrail remains. The stair and balustrade do not meet contemporary building code standards. Walls are hard plastered and have a tooled dado line.

*Concrete stair with pipe handrail*

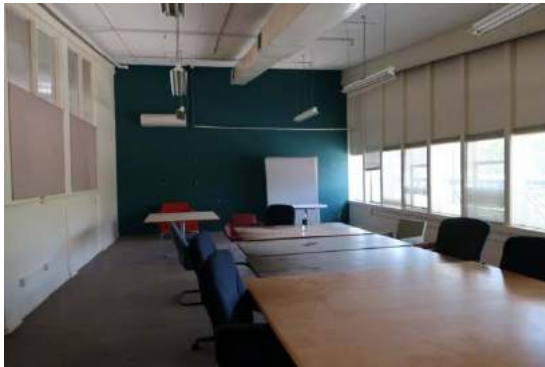
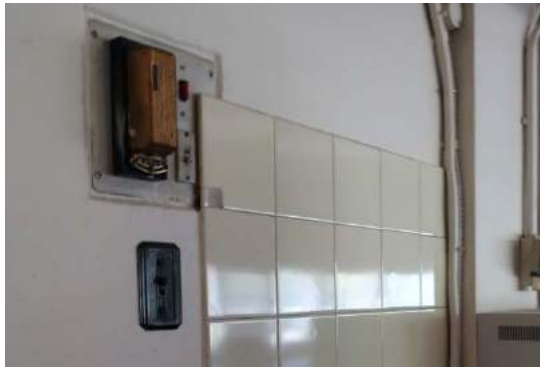
The brick walls to the former mess room extend up to the underside of the gable roof. This section has high level timber framed windows with obscure ribbed glass which overlook the workshop. The current fit-out dates from the early 2000s. The ceiling is perforated acoustic panels (south part) and modern plasterboard (north-east part). Early cream tiles as well as a light switch and heater control switch remain adjacent to the door.

*Left: south-west end of room Right: early cream tiles, light switch and heater control switch*

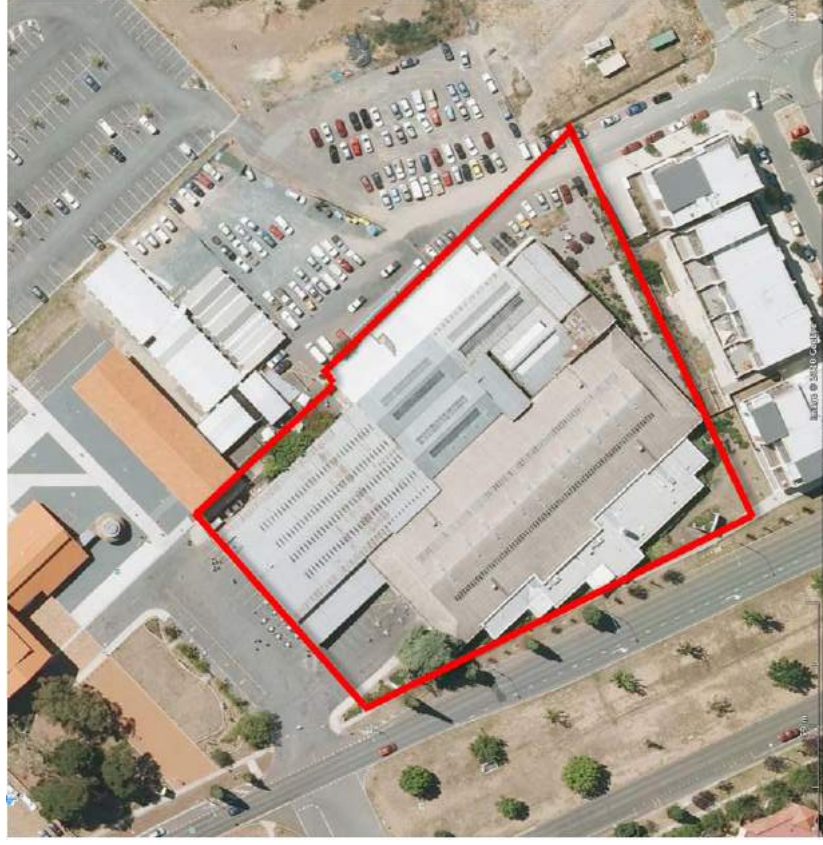
## SITE PLAN

The site boundary is indicated by red lines on the above plan – the eastern boundary includes the orientation of the building parallel to the railway siding and the western aligns with the block boundary on Wentworth Avenue. Northern and southern boundaries align with the former Transport Depot building footings.

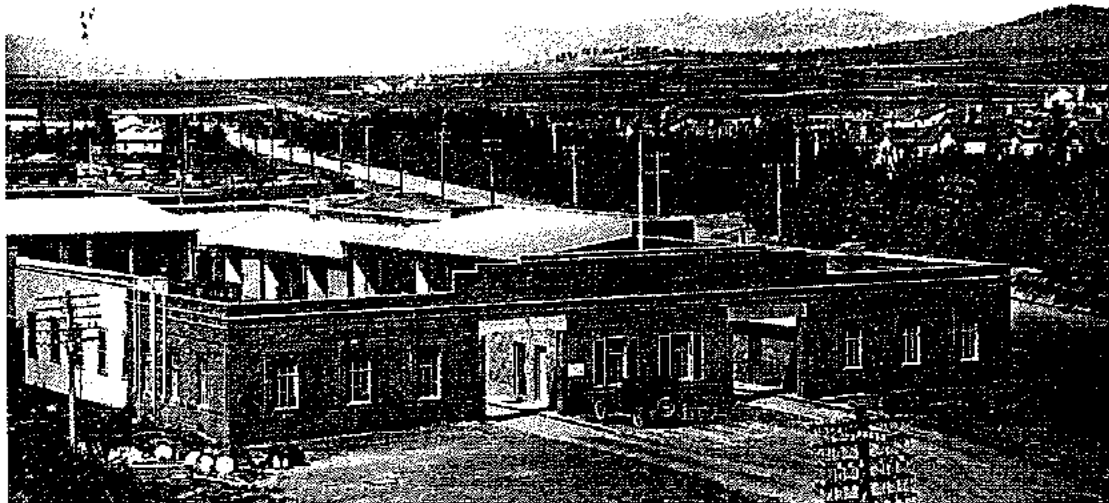
The *Eastlake Garage*, the original Transport Depot, was designed by the Architect's Department in 1926 and was constructed in 1927, refer to Plate 4, a 1929 photograph from the "Mildenhall Collection", and Plan Ag 313 'Garage at Kingston' dated 13/12/26 (in the attachments) 2. The architectural elevations and the photograph taken in early 1929, show the original Kingston Transport Depot. The building was constructed around a vehicle turning courtyard with brick external walls to all sides except along part of the north eastern façade that faced onto the railway lines and Molonglo River, and away from the Avenue. A continuous brick parapet concealed the skillion roofs that sloped inward to the unroofed vehicle turning area. The parapet stepped up in the centre of the north western and south eastern elevations. The photograph shows that the land to the north east of the depot falls away steeply towards the railway line.

**Plate 4:** The Depot from the Powerhouse, 1929. Source: Mildenhall Collection National Archives of Australian.

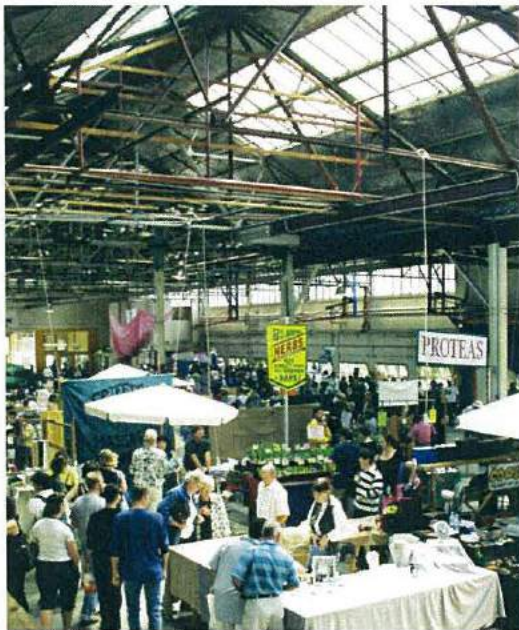
**Plate 9:** Lower level 1936 workshop on market day with the 1950s extension beyond.

The Canberra Times articles reported that "The additions have been necessitated by the growing demand of transport services, and, by the desirability of co-ordinating the various repair departments in one unit. The present repair shop will be transferred from the engineering and fitting department to the new building when completed." And that "provision will be made for staff recreation room, repair pits, store rooms, offices, fitting shop and garages for housing of trucks and buses." This structure is intact. Refer to Plate 9 that shows the roof structure in the foreground.

The lower level large open plan spaces are approached down a central concrete ramp. This area appears to consist of a number of structures that have been built at different times with steel bolted roof trusses, refer to Plate 9. The central section is a double gable roofed area constructed from a simple bolted steel truss system supported on steel columns.
