# Conservation Management Plan

## **FORMER TRANSPORT DEPOT**

Prepared by  
**Philip Leeson Architects Pty Ltd**

*Issue for*  
*Submission to ACT Heritage*  
**April 2021 (Approved June 2023)**

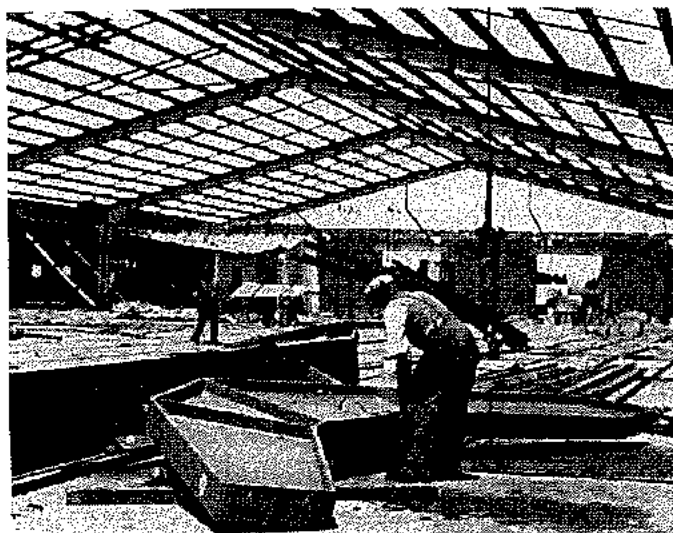
Plate 10: Inside the Depot looking southeast, with the fully welded rigid portal frame over the existing 'Garage' under construction, 1941. Source: Val Emerton. Jack Benson photograph.

The fully welded rigid portal frame and roof over the existing main structure and its south eastern extension was designed by the Department of Works for the Department of the Interior, Canberra, in January 1940 s. Refer to Plates 10 & 11.

The main Garage level is constructed from a fully welded rigid portal frame. Refer to Plates 10 & 11. Generally this space is about 85 metres long. The engineering drawings show that the end portals have a span of approximately 31 metres and the typical portal spans 29.7 metres. The central portal spans approximately 35.5 metres.

A photograph, Plate 10, taken by John Benson, Val Emerton's father, shows the structure under construction. The fabricated haunch can be seen lying on the ground prior to installation with its splices clearly evident.

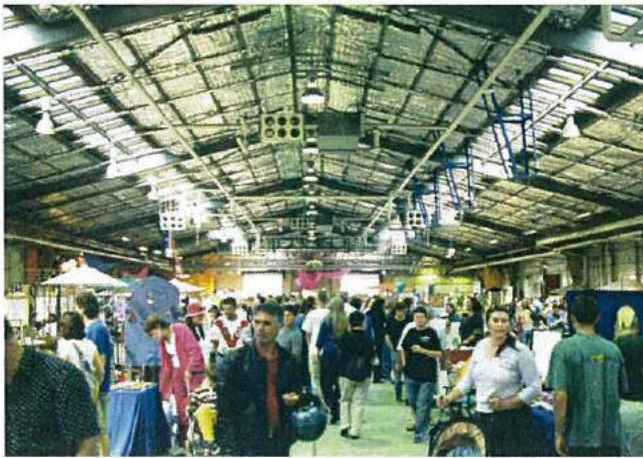
**Plate 11:** Upper level (Garage) on market day.

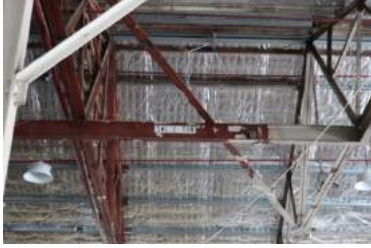
Items	Photo	Conservation Action
Monorails, throughout workshop areas of building

All monorails shall be retained
Remnant heating services, throughout building

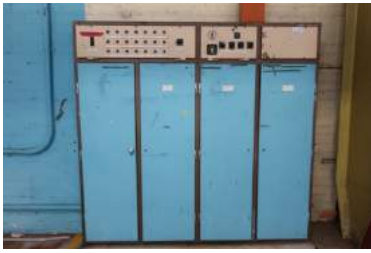
Items	Photo	Conservation Action
Circa 1950s mechanical plant control board, upper hall

Should be retained
Overhead tank, south-east end of upper hall

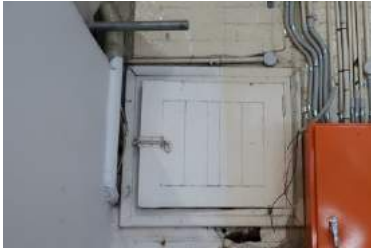
Should be retained
Small timber door/hutch, south-east end of upper hall

Should be retained
Bell/alarm, south-east end of upper hall

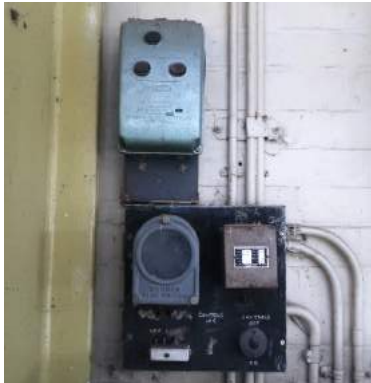
Should be retained
Venner time switch and control panel, south-west side of upper hall

Should be retained

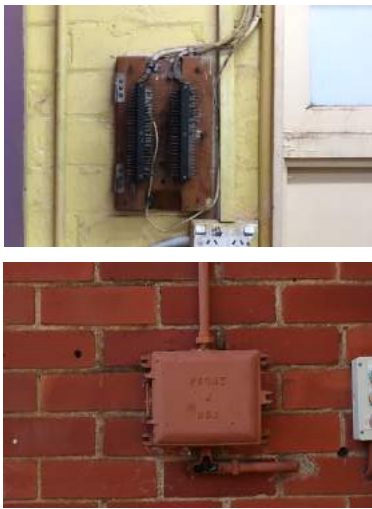
Items	Photo	Conservation Action
Telephone distribution board (office, upper hall) and phone junction box (exterior, upper hall)

Internal and external components should be retained
Remnants of vehicle inspection pits (now filled in), upper hall, adjacent to 1936 workshop

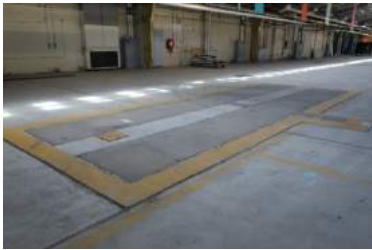
Footprint should be retained
Inspection bay?

Footprint should be retained
Nederman swinging arms, presumed fume extraction apparatus, 1936 workshop and upper hall

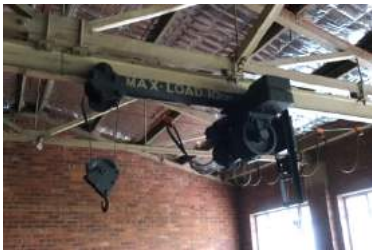
Representative examples should be retained
Monorail and hoist, 1951 workshop, first floor (the loft)

Shall be retained

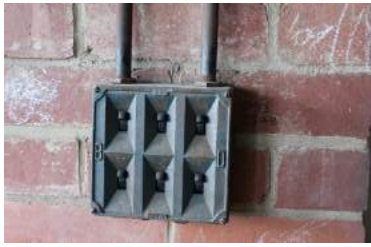
Items	Photo	Conservation Action
Original switches, 1951 workshop, first floor (the loft)

Shall be retained
Original light shades and suspended power sockets (yellow arrow), 1951 workshop, first floor (the loft)

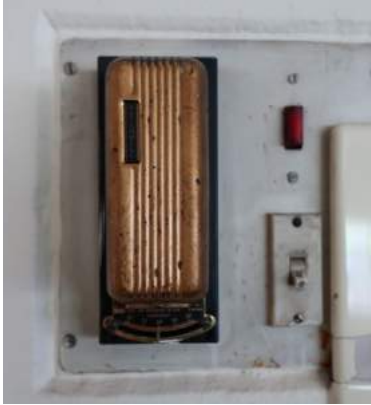
Items	Photo	Conservation Action
Thermostat, 1951 workshop, first floor

Should be retained
