Notice of Approval of Conservation Management Plan under Section 61K of the *Heritage Act 2004*

John Fowler Road Locomotive No. 16161

Conservation Management Plan

August 2020

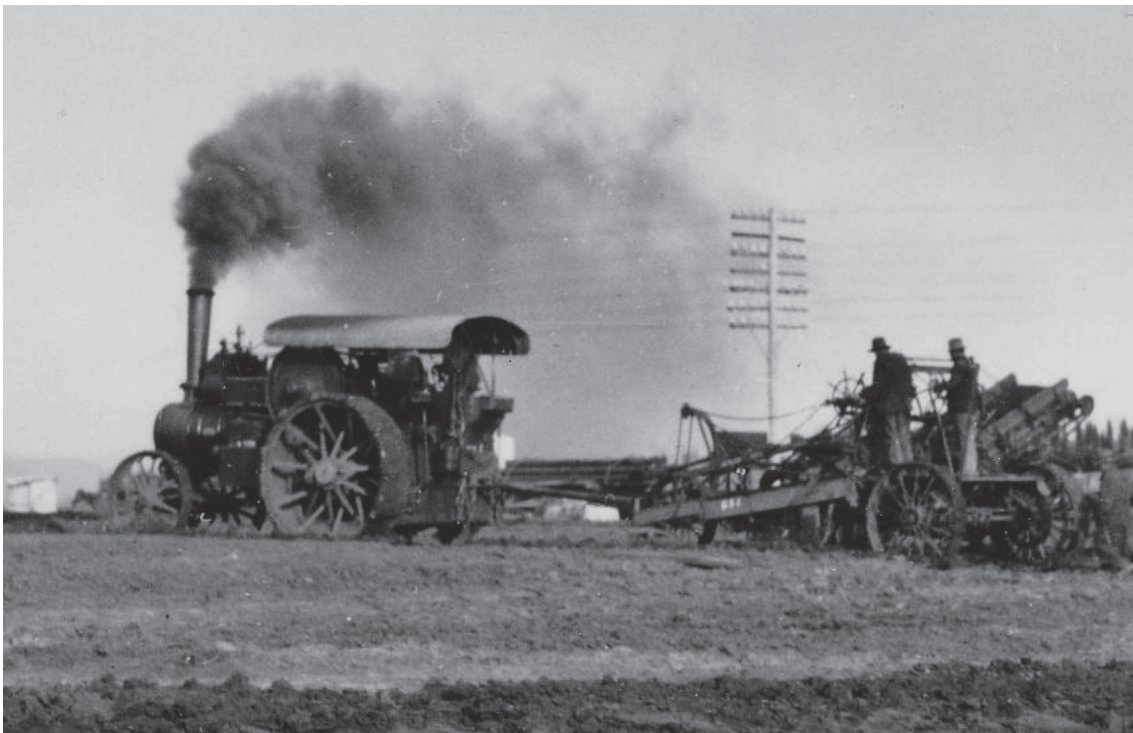
Figure 12 One of the Fowler road locomotives hauling a 'New Era' elevating grader at the South Ainslie business sites (c. Jan-June 1926)
Source: National Archives of Australia (Mildenhall Collection)

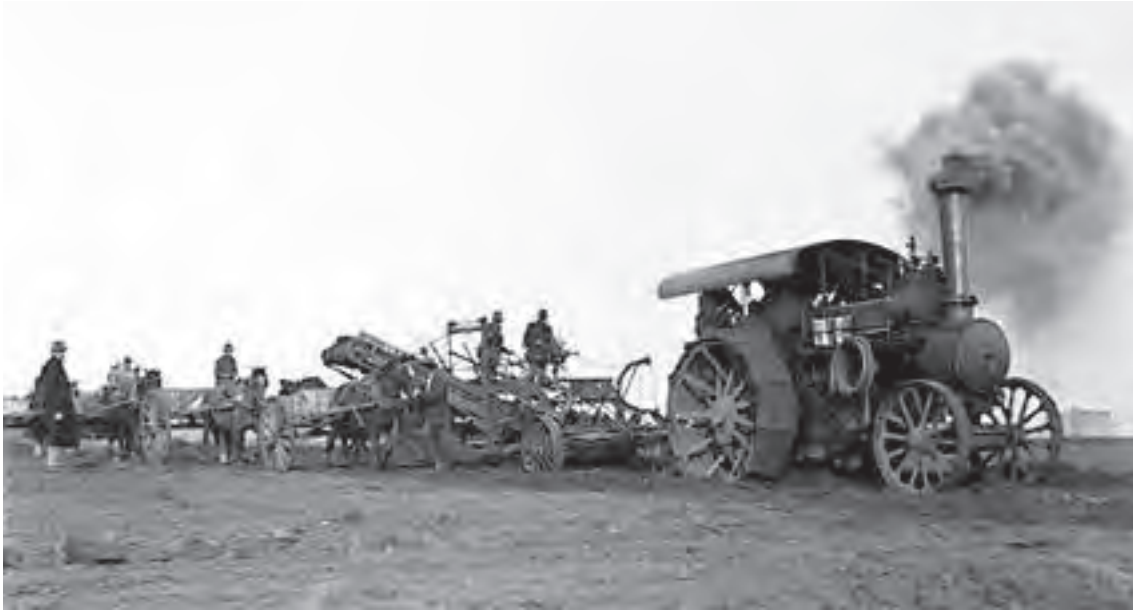
Figure 13 Another view of one of the two Fowler road locomotives at the South Ainslie business sites (c. Jan-June 1926): due to the soft ground the rear wheels are fitted with spuds (cleats) to improve traction
Source: National Archives of Australia (Mildenhall Collection)

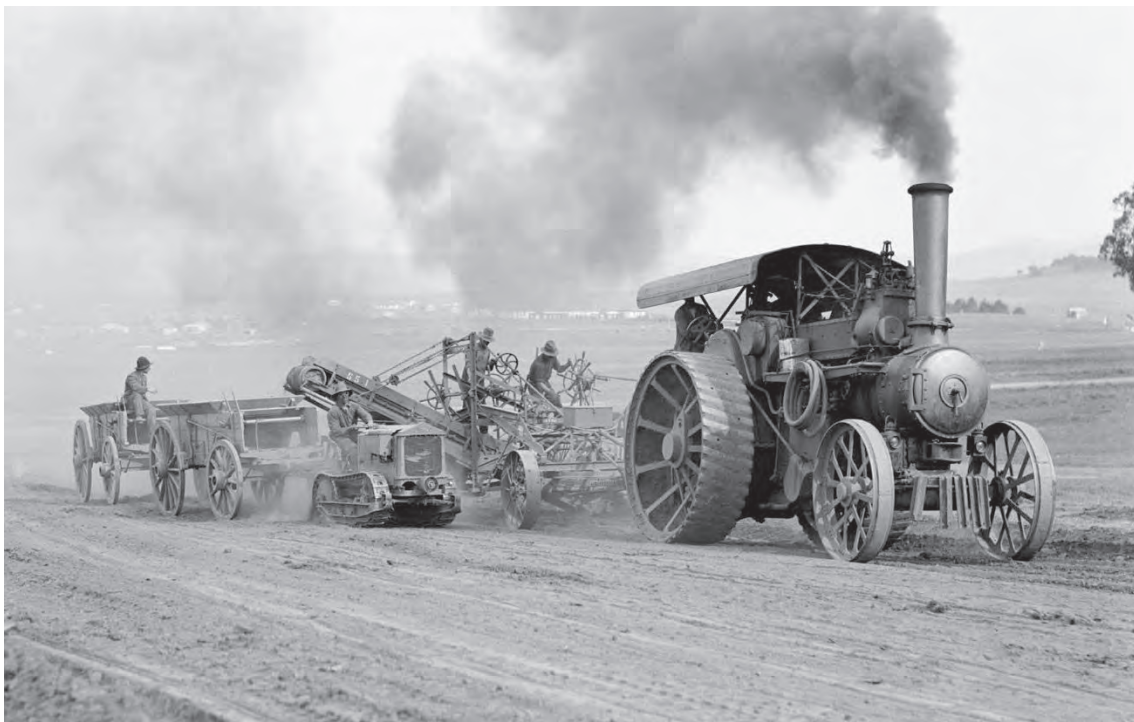
Figure 14 One of the Fowler road locomotives towing the New Era elevating grader while forming a road way
Source: National Archives of Australia (Mildenhall Collection)

- 40 *Burnie Advocate*, 8 June 1926, p.1
- 41 The manufacturer of the elevating grader was identified from Figure 14 (NAA: A3560, 2387) where the name "Austin New Era Senior" is marked on the grader frame. The serial number of the grader is most likely the 4350 number painted on the cross member, and the FCC plant number is 651.

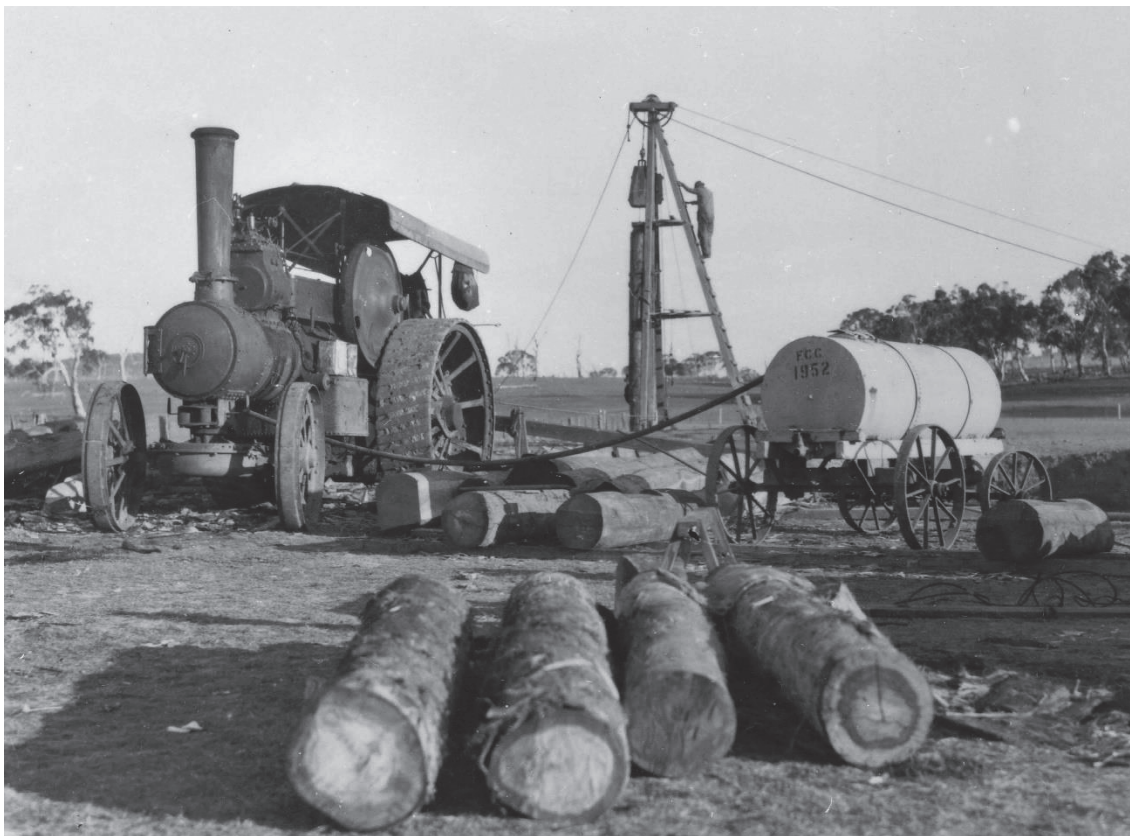
Figure 16 Fowler road locomotive no.16162 being used to drive piles for a bridge
Source: National Archives of Australia (Mildenhall Collection)

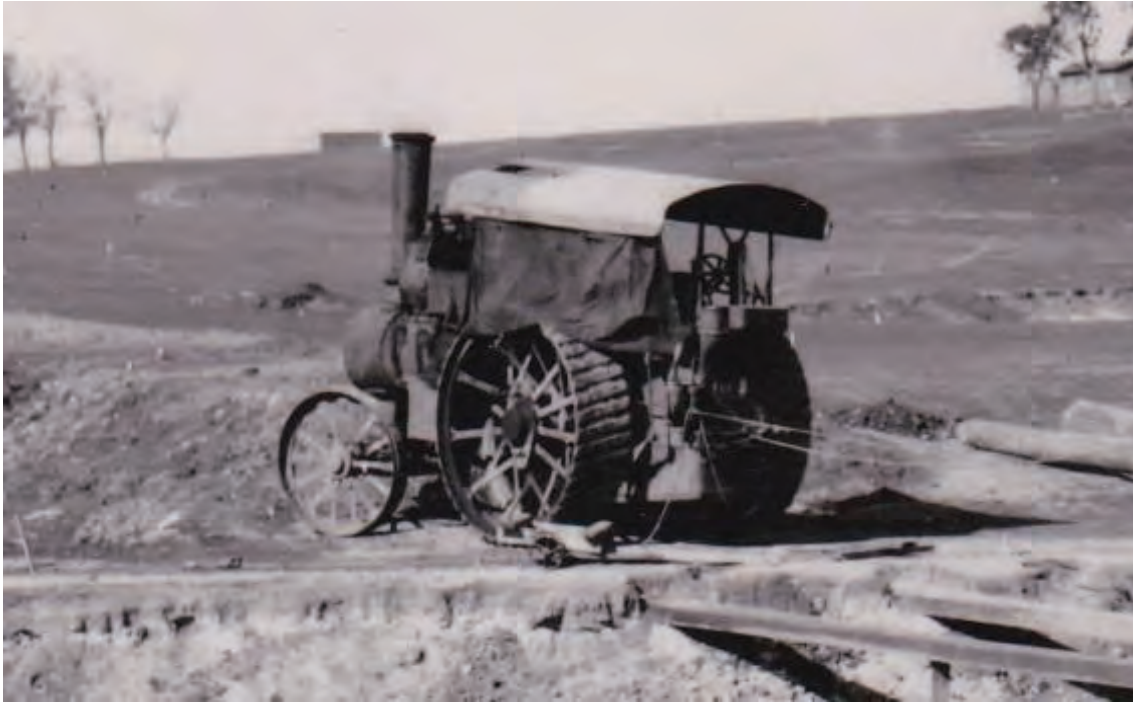
Figure 18 Close up view of Fowler road locomotive no.16162 showing the slot in the canopy above the flywheel

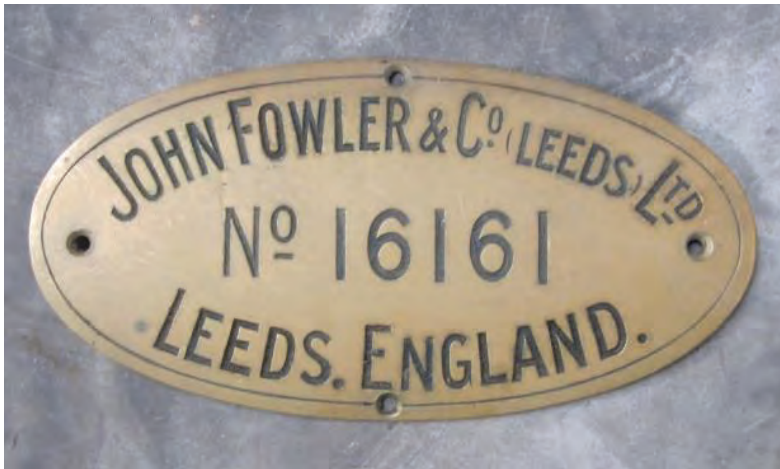
Figure 26 Manufacturer's nameplate: this is not presently fixed to the engine. It was normally screwed to the cladding on the flywheel side of the engine
Source: Rohan Lamb, December 2013

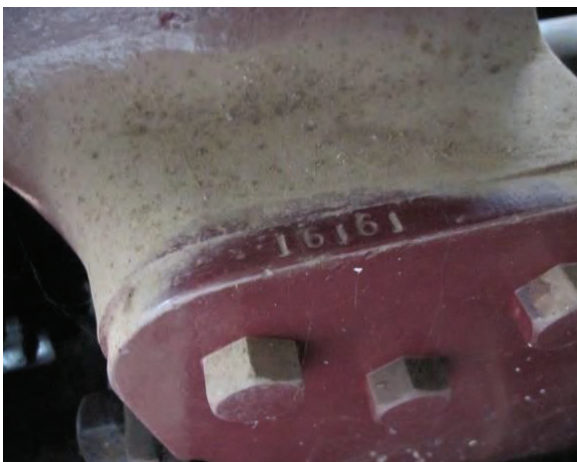
Figure 27 Left and right: Engine serial number 16161 stamped into the edge of the spectacle plate
Source: Rohan Lamb, December 2013

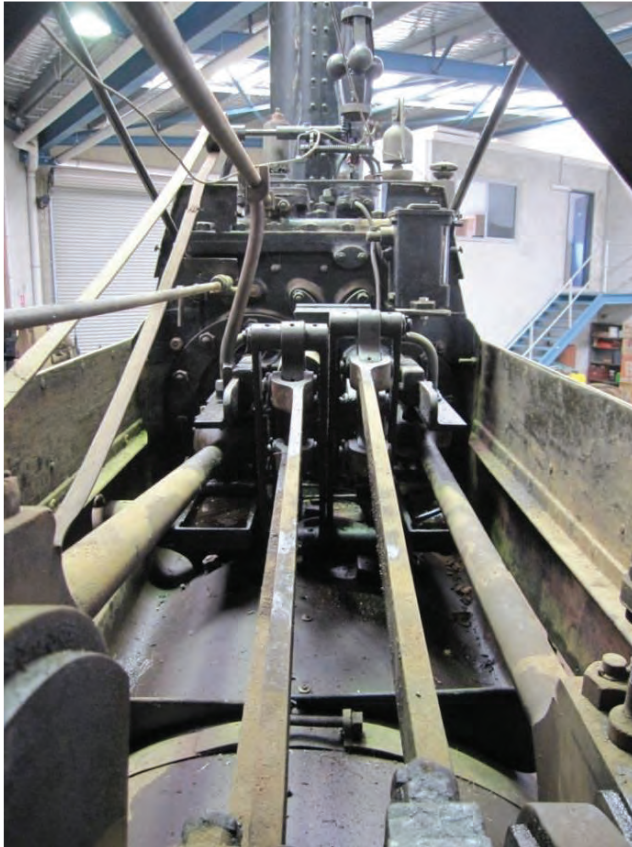
Figure 29 Engine on top of the boiler looking forward towards the cylinder with the Stephenson's reversing links in the middle
Source: Rohan Lamb, December 2013

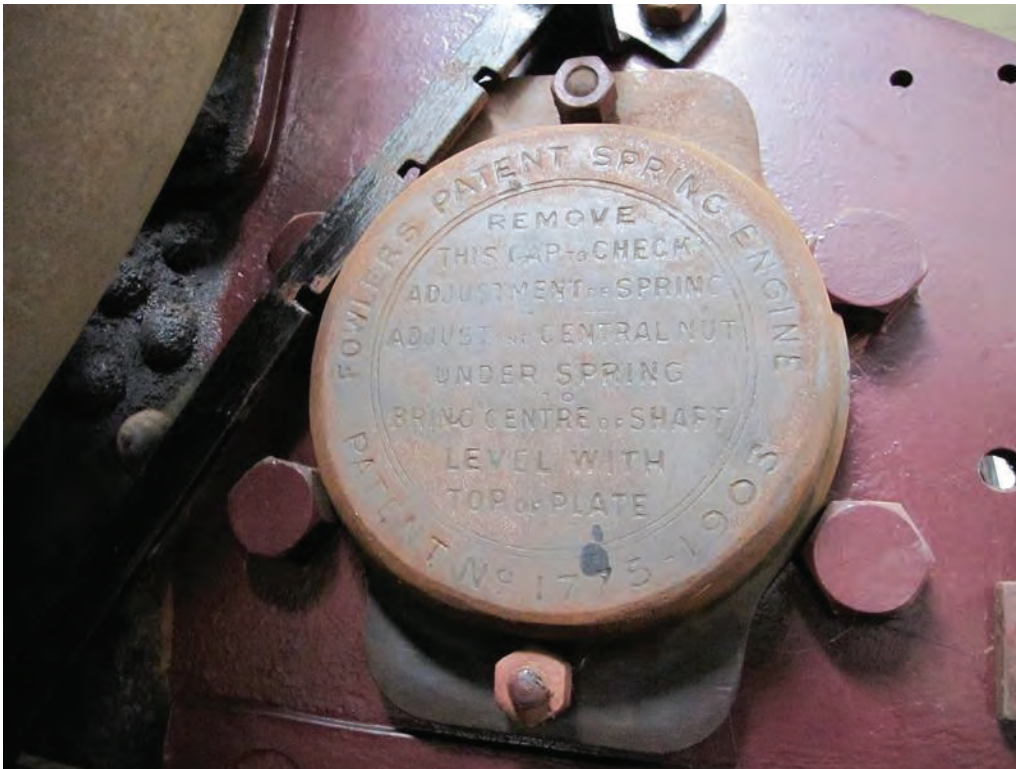
Figure 32 Rear axle spring adjustment cover: note the reference to patent no.1775-1903
Source: Rohan Lamb, December 2013

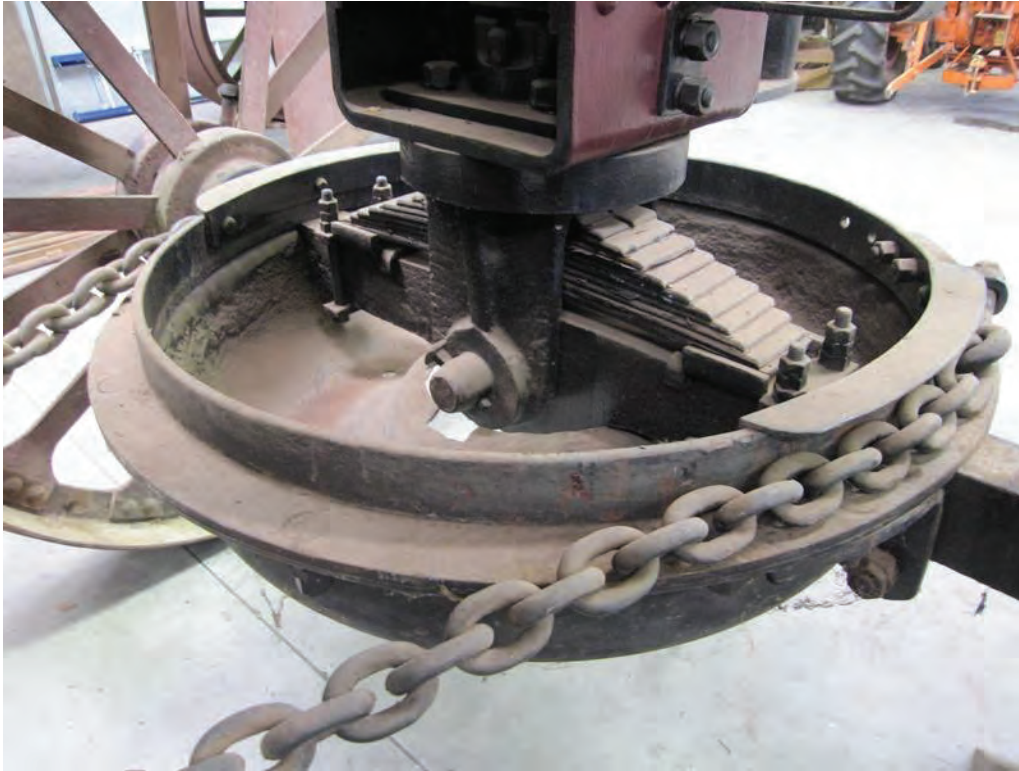
Figure 34 Front axle leaf spring

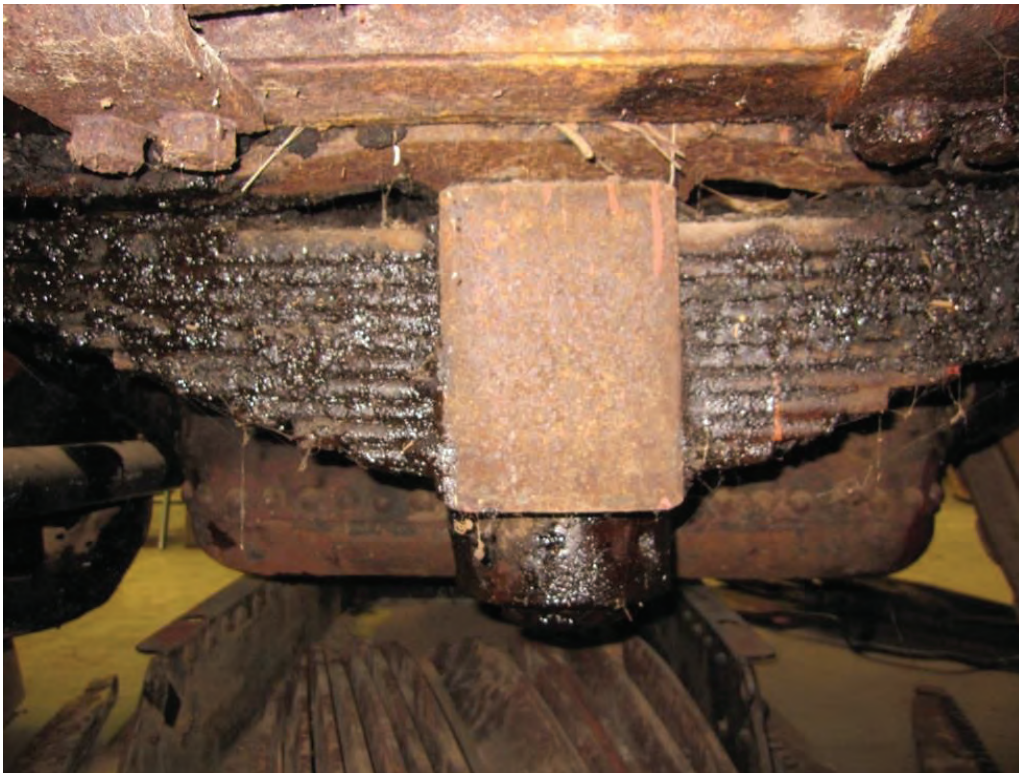
Figure 35 Rear axle leaf spring

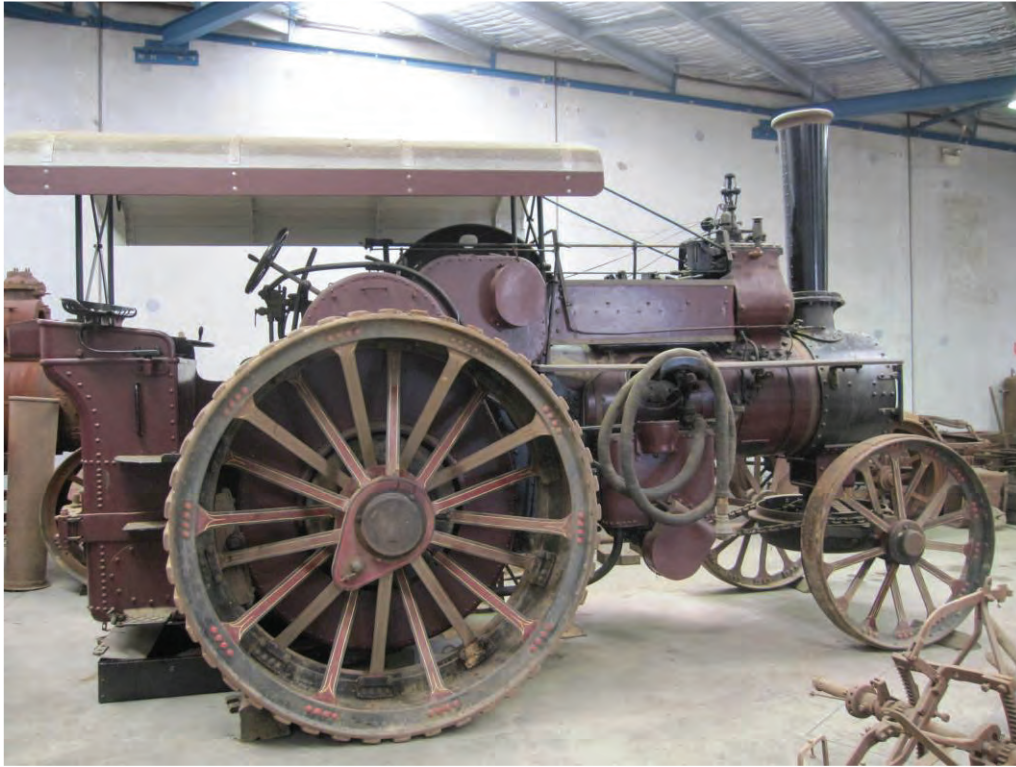
Figure 36 View of Fowler road locomotive no.16161
Source: Rohan Lamb, December 2013

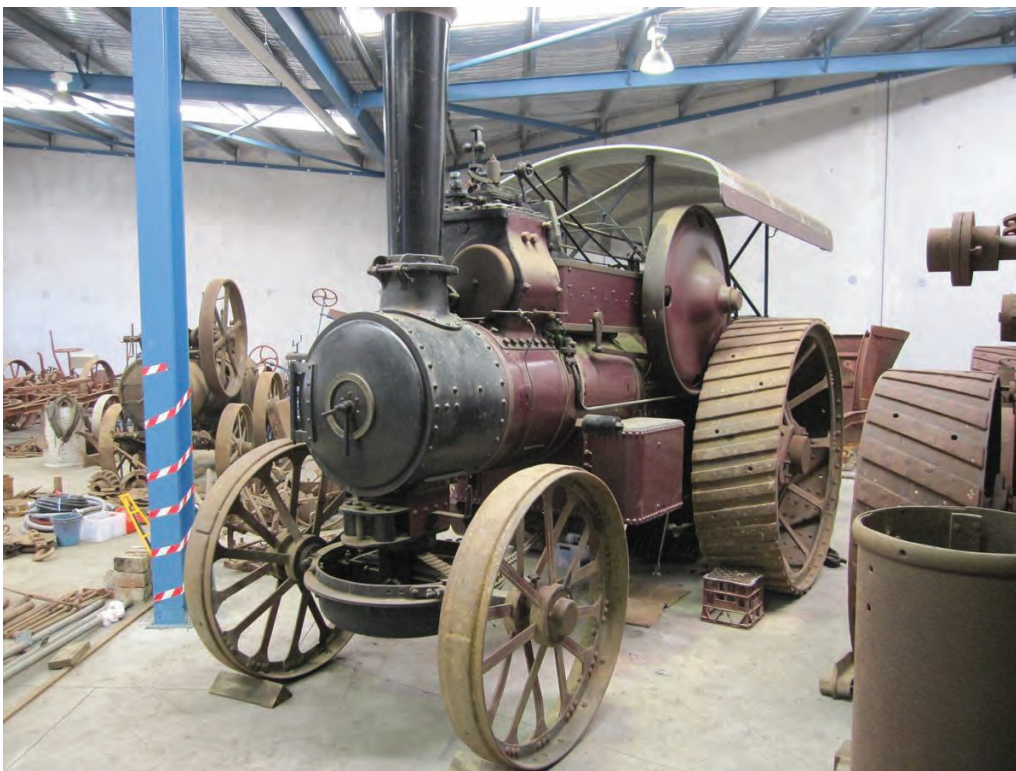
Figure 37 Flywheel side of Fowler road locomotive no.16161
Source: Rohan Lamb, December 2013

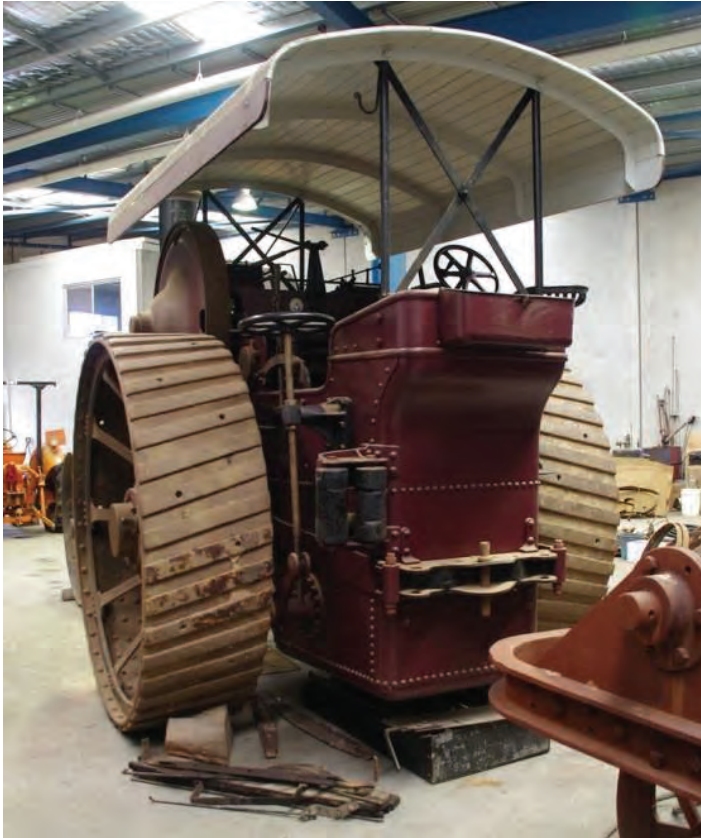
Figure 38 Rear view showing rear tender, hand brake, and canopy
Source: Rohan Lamb, December 2013

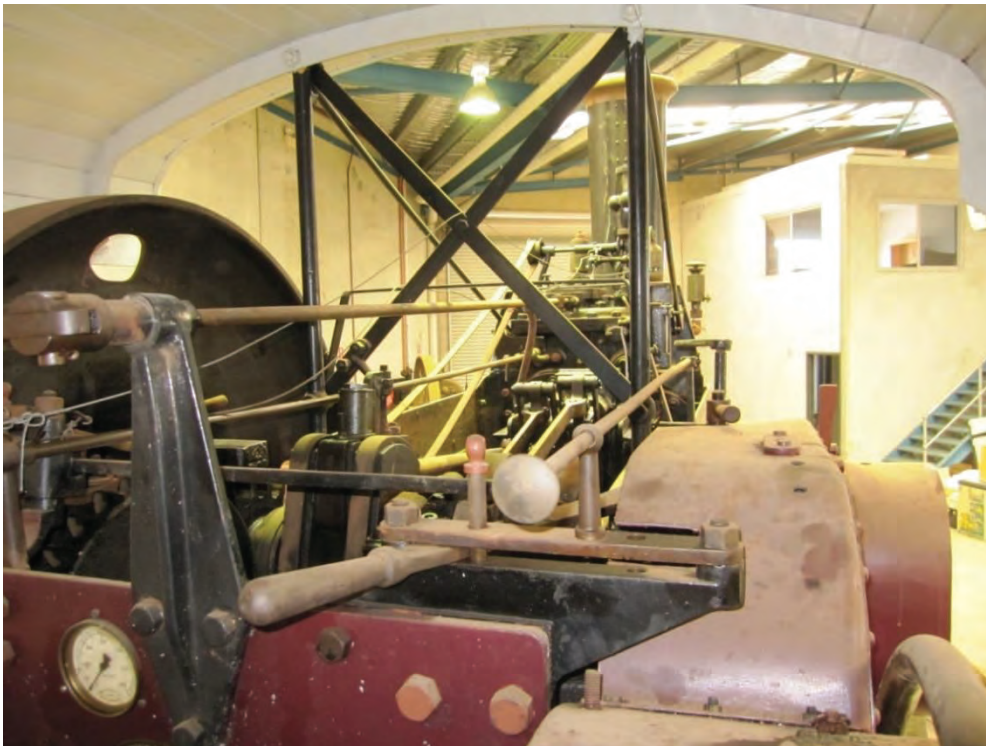
Figure 39 View from the footplate showing the driving levers and engine
Source: Rohan Lamb, December 2013

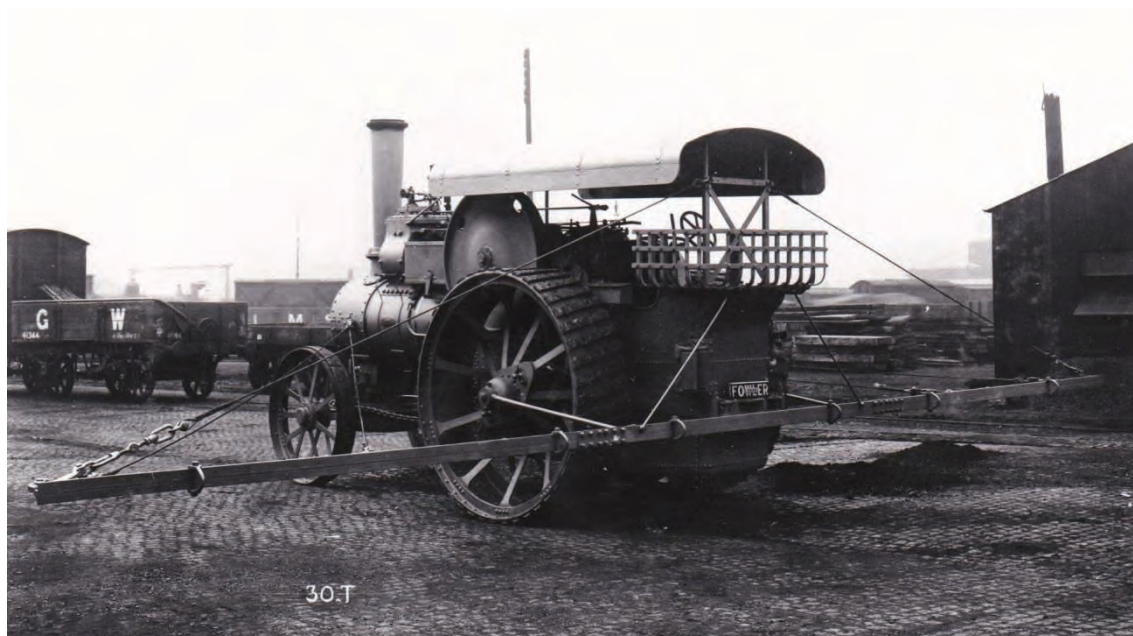
Figure 43 Fowler no.16163 in Fowler's yard, Leeds with the 40' (12.2m) draft beam in place
Source: Museum of English Rural Life

The engine is significant for a unique modification requested by the council. It was supplied with a 40 foot (12.2m) wide drawbar intended for towing road graders (Figure 43). By using the bar it was possible to grade a wider section of road with one pass. It is not known if this experiment was successful.

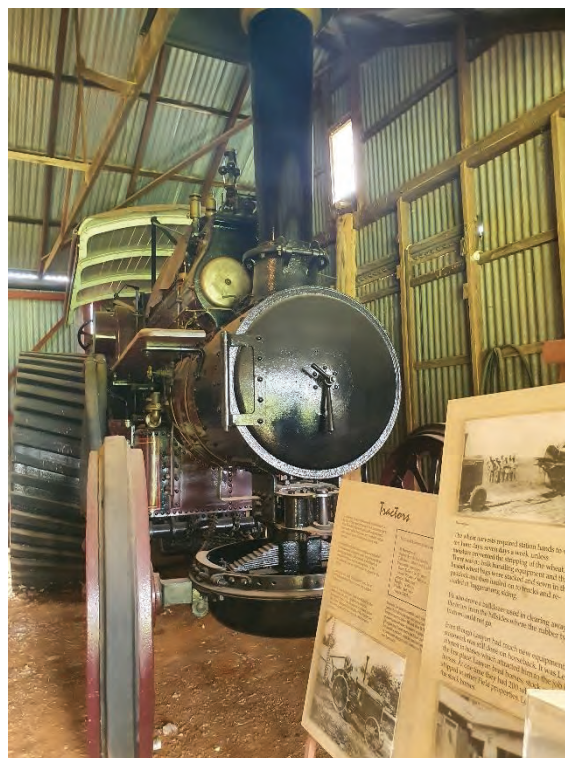
Figure 1 Road locomotive stored at the Lanyon Homestead, March 2020 (Grant Rootes)

The assessment of the engine was based on photographs supplied by the LDA taken in March 2020, and from additional documents supplied referring to works completed during its return to operational condition by K & H. Ainsworth Engineering Pty Ltd. Physical assessment by the author was not possible due to the closure of the Lanyon Homestead in January 2020 at the time of the planned inspection. The photographs of specific aspects of the engine have not been updated, and therefore reflect the condition of the engine in 2014. The road locomotive is presently stored in a corrugated iron building at the Lanyon Homestead. Its location in the building parked next to a wall of the building prevented access to, and photography of the flywheel side of the road locomotive. Easily removed items such as the nameplate and smokebox door nameplate ring have been removed for safe storage.

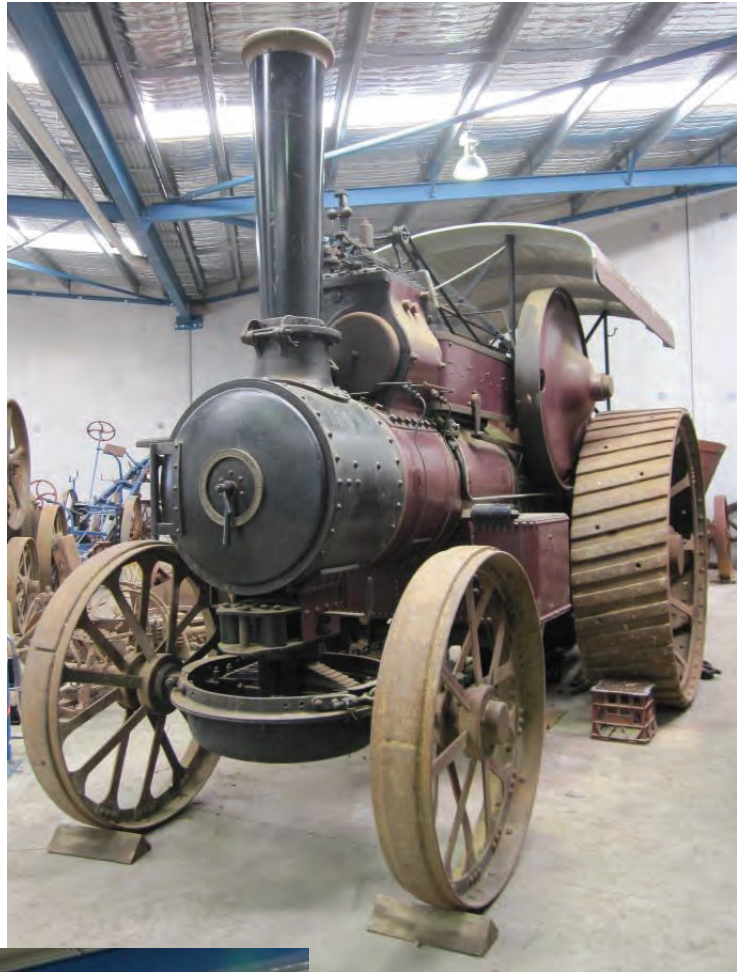
Figure 2 Flywheel side of the road locomotive, December 2013

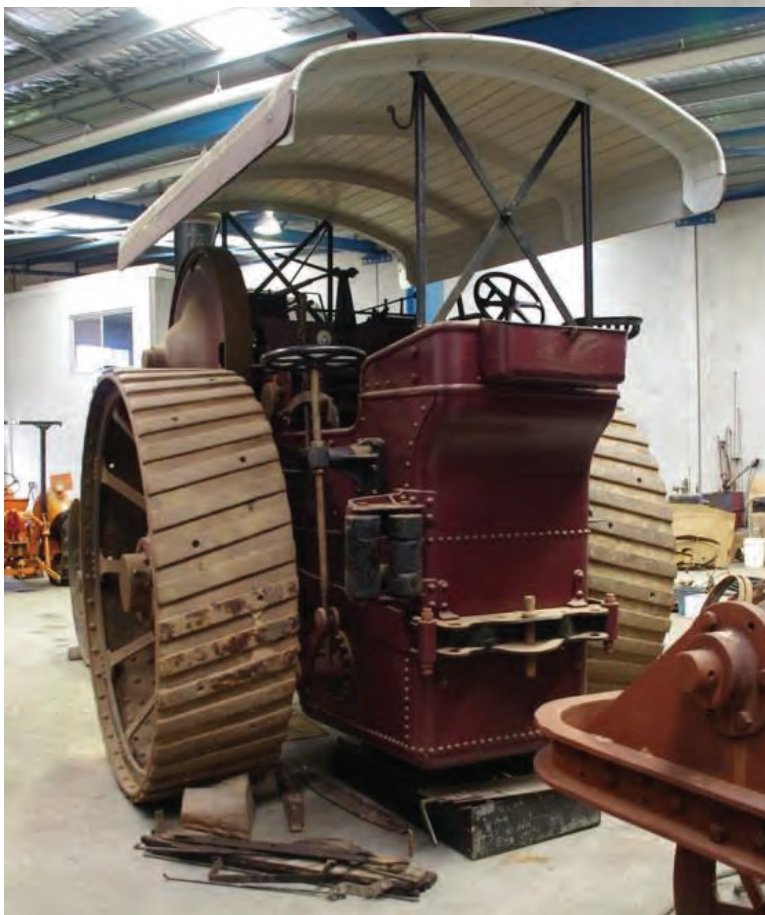
Figure 3 Rear view of the road locomotive, December 2013

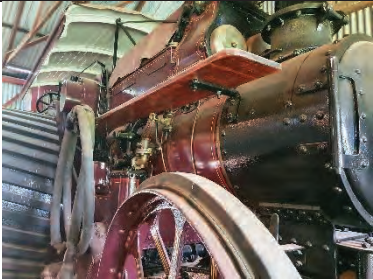
Item/Area	Originality	Condition	Actions
<p>Cladding - Barrel</p>

<p><i>Grant Rootes, March 2020</i></p>	<p>The cladding was replaced with like for like materials during the overhaul.</p>	<p>During the overhaul of the engine it was found some of the original cladding had been replaced, and the much of timber lagging underneath had deteriorated. All the cladding and timber lagging was replaced with new materials.</p>	<p>Clean oil stains at end of operating period, clean dust from surfaces periodically</p>
<p>Lagging</p>	<p>The timber lagging was replaced with like for like materials during the overhaul.</p>	<p>During the overhaul of the engine it was found much of timber lagging underneath had deteriorated being burnt to charcoal. All of the timber lagging was replaced with new materials.</p>	<p>No further action</p>

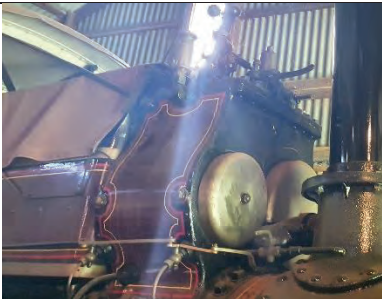
<i>Grant Rootes, March 2020</i>	The engine and motion gear are all original components.	The engine and motion gear were all cleaned and serviced during the overhaul. The cylinder covers were polished to bright steel	Maintain preservative coating on bright motion gear to minimise surface rust. Turn engine periodically to ensure it does not seize.
Packing Glands

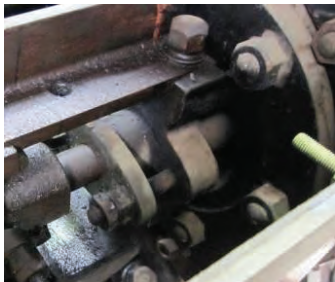
Valve rod and piston rod packing glands brasses are original. Gland packings have been replaced.	During the overhaul all asbestos gland packings were removed and replaced with PTFE materials.	Inspect and maintain gland packing during operation. Ensure engine is turned and left in different positions to minimise potential of pitting of valve and piston rods.
Crankshaft

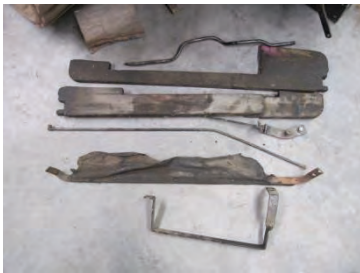
Timber boards which seal along the bottom of the motion covers present. Metalwork for canvas covers present. Limited canvas cover material present. They all appear to be the original parts.	<p>The motion dust covers are in poor condition with most of the canvas missing, and the metal work, and timber items presently not fitted to the engine. It is remarkable for these items to survive, as they were generally removed in service.</p> <p>Re-instatement of the original dust covers was not undertaken as part of the overhaul. A canvas cover has been provided to keep dust out of the motion gear while stored.</p>	Replace canvas on dust covers & retain original remnants. Assess if timbers can be reused. Due to operational reasons it may be decided to not refit these to the engine as they restrict access for lubricating the motion gear.

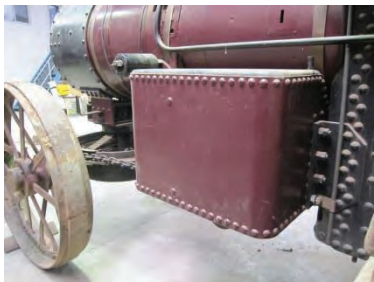
Top and sides are original. The bottom plate has been replaced with a plate welded in as this a structural area where the steering chain shaft is mounted.	To allow the timber lagging to be replaced, the front tank was removed. It was inspected and found to be in good condition with the interior painted with bituminous paint. The mounting was incorrect, so spacers were made and the tank remounted in its correct position.	Ensure tank is dry when stored for long periods
Rear Tank

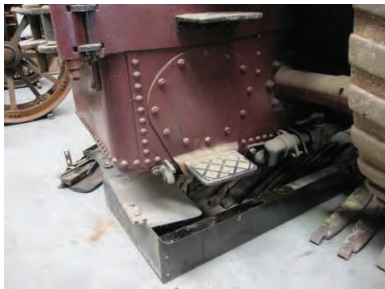
Original tank.	Tank inspected and found to be in good condition.	Ensure tank is dry when stored for long periods
Mechanical Feed Pump & Injector

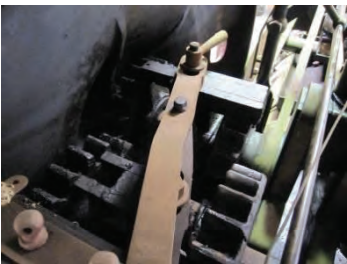
Original driving gears fitted.	All gears cleaned and lubricated during overhaul. They are all in very good condition.	Clean and lubricate as required.
Front Wheels & Axle

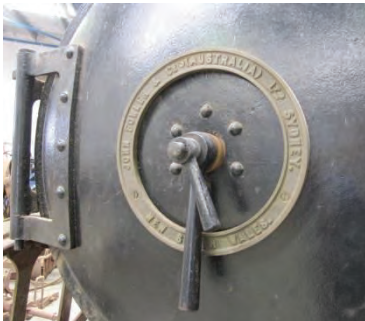
Original nameplate present.	In good condition. Removed from the engine for safe keeping offsite.	Reinstate on road locomotive once secure display is possible.

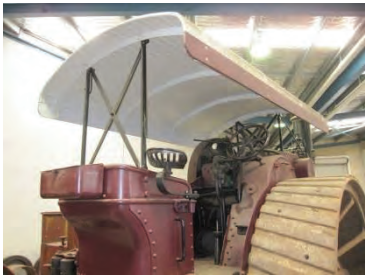
The canopy timberwork has been replaced with new boards, and canvas covering.	In good condition. The top of this has been covered during storage to minimise dust and bird dropping building up on roof.	Continue to remove dust periodically

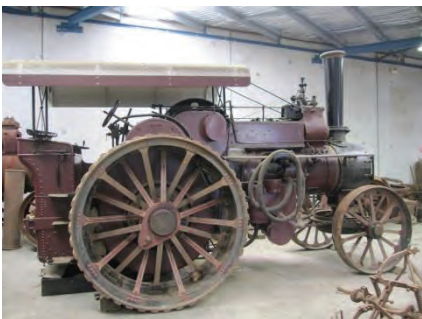
The engine has been repainted. The colour and pin striping require confirmation.	The engine was repainted during the overhaul with pin striping added to Fowler's original standard.	Clean surfaces periodically of any oil stains, dust and animal droppings.
Polishing - Metalwork	Most surfaces which were originally polished have not been painted over. The exception to this is some of the pipework which was apparently originally polished and when replaced was painted instead.	Brass - All bright surfaces tarnished. Steel – All bright surfaces exhibit light surface rust	Ensure regular cleaning program and use of preservative on bright surfaces.
