**Address: Kippax Place, Hardwick Crescent, Flack Street & Moyes Crescent,  
Holt, ACT 2615**

**Reference: LS018176 EP**

SITE PHOTOGRAPHS	
Client Name JPS Engineering Consultants	Site Location Section 51, Holt, ACT2615		Project No. P21030

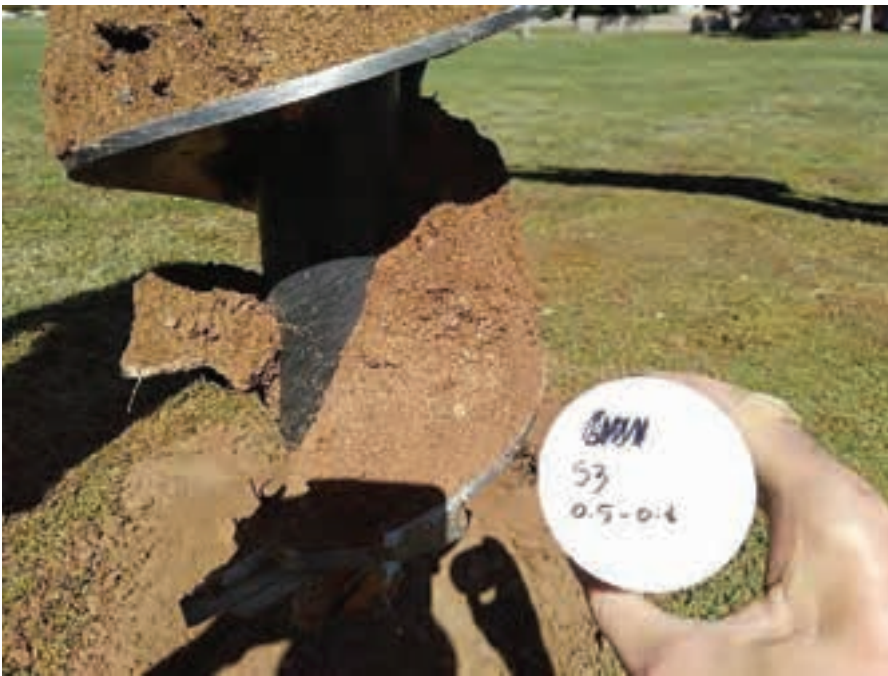
Photo No.	Date	
2.	13/04/2021	
<b>Description</b> Soil profile at a depth of 0.5 – 0.6 m bgl (fill) at sampling location S3

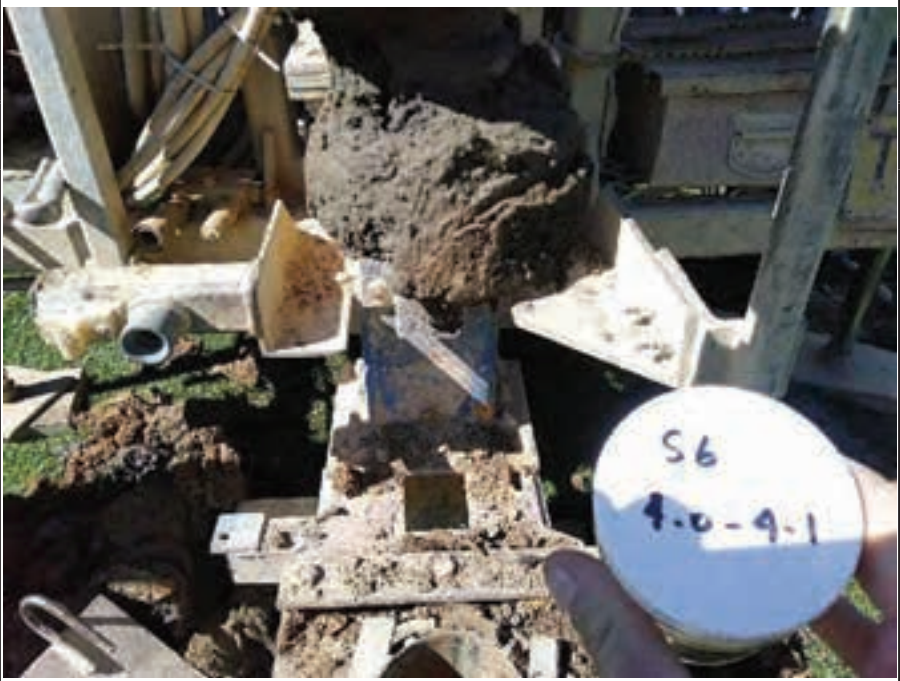
Photo No.	Date		
3.	08/04/2021		
<b>Description</b> Borehole S6 showing the grey clay observed across the site.

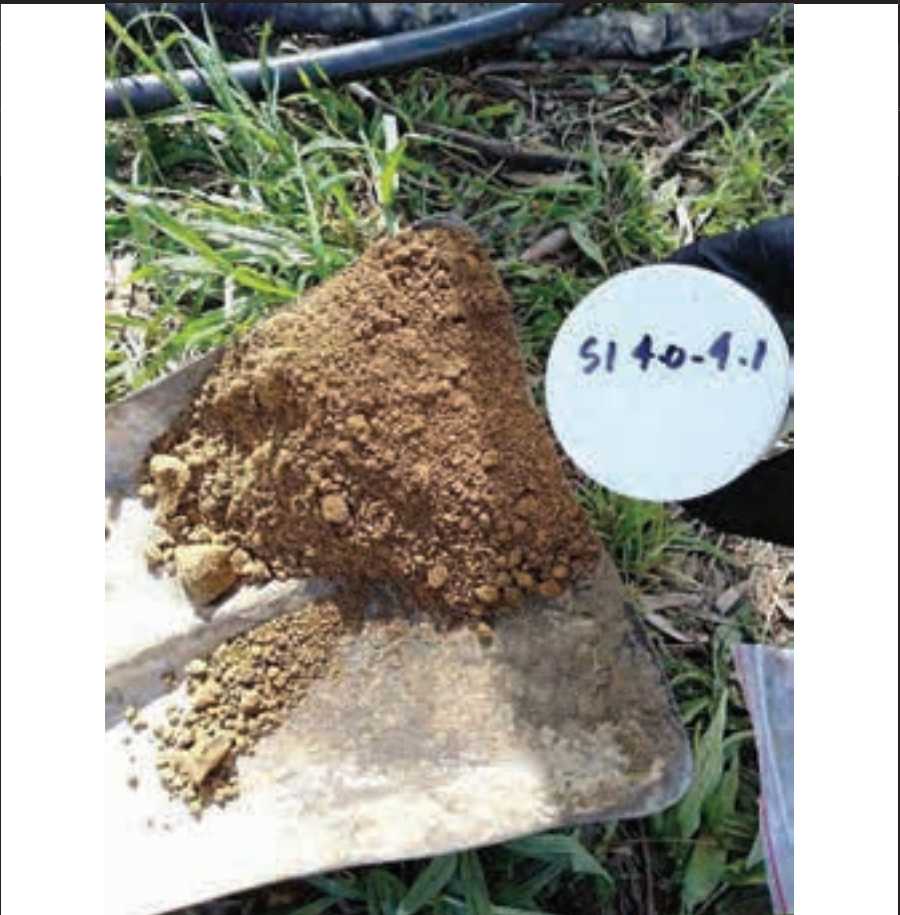
Photo No.	Date		
4.	07/04/2021		
<b>Description</b> Photograph of material recovered at 4.0 m bgl at borehole S1

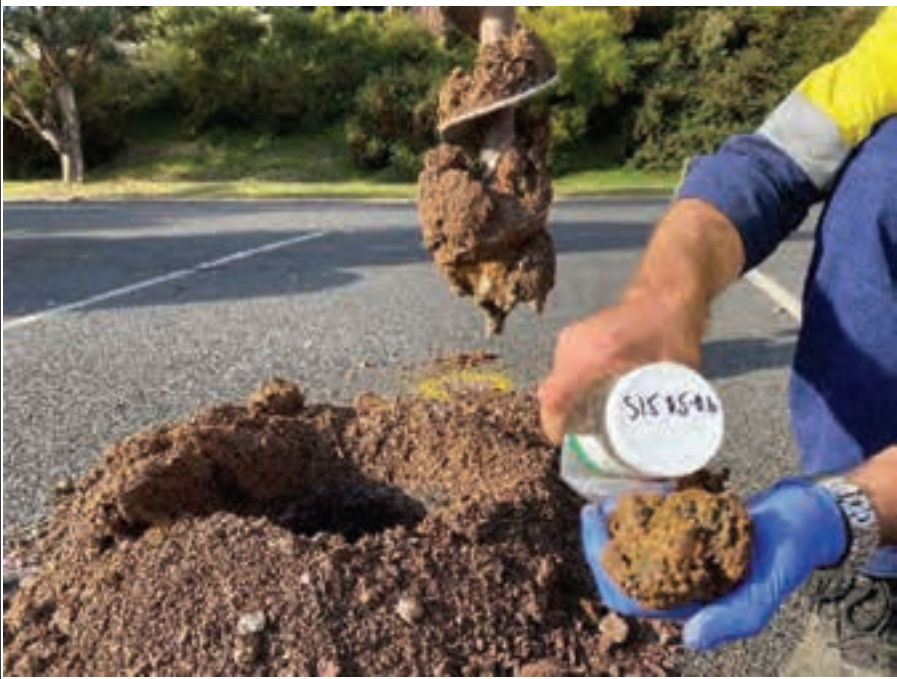
Photo No.	Date	
5.	20/04/2021	
<b>Description</b> Drilling and sampling of borehole S15 in Moyes Crescent. Natural material is observed in front of the photograph while the road base is observed around the hole on the ground.

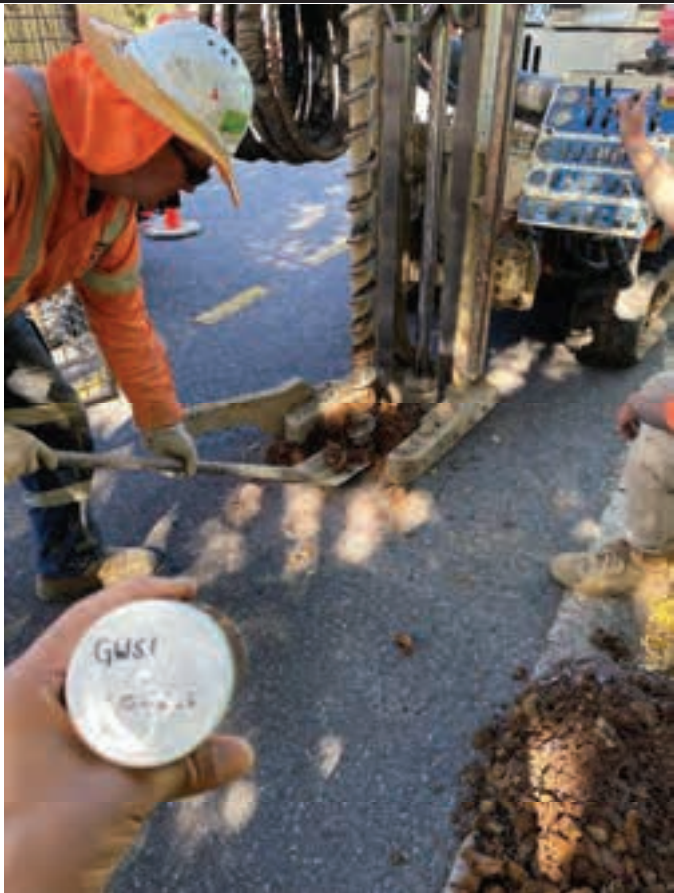
6.	15/04/2021	
<b>Description</b> Drilling, installation and soil sampling of groundwater monitoring well GW51.

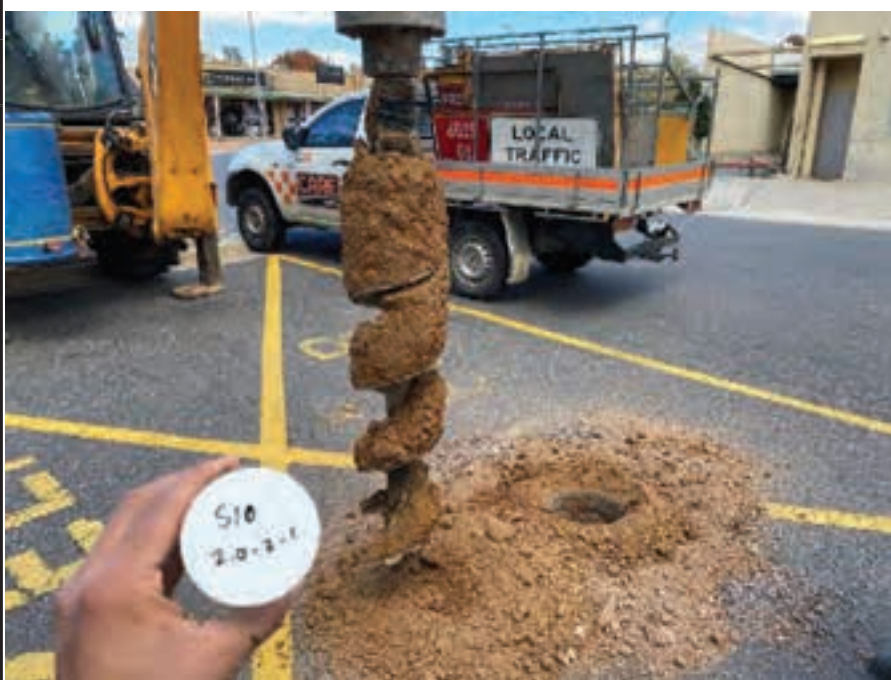
Photo No.	Date	
7.	21/04/2021	
<b>Description</b> Soil profile at 2.0 m bgl in borehole S10 in Kippax Place. Natural material is observed.

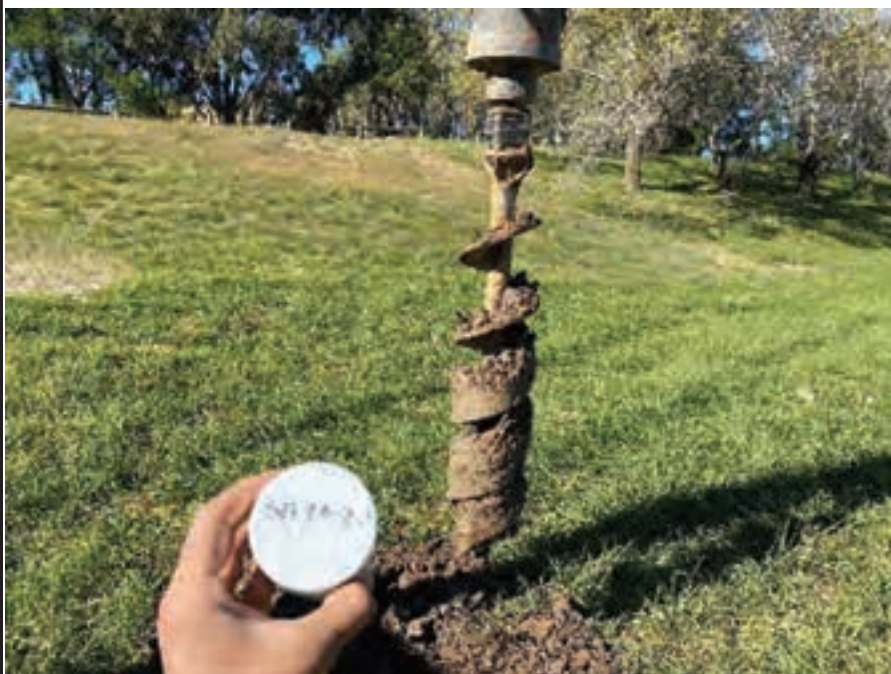
8.	21/04/2021	
<b>Description</b> Soil profile at borehole location S22 in the southeast portion of the site. A grey clay is observed in the auger.

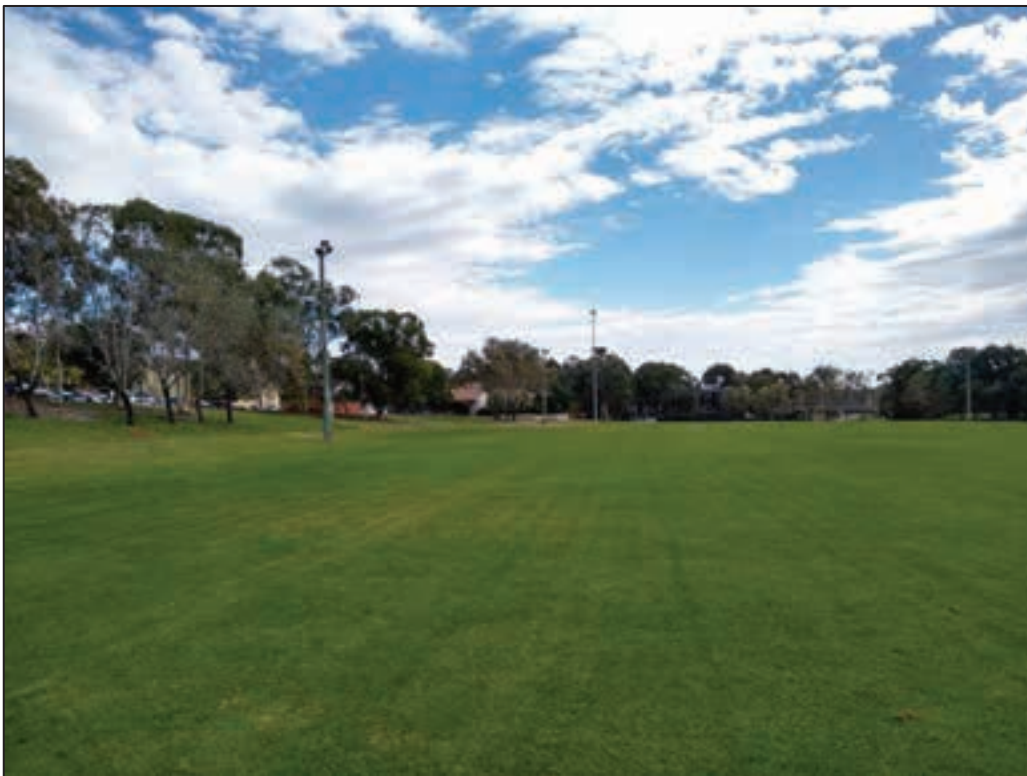
**Figure 1: View of proposed redevelopment area looking north from Bore 7.**

The site is currently used as a playing field and was grass vegetated with trees up to ~20 m tall along the boundaries. The site is located in a lower lying area and is relatively flat, with a battered slope up to approximately 3.5 m high at the southern end of the western boundary. A drainage swale runs approximately south east to north west along the eastern boundary of the site. Figure 1 below shows the playing fields looking north from near Bore 7.

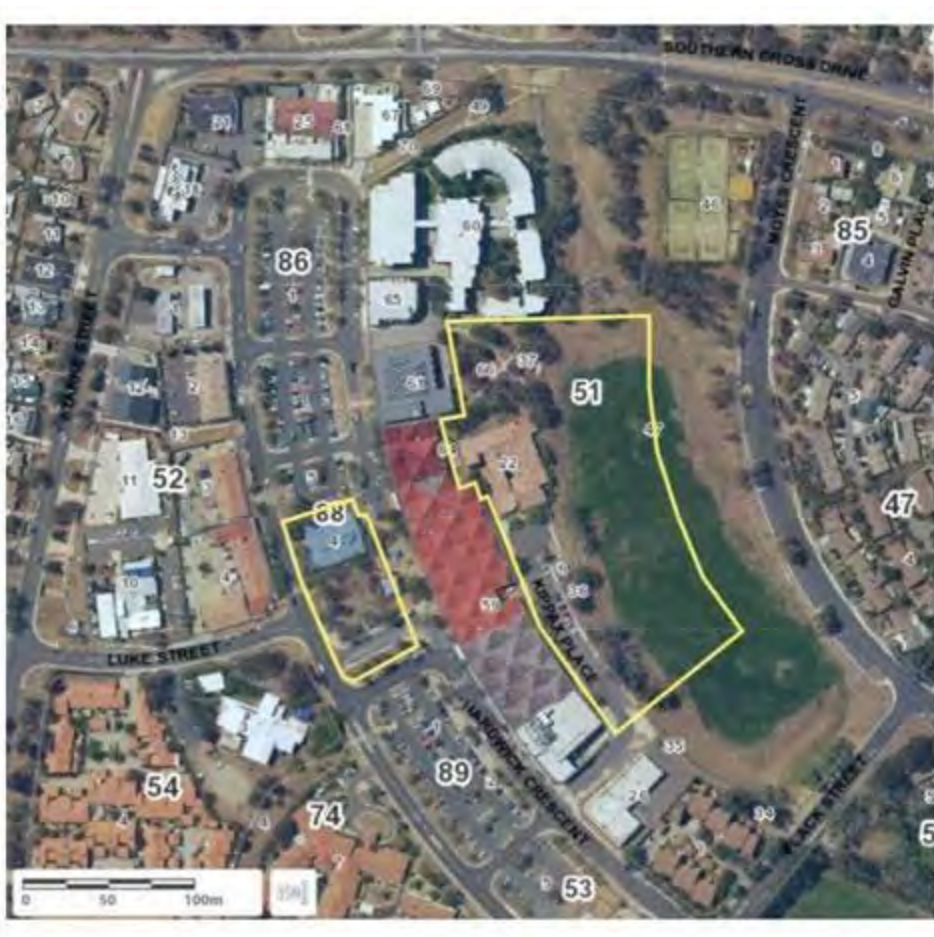
Also a map which may assist with Section 51 Holt showing the indicative boundary for the future commercial and residential development. Noting Road A is not providing access to residential at this stage.

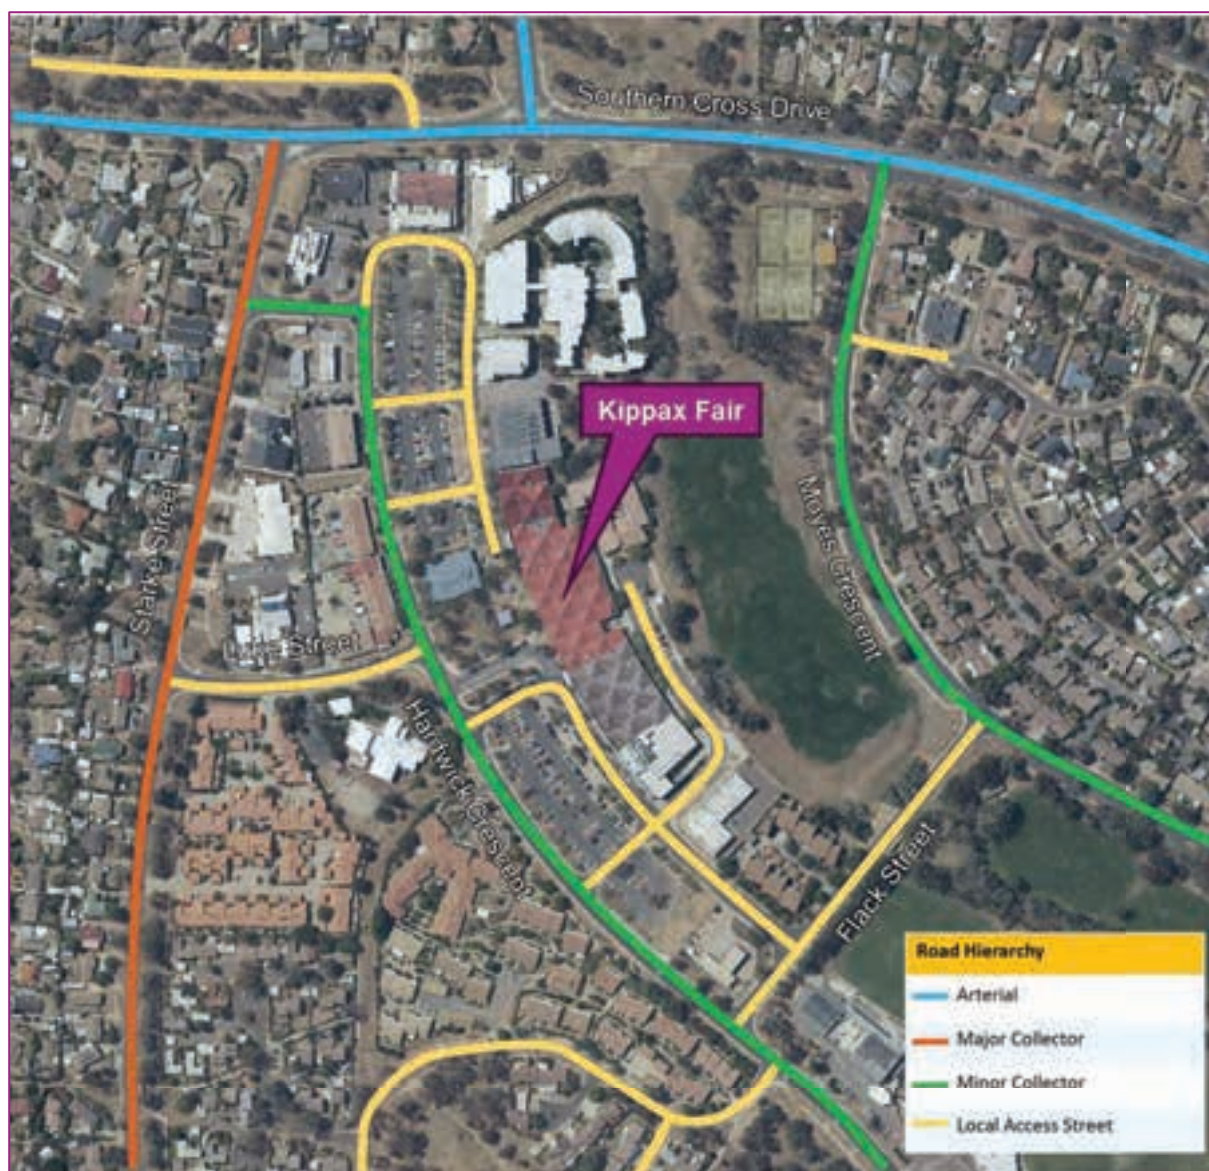
**Figure 6 Kippax Group Centre Existing Conditions**

The site is bounded by Southern Cross Drive (arterial road) on the north, Moyes Crescent (minor collector) on the east, Flack Street (local road) on the south and the Starke Street (major collector) on the west. The existing road hierarchy surrounding the development is shown in Figure 6.

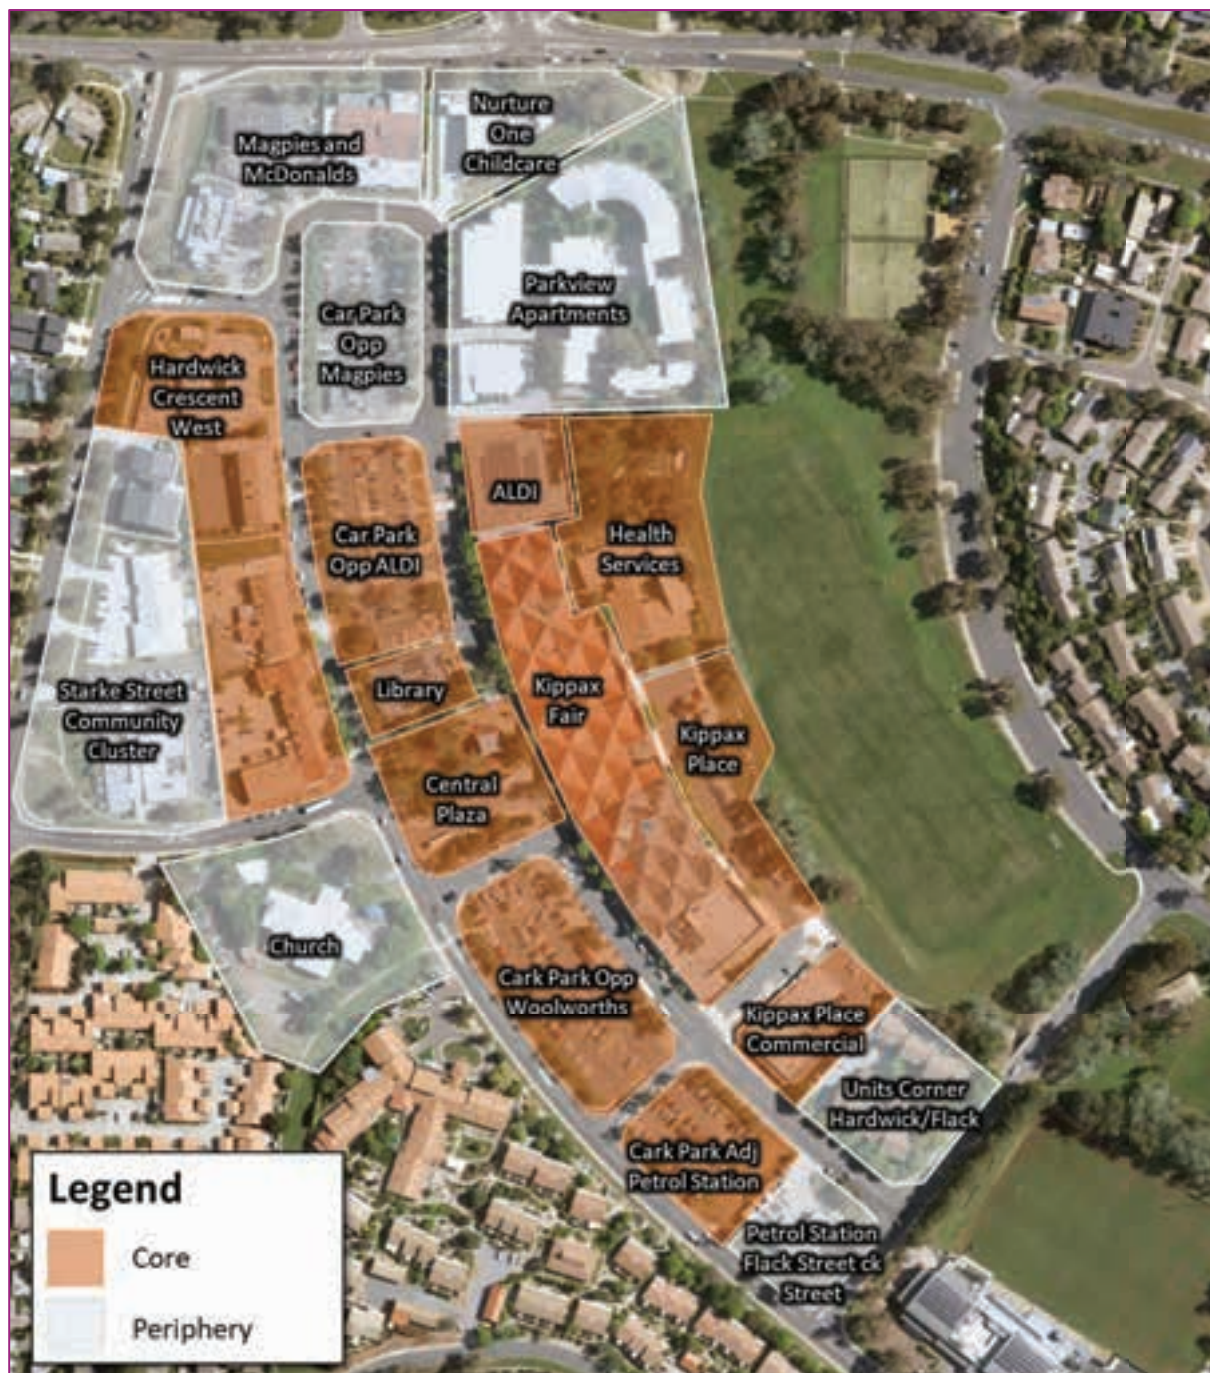
**Figure 7 Kippax Centre Existing Site Areas**

the development. There is a range of facilities within the site which caters to various user groups. For the purposes of this study, the areas are designated as 'Core' and 'Periphery' for better understanding. The various blocks of the Kippax Centre are shown in Figure 7.

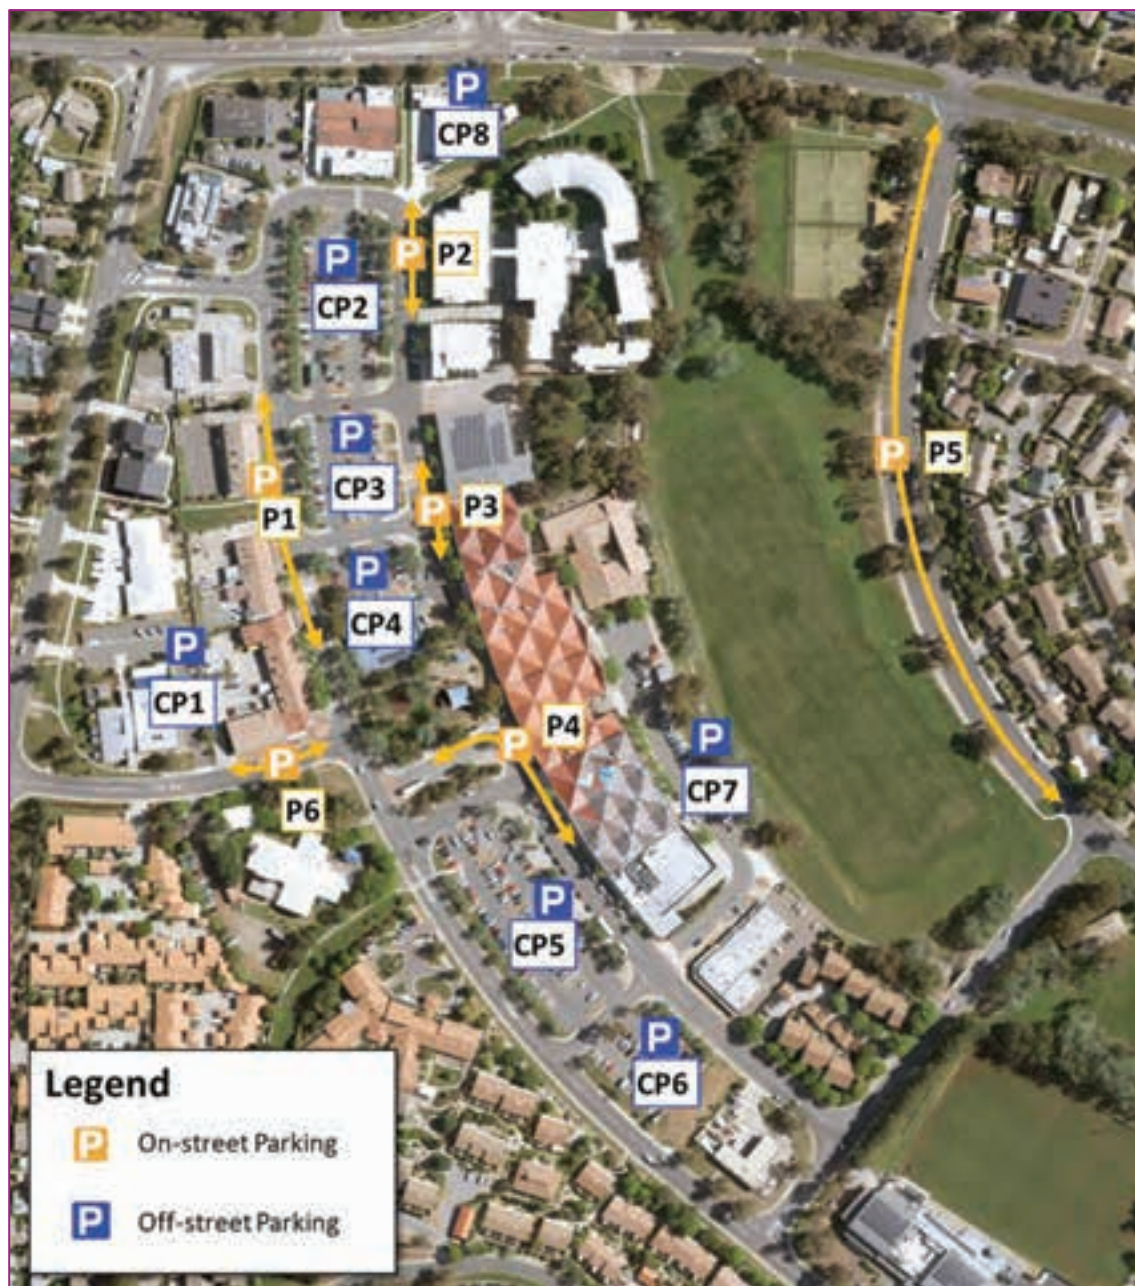
**Figure 8 Existing Parking Provision**

There are several car parking areas provided within the Core, Periphery and the adjacent streets which are utilized by the Kippax Centre users. The car parking provisions surrounding the site are shown in Figure 8

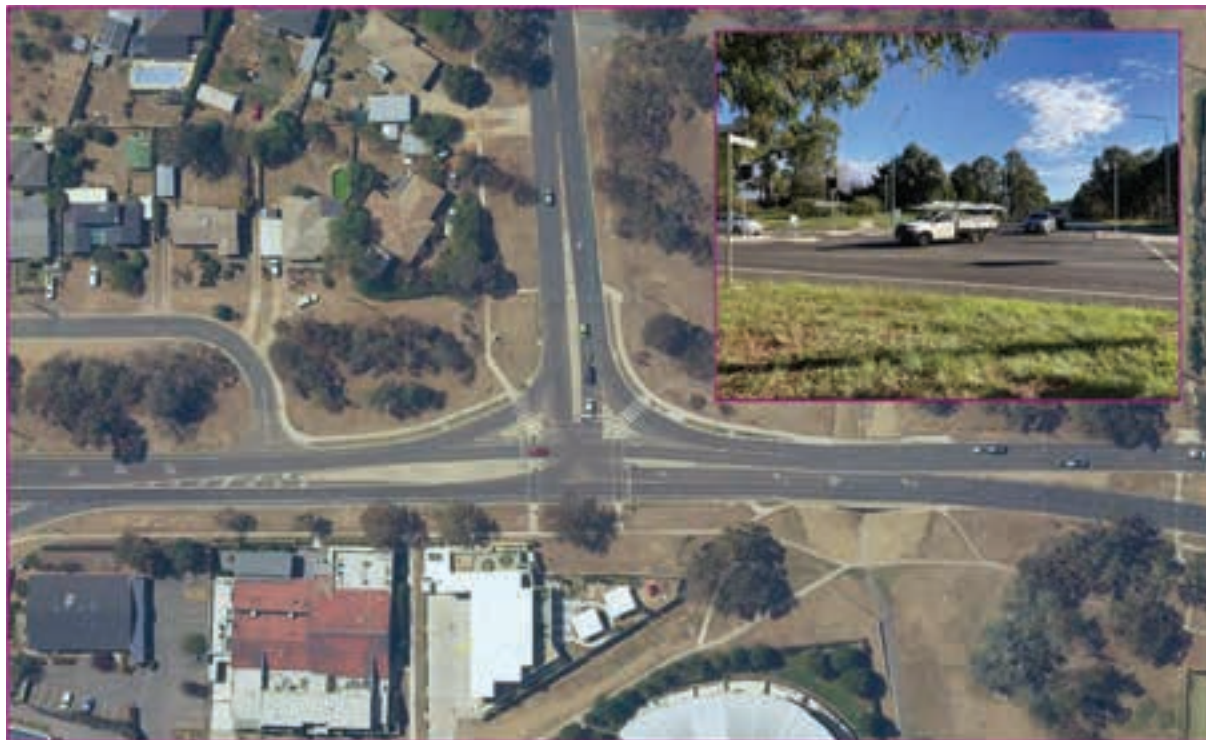
**Figure 10 Southern Cross Drive / Florey Drive Intersection – Site Photo**

intersection with an approach distance of 135m. The existing layout of this intersection is shown in Figure 10

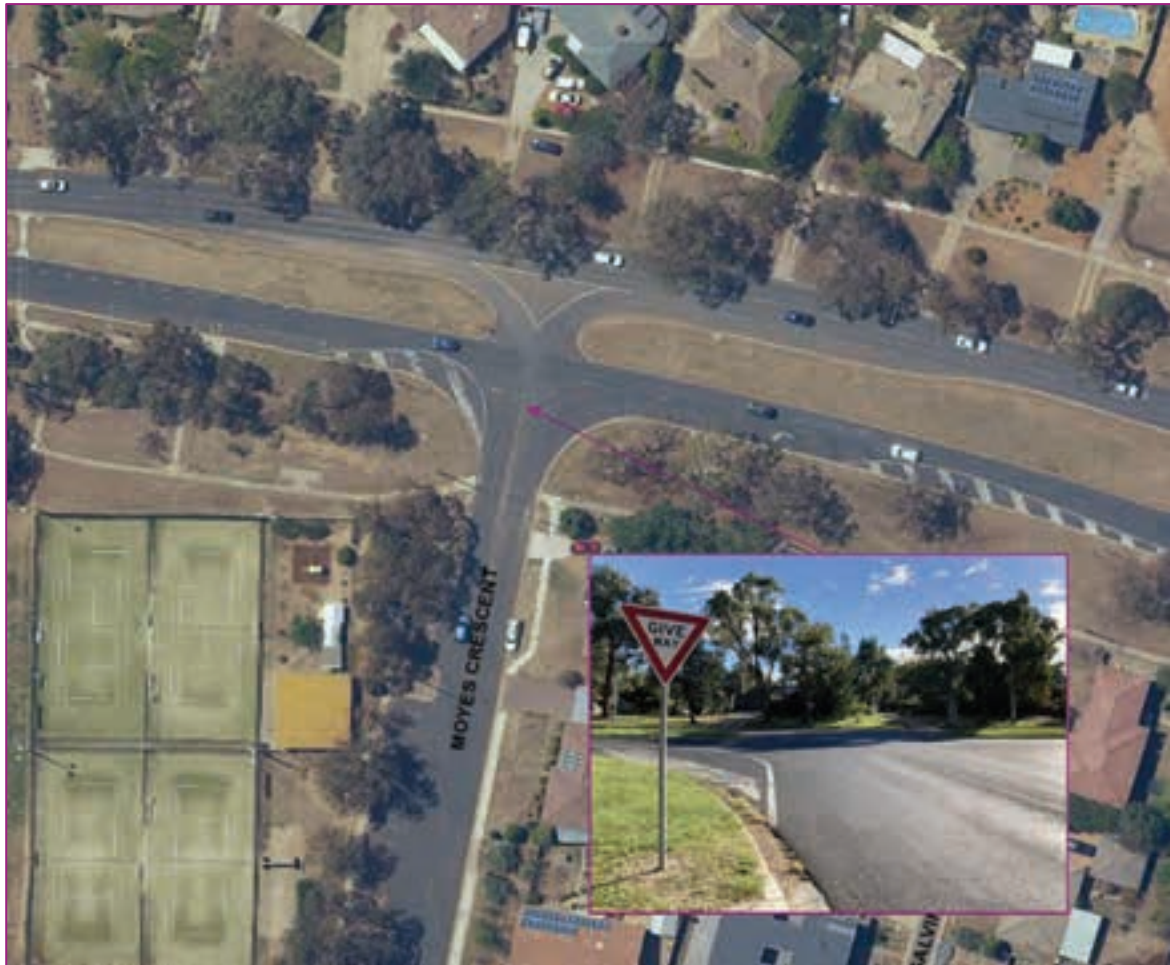
**Figure 11 Southern Cross Drive / Moyes Cr Intersection – Site Photo**

The Southern Cross Drive / Moyes Crescent intersection is an unsignalized priority-controlled T-intersection. Minimal traffic was observed at this intersection during the site visit. The site layout is shown in Figure 11

It was observed during the site visit that the pedestrian walkways are provided along the surrounding roads and the parking areas are clearly marked. In addition to the bus interchange hub located within the development, a bus stop is located on Moyes Crescent.

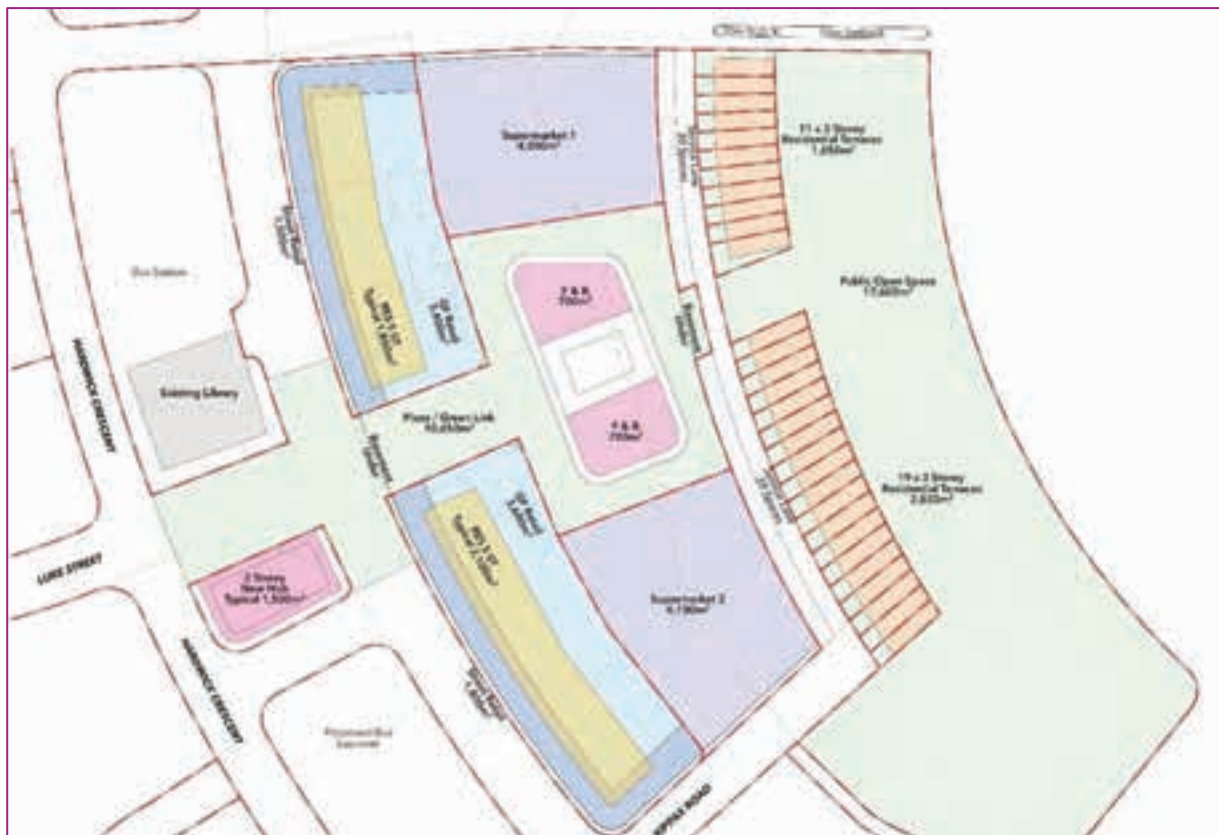
**Figure 12 TPV Indicative Layout**

The indicative layout showing the expansion of Kippax Fair within Section 51 as per the JPS Engineering Report is shown in Figure 12

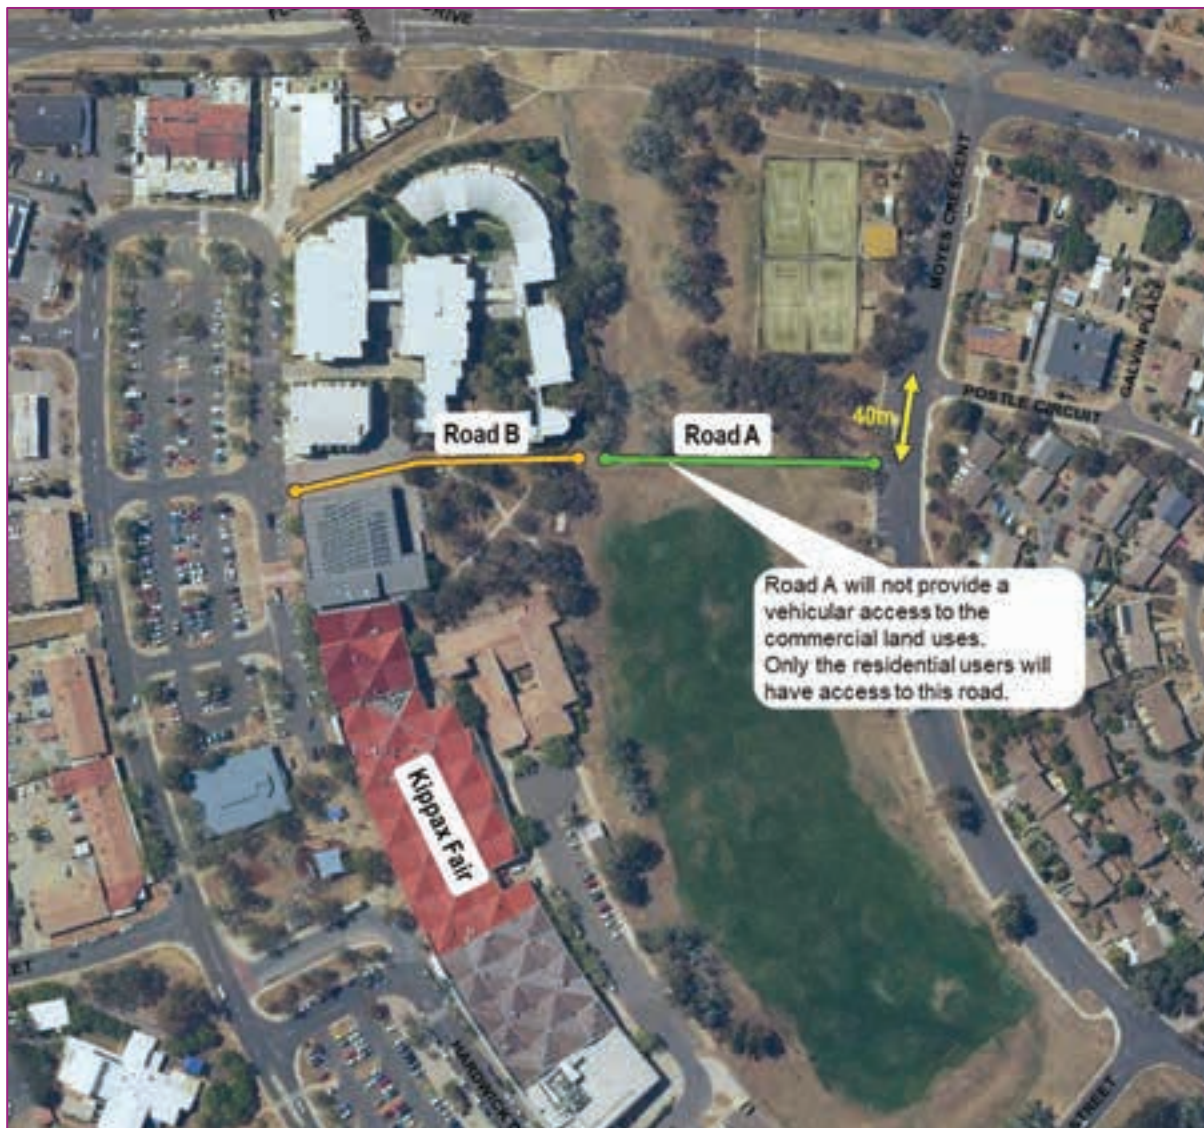
Figure 13 Road A and Road B – Indicative Plan

Road A will not provide access to the retail and commercial uses. Road B will be a shared pedestrian and cyclist path.

Road A is considered as a 'Access Street B' as per 'Table 2A - Street network requirements – all estates except in industrial zones' of the Estate Development Code with traffic volumes ranging from 301- 1000 vehicles per day. It connects to Moyes Crescent with a new proposed intersection with a 40m offset from the existing Postle Circuit intersection, resulting in a staggered intersection arrangement. This arrangement will result in the removal of some existing on-street parking spaces along Moyes Crescent and may require relocation of the existing bus stop when implemented. The indicative arrangement of Road A and Road B is shown in Figure 13.

It is expected that about 7 - 8 on-street parking spaces will need to be removed along the Moyes Crescent due to the introduction of Road A and the new intersection. The displaced parking spaces may be compensated along the Road A during the detailed stage.

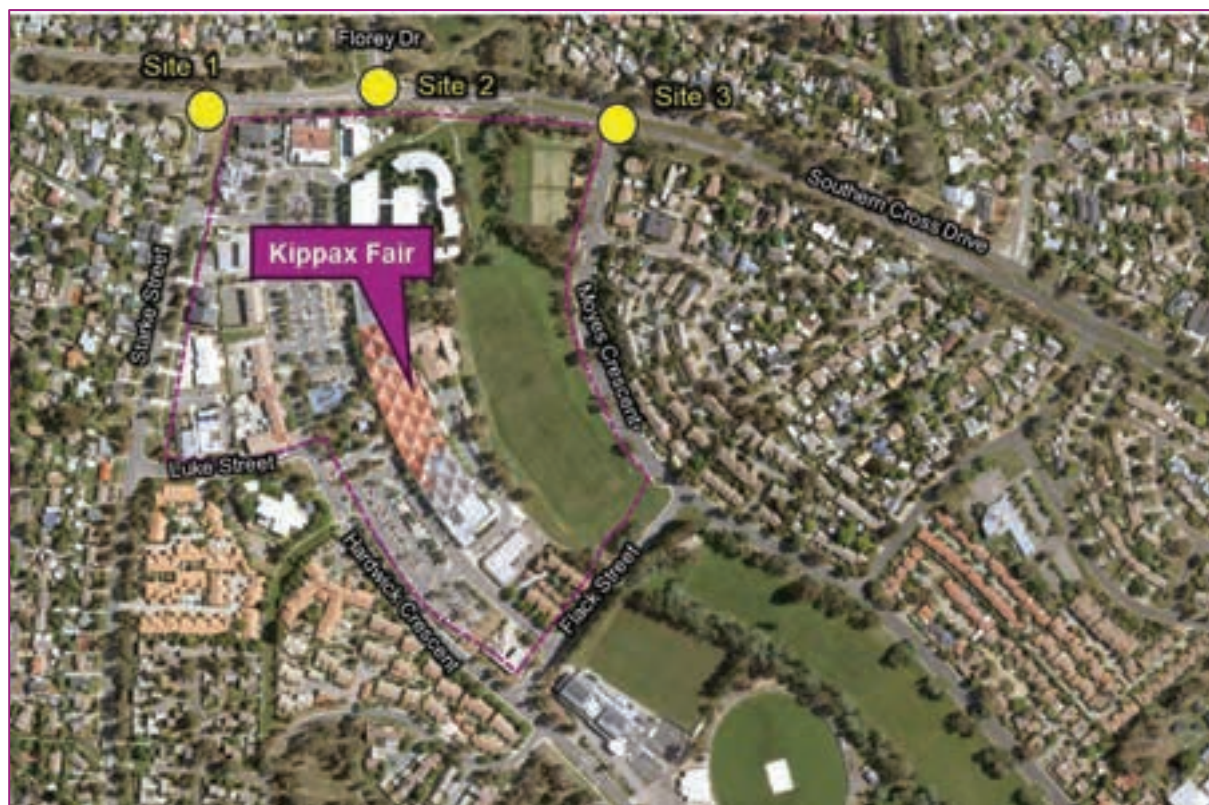
**Figure 15 Sidra Analysis Intersections**

The intersections which were analysed as part of the base year and future year analysis (which were agreed with TCCS) are shown in Figure 15 and listed below:

- Site1: Southern Cross Drive / Starke Street Intersection
- Site2: Southern Cross Drive / Florey Drive Intersection
- Site3: Southern Cross Drive / Moyes Crescent Intersection.

A linked Sidra intersection model was developed for the above intersections. Table 9 of the RTA Guide to Traffic Generating Developments provides a guide in relation to LOS and acceptable operation levels SIDRA analysis.

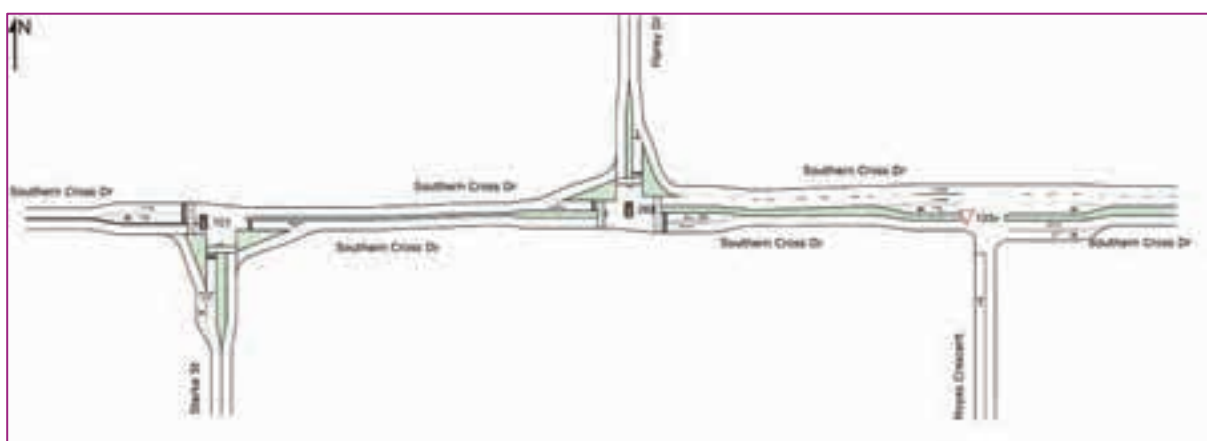
**Figure 16 Base Year Sidra Layout**

As the Starke St intersection is currently being upgraded, this intersection was considered as a signalized intersection in the base year analysis. The Sidra layout is shown in Figure 16.

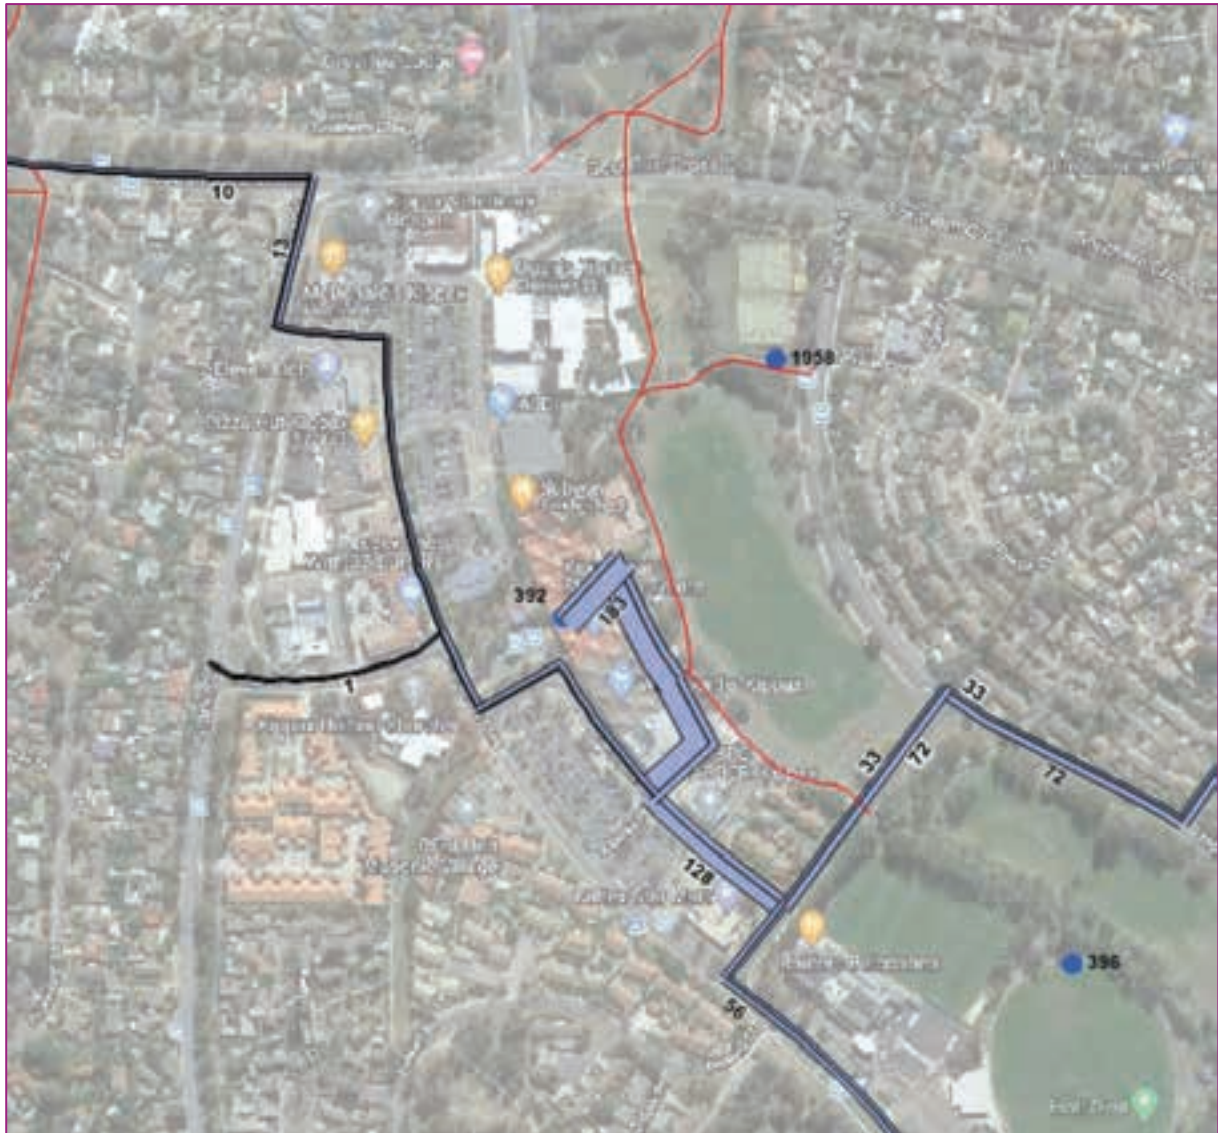
Figure 17 CSTM Kippax Zone Traffic Distribution – AM Peak

2. The trip distribution of this zone was extracted using Select Link Analysis of the relevant CSTM zone for the AM and PM peaks. The outputs are presented in Figure 17 and Figure 18. It was observed that the majority of Kippax Centre traffic was travelling south and only about 15% and 30% of the development traffic was utilizing the study intersections on the north side during AM and PM peaks, respectively. The traffic distribution to the north in the AM was considered low and hence the PM peak distribution was adopted for the AM peak.

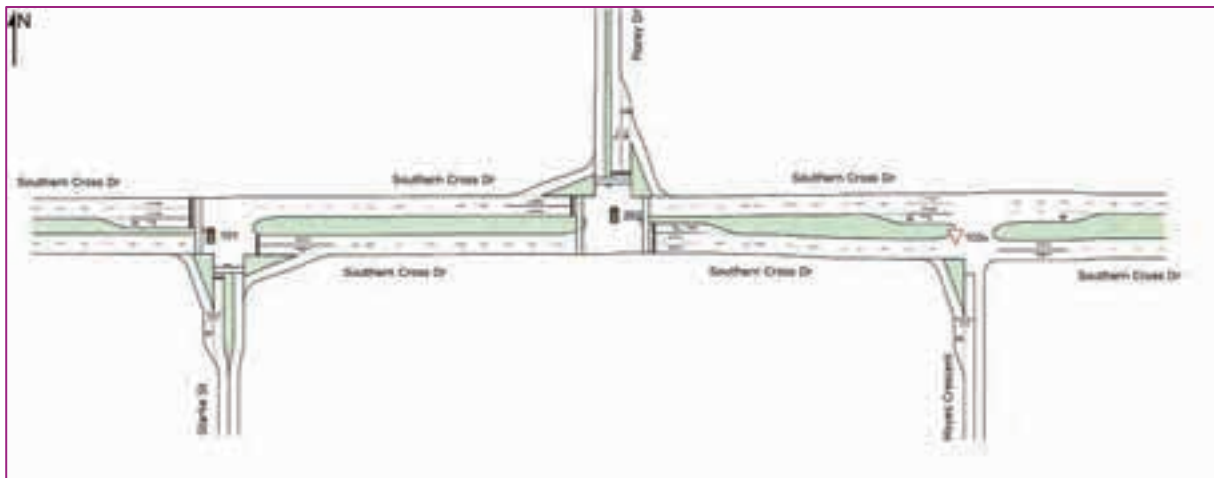
**Figure 19 Study Intersections - Mitigation Layout**

- **East Approach:** Approach lanes increased to two (2) full lanes from the existing single for through movement and a short lane for the left turn movement. In the revised arrangement, one lane is dedicated for through movement and another lane is shared between through and left turn movement.
- **South Approach:** The existing shared left and right turn lane is proposed into a dedicated right turn lane and short lane for the left turn movement.
- **West Approach:** The exit lanes of the west approach is widened to two (2) lanes from the existing single lane exit.

The potential improvements to the study intersections are shown in Figure 19.

The summary of the Base Case with Mitigations for the Opening Year 2025 analysis outputs are presented in Table 20 to Table 22 for the study intersections

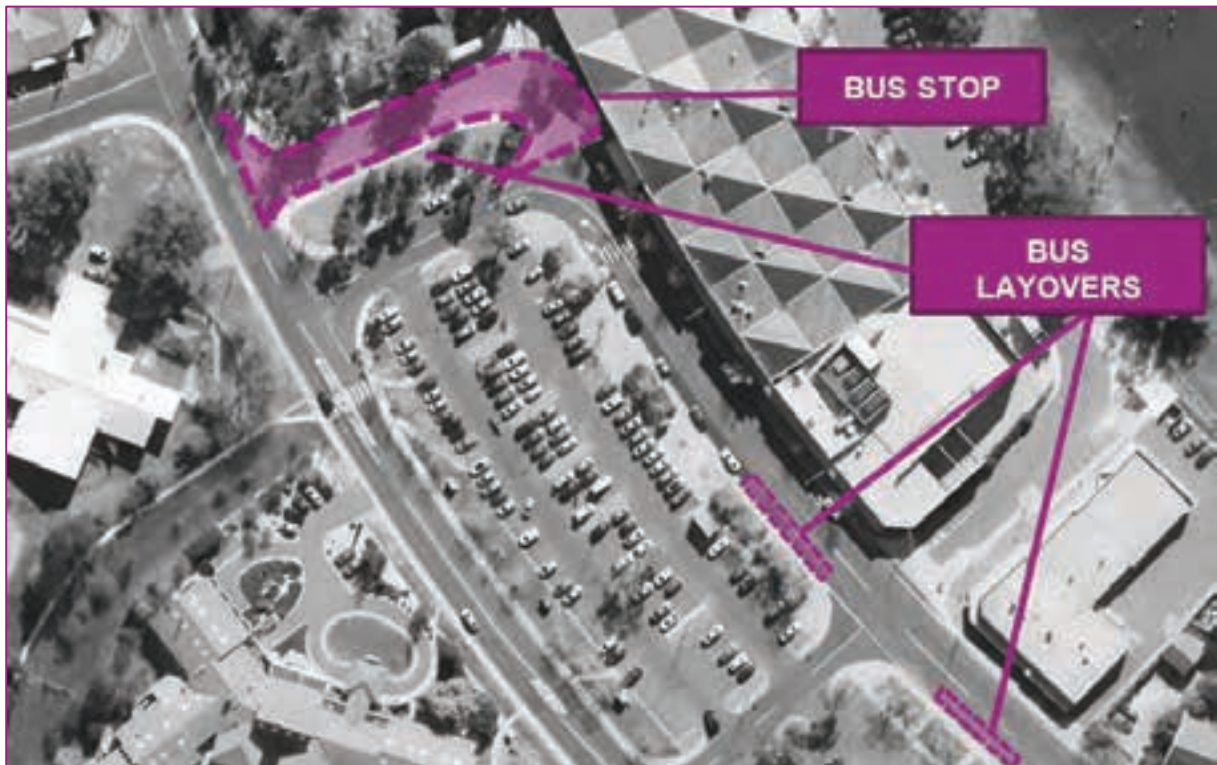
**Figure 20 Kippax Group Centre – Existing Bus Stops and Layovers**

AECOM been advised that bus interchange will remain at the current location compared to the various options developed in the 2016 AECOM Study. Figure 20 shows the existing bus stops and layover locations. The available kerb length on the current bus stop is 45m and the layover opposite the library is also approximately 45m, which would accommodate two buses in independent operation.

Two bus layovers (approximately 20m length) are located on Hardwick Crescent south-east of the main entrance. A secondary entrance to Kippax Fair is located to the north of the bus stops. The stops are all located within 200m of the Kippax Fair access points.

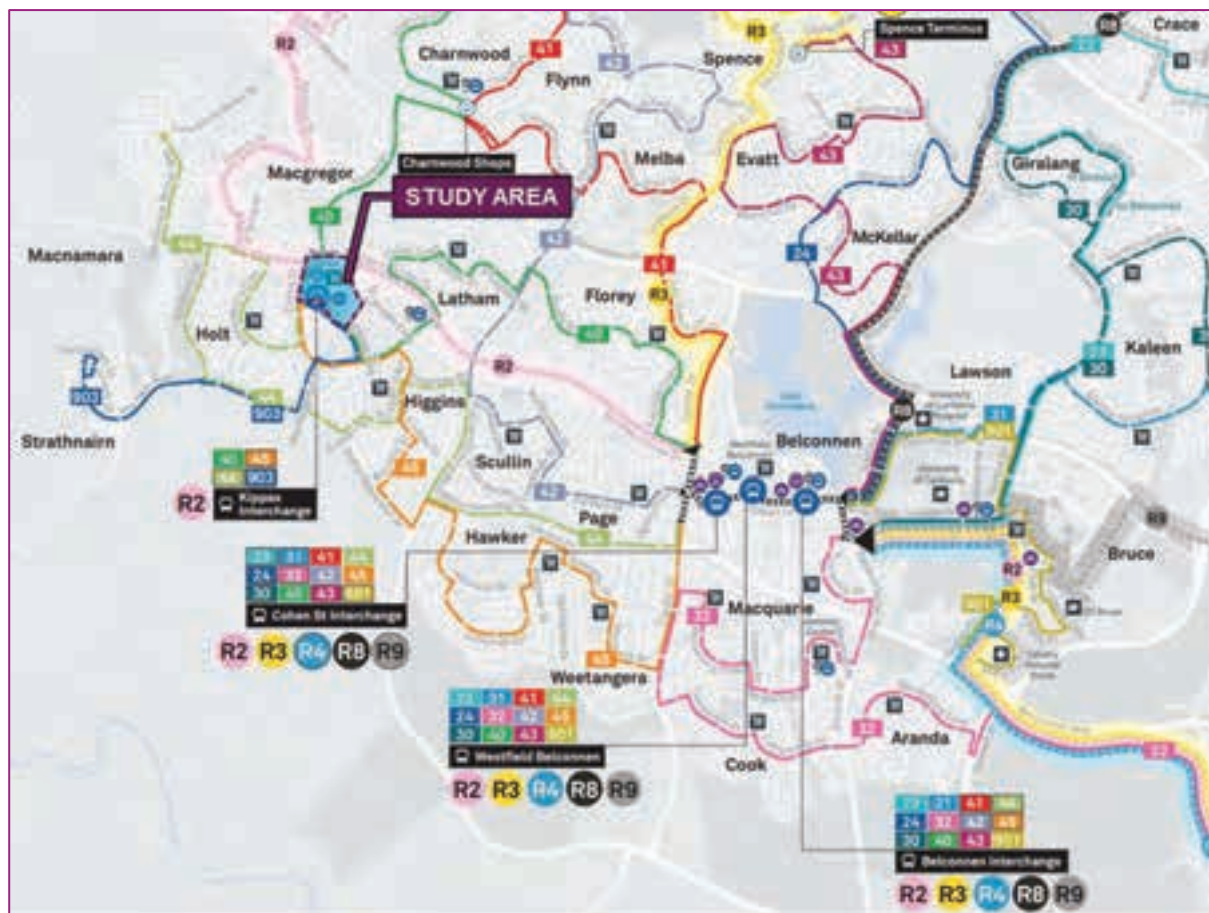
**Figure 21 Existing Weekday Public Transport Network**

Figure 21 shows the location of the study area in relation to the existing public transport routes. It can be seen that five bus routes are currently servicing Kippax Centre.

Table 32 outlines the existing bus routes and their peak and off-peak frequencies. The peak frequency of bus services for the Centre is 23 buses per hour, or approximately 1 bus service every 3 mins. Based on site observations and current local knowledge of the area this is considered a suitable frequency of bus services for the Centre.
