**Address: Kippax Place, Hardwick Crescent, Flack Street & Moyes Crescent,  
Holt, ACT 2615**

**Reference: LS018176 EP**

SITE PHOTOGRAPHS	
Client Name JPS Engineering Consultants	Site Location Section 51, Holt, ACT2615		Project No. P21030

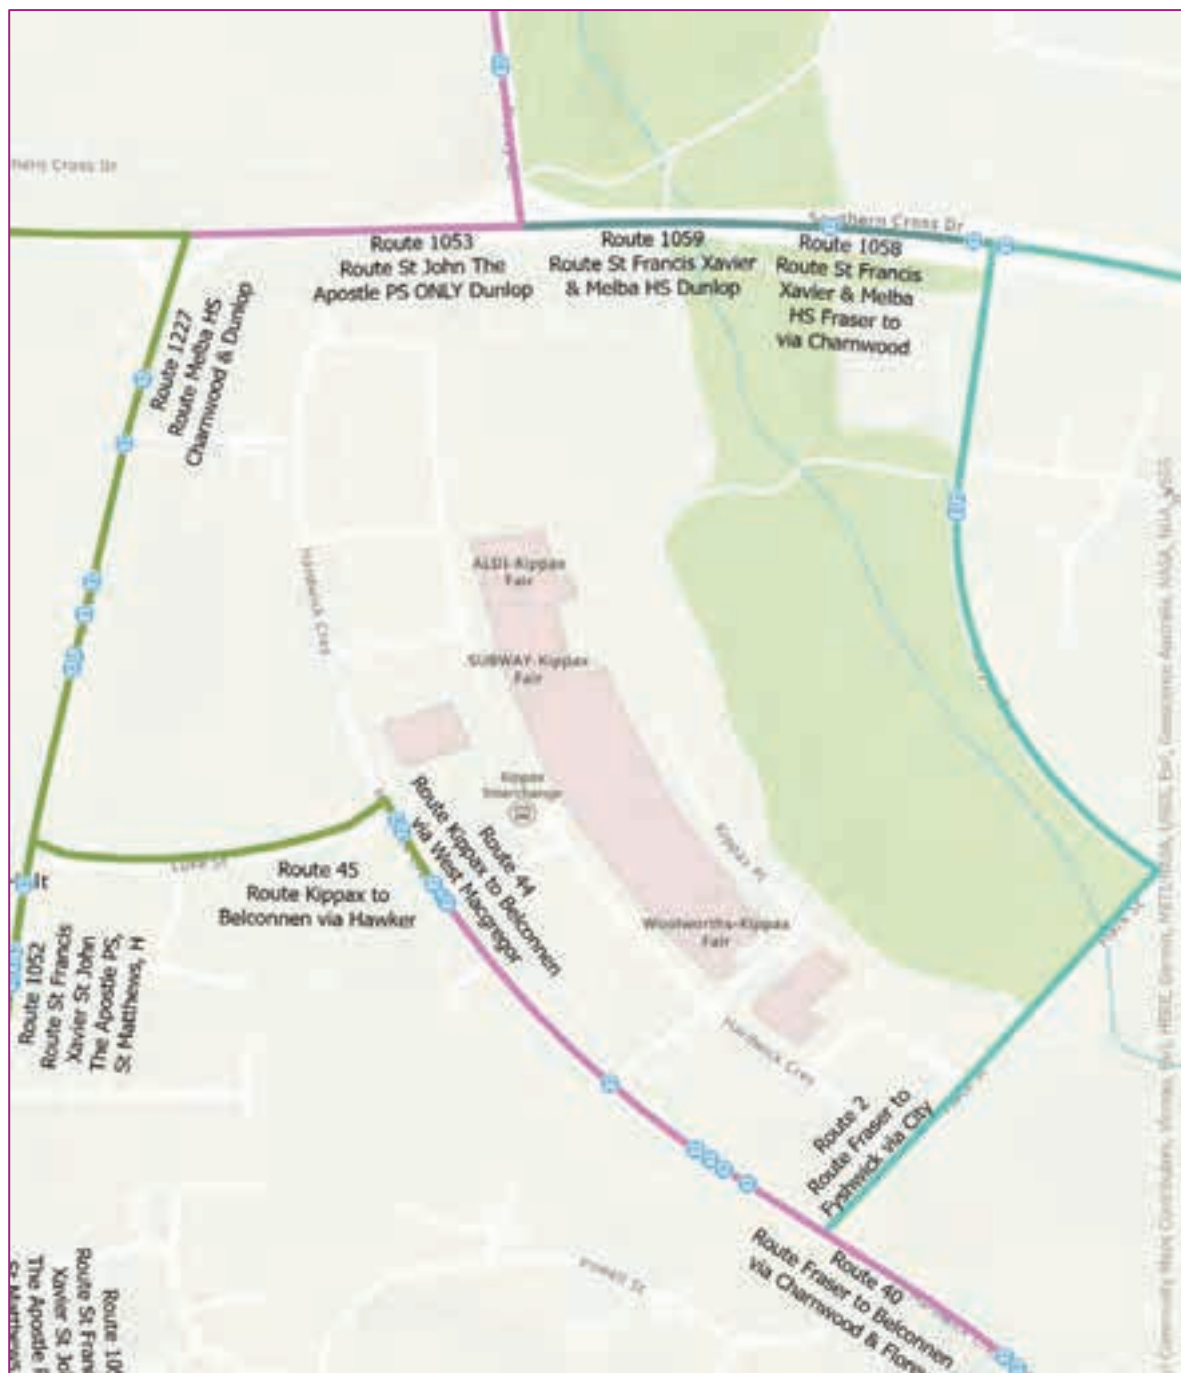
**Figure 22 Future Bus Routes Extract from 2041 CSTM**

Additionally, the future bus routes within the vicinity of the site was extracted from the CSTM 2041 model. It was observed that the CSTM only included additional school bus routes in addition to the existing bus routes. The route layer extracted from CSTM is shown in Figure 22 and the routes are listed below.

- Route 1052
- Route 1053
- Route 1058
- Route 1059
- Route 1227

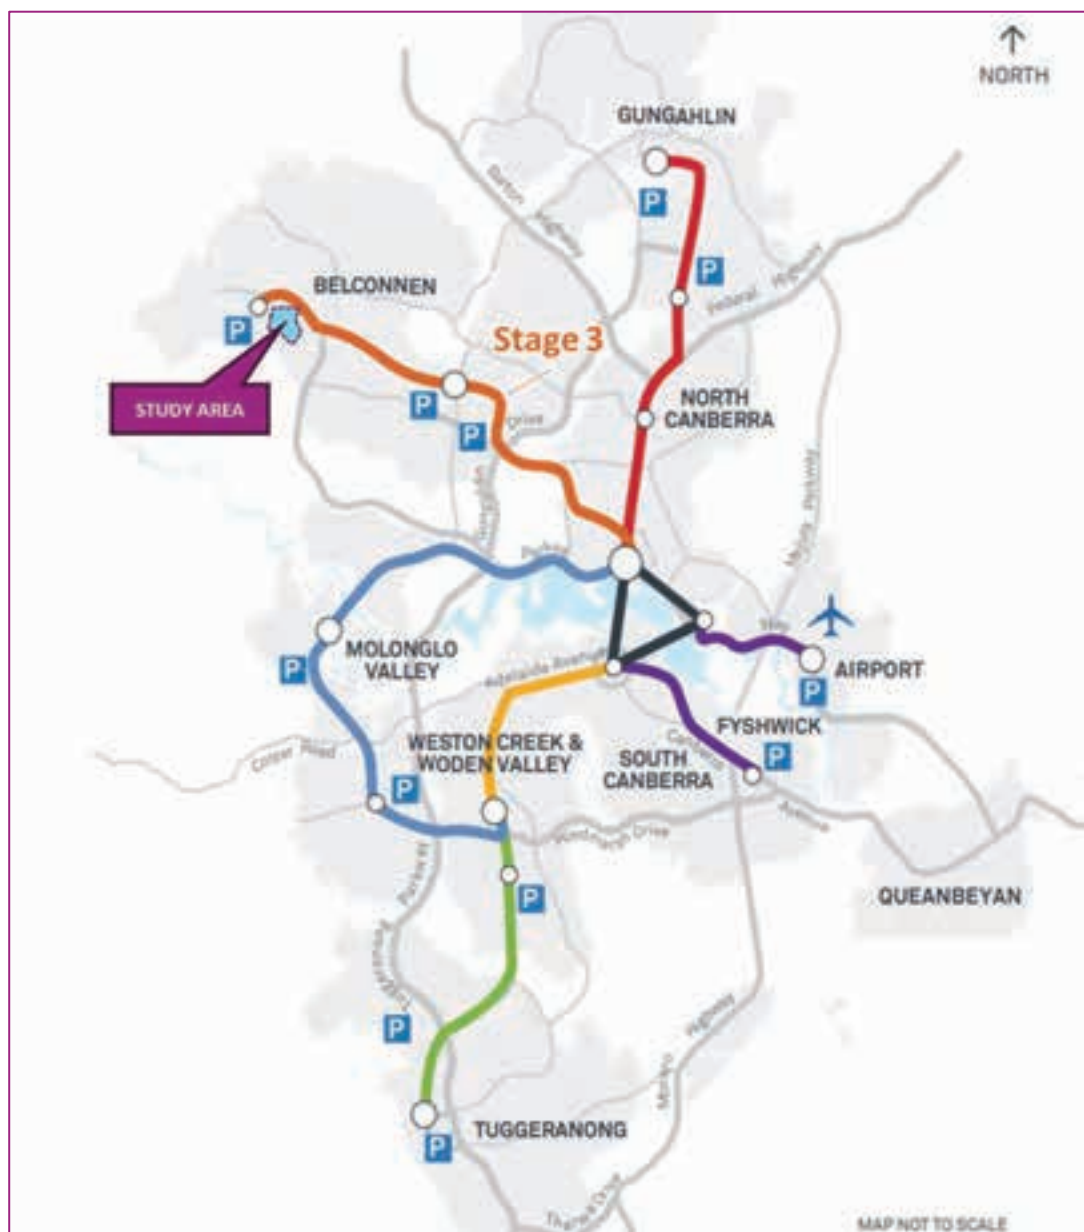
**Figure 23 ACT Light Rail Masterplan**

The future Canberra Light Rail is proposed to be extended to Kippax along Southern Cross Drive. Figure 23 presents the indicative future expansion plans for the Canberra Light Rail. Kippax Centre would be serviced by the Stage 3 expansion works. The light rail would likely help to significantly increase the mode share of public transport travel to and from the Kippax Centre.

The 2016 AECOM study considered that the future light rail service will terminate at the Kippax Centre. However, the Figure 23 shows that the service might extend beyond this area. As the exact location of the stops are unknown, it is assumed that there is a potential stop near the intersection of Southern Cross Drive / Moyes Crescent, which is within a 400m radius. The optimal pedestrian route to this potential stop from the Kippax Centre is through Road B and then Road A to access the potential light rail stop. Alternatively, a shuttle service is recommended between the potential stop to the Kippax Centre Bus Stop through Moyes Crescent via Flack Street.

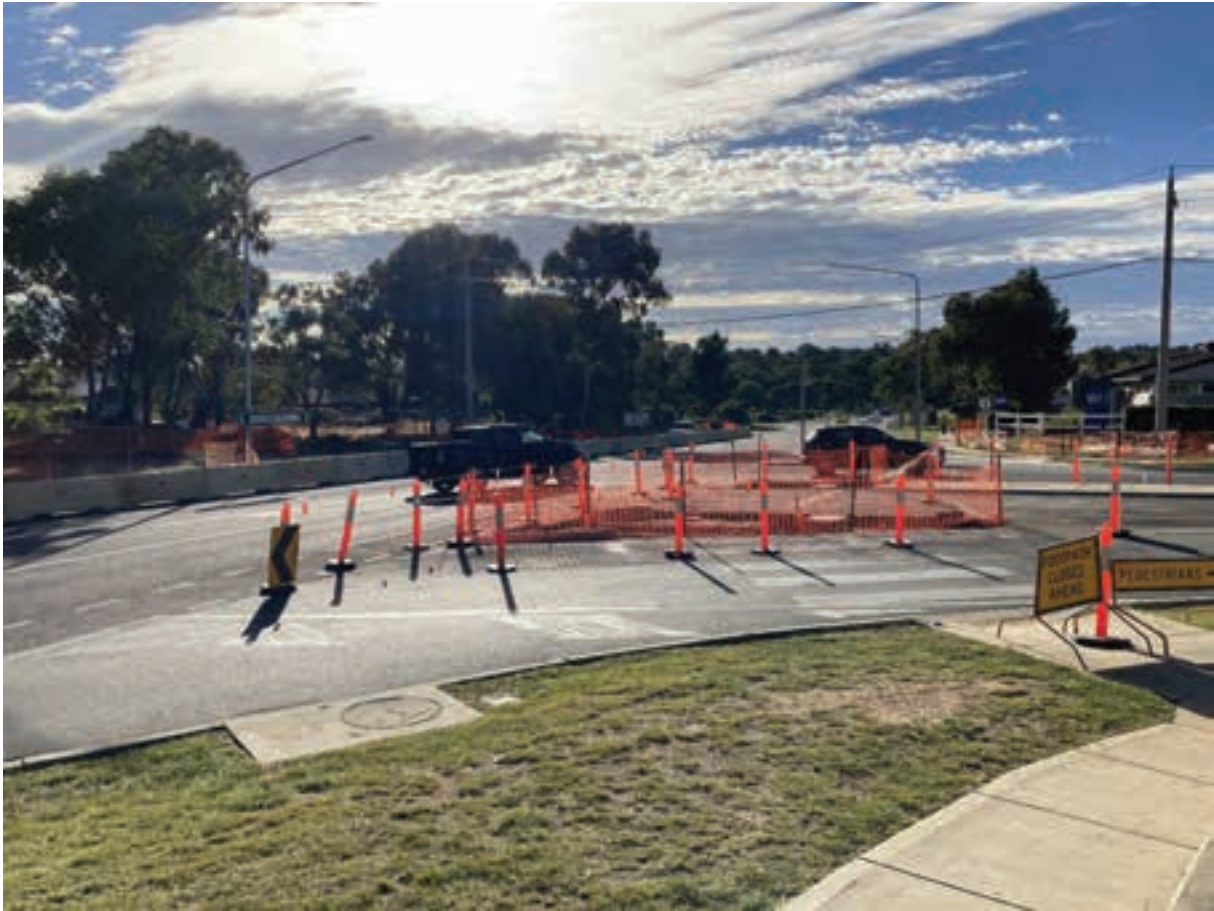
Figure 7 Construction site observed at Southern Cross Drive and Starke Street

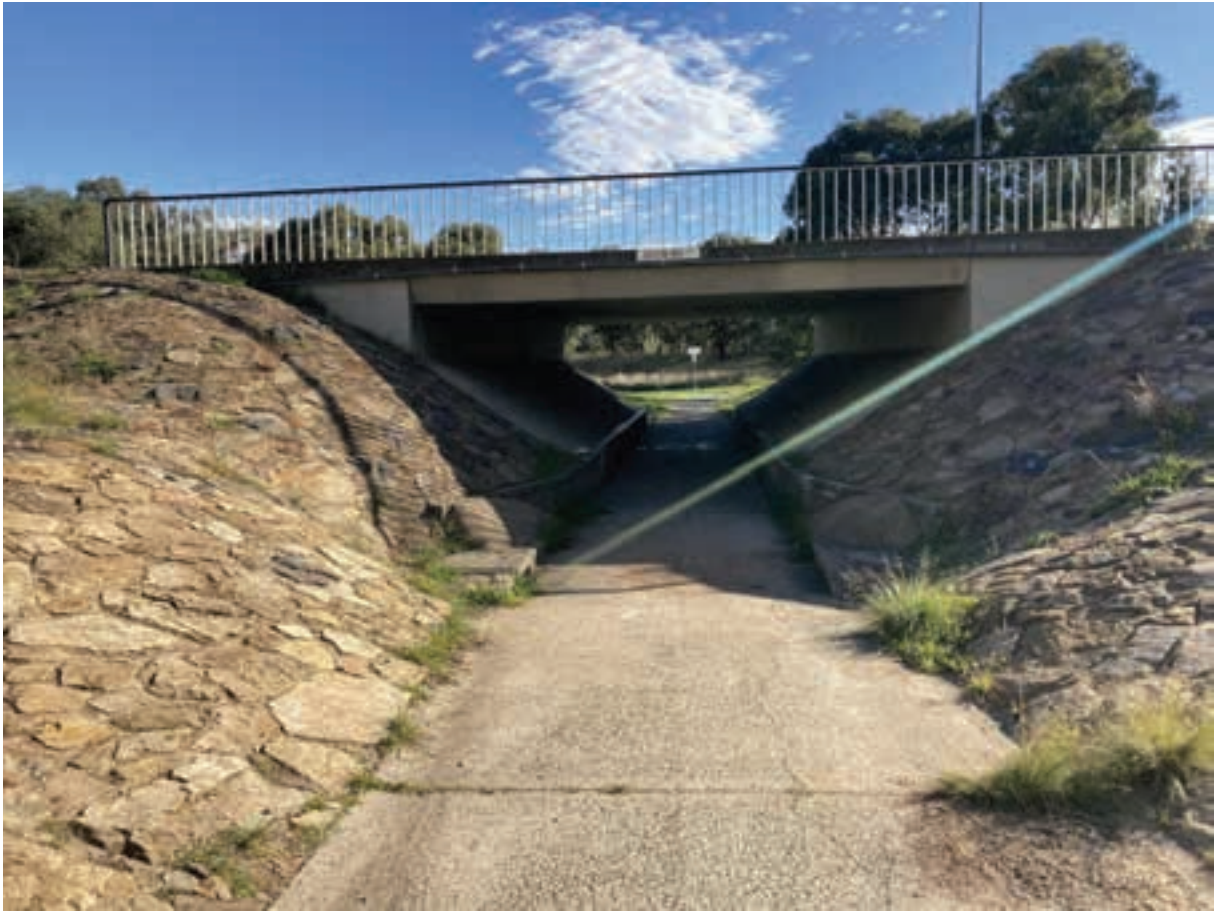
Figure 11 Underpass between Southern Cross Drive / Florey Drive and Southern Cross Drive / Moyes Crescent

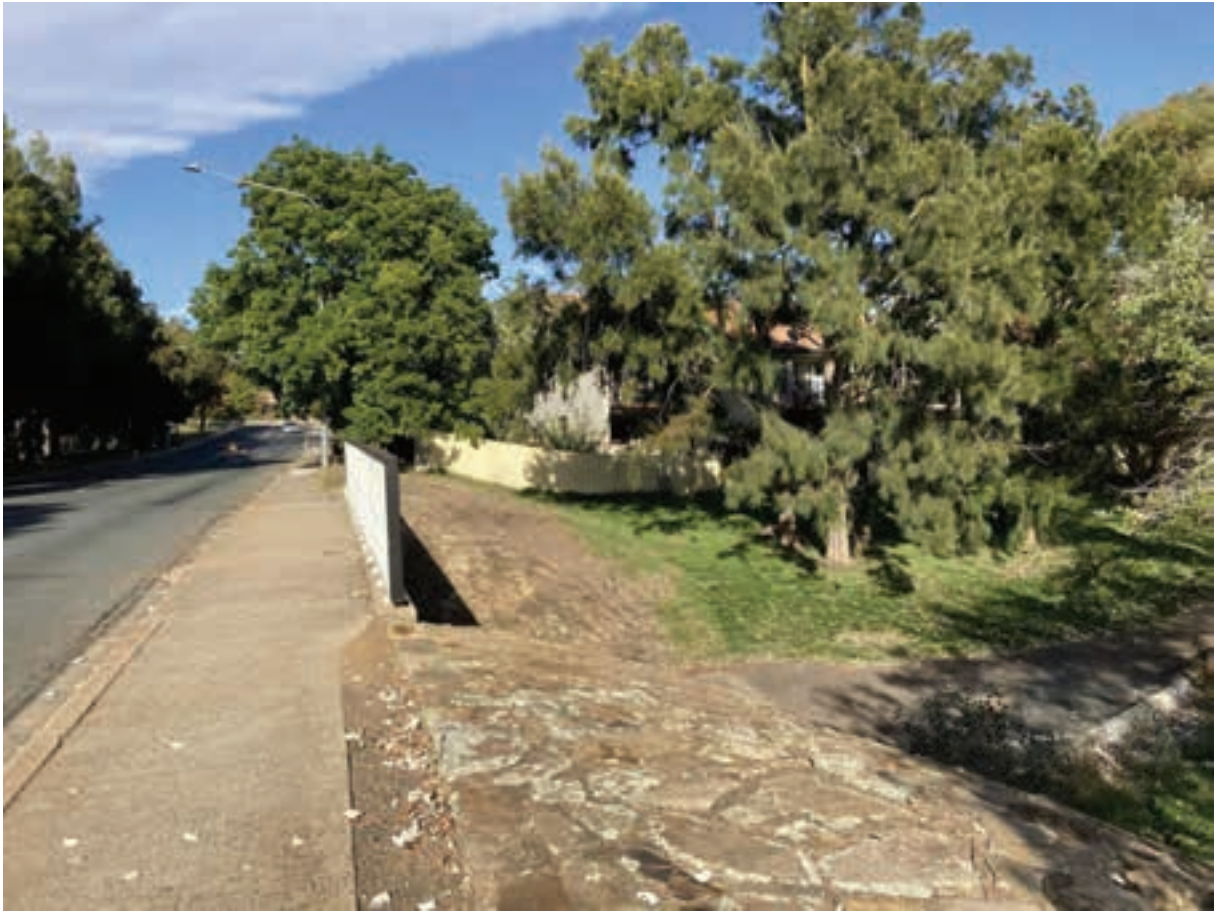
Figure 16 Underpass observed on Flack Street

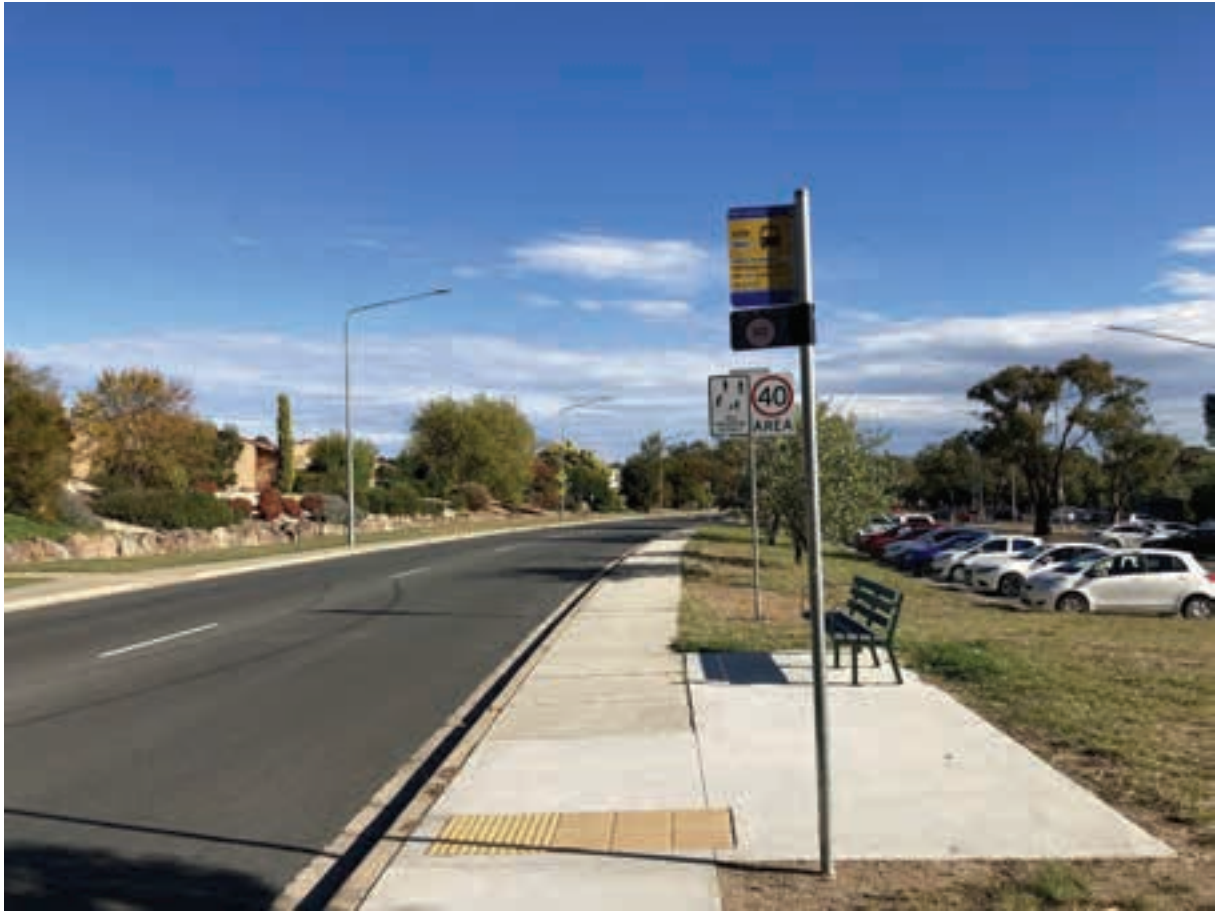
Figure 18 40 Speed limit and bus stop observed on Hardwick Crescent

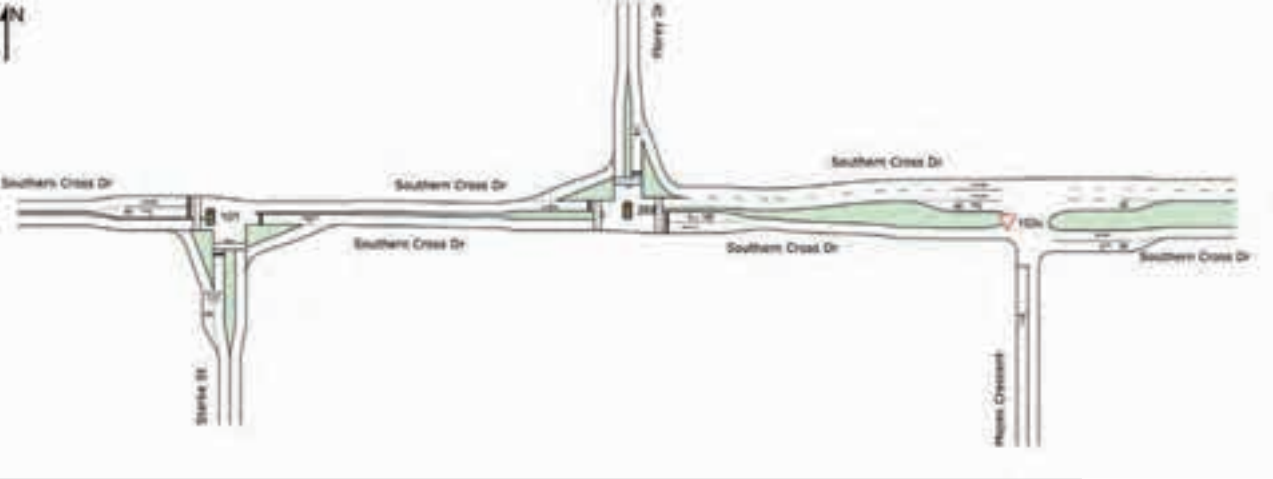
Network: N101 [Kippax - 2021 - AM Peak]

SITES IN NETWORK		
Site ID	CCG ID	Site Name
101	NA	Site1 - Southern Cross / Starke St - AM Peak - 2021
262	NA	Site2 - Southern Cross / Florey Drive - AM Peak - 2021
103v	NA	Site3 - Southern Cross / Moyes Cr - AM Peak - 2021

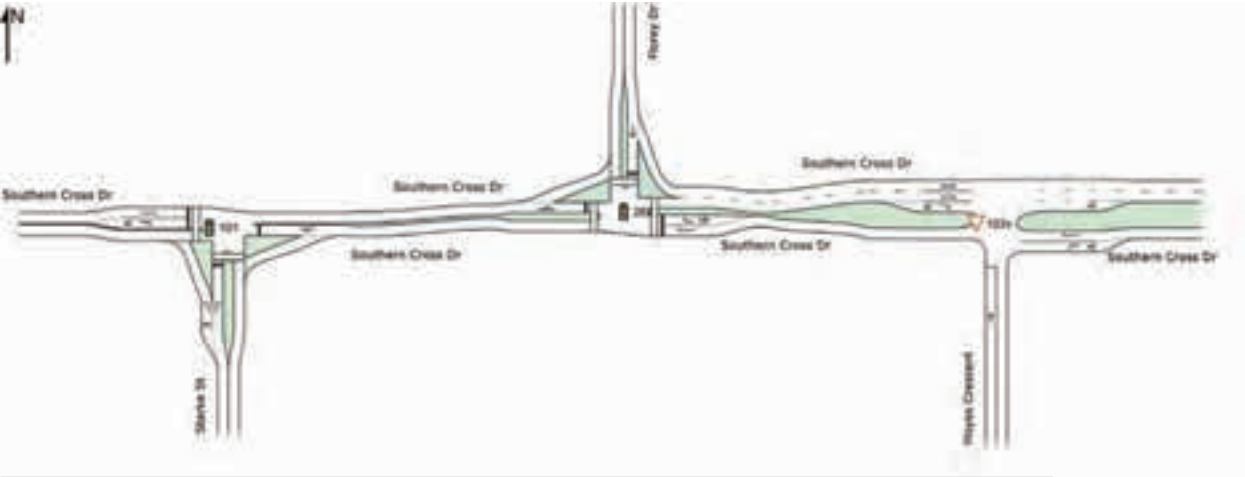
📍📍 Network: N101 [Kippax - 2025-No DVLP - AM Peak]

SITES IN NETWORK		
Site ID	CCG ID	Site Name
101	NA	Site1 - Southern Cross / Starke St - AM Peak - 2025-No DVLP
262	NA	Site2 - Southern Cross / Florey Drive - AM Peak - 2025-No DVLP
103v	NA	Site3 - Southern Cross / Moyes Cr - AM Peak - 2025-No DVLP

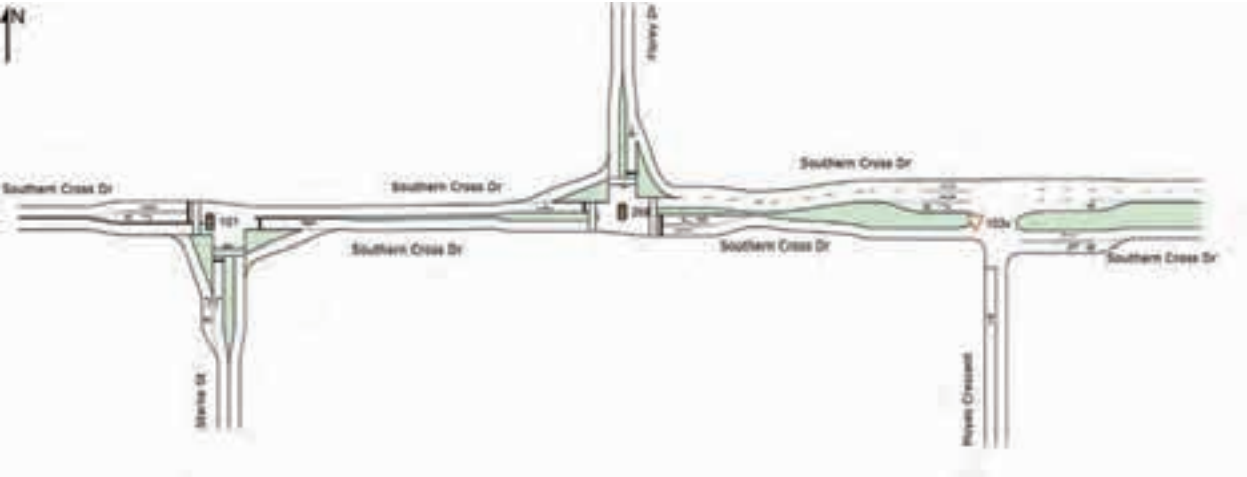
📍📍 Network: N101 [Kippax - 2035-No DVLP - AM Peak]

SITES IN NETWORK		
Site ID	CCG ID	Site Name
📍 101	NA	Site1 - Southern Cross / Starke St - AM Peak - 2035-No DVLP
📍 262	NA	Site2 - Southern Cross / Florey Drive - AM Peak - 2035-No DVLP
📍 103v	NA	Site3 - Southern Cross / Moyes Cr - AM Peak - 2035-No DVLP

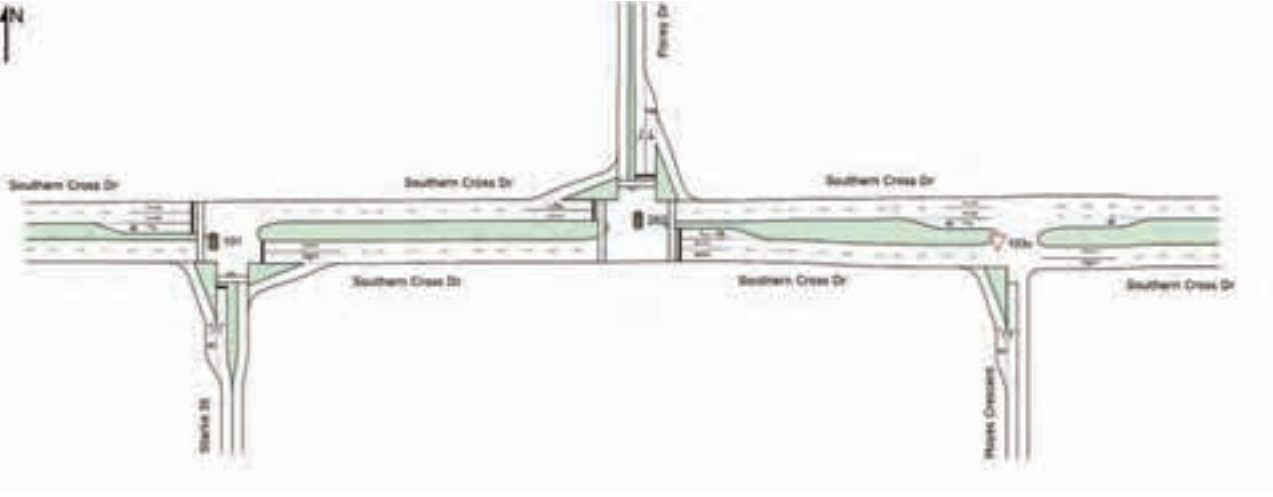
## 📍📍 Network: N101 [Kippax - 2025-Base Case No DVLP Mitigations - AM Peak]

SITES IN NETWORK		
Site ID	CCG ID	Site Name
🚦 101	NA	Site1 - Southern Cross / Starke St - AM Peak - 2025 - No DVLP (Base Case) Mitigation
🚦 262	NA	Site2 - Southern Cross / Florey Drive - AM Peak - 2025 - No DVLP (Base Case) Mitigation
🚦 103v	NA	Site3 - Southern Cross / Moyes Cr - AM Peak - 2025 - No DVLP (Base Case) Mitigation

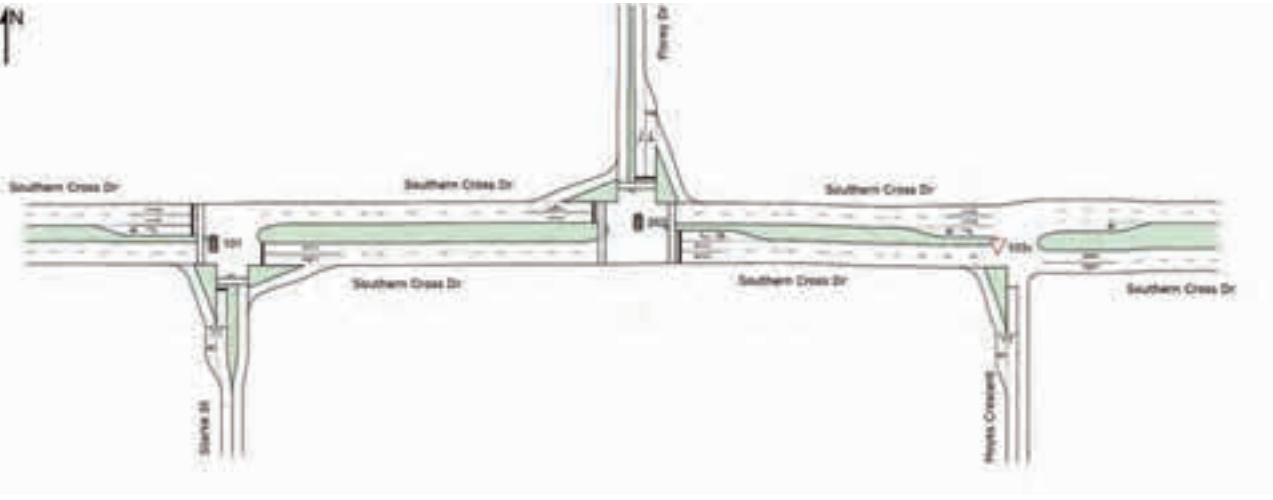
## 📍📍 Network: N101 [Kippax - 2025-Mitigation With DVLP - AM Peak]

SITES IN NETWORK		
Site ID	CCG ID	Site Name
🚦 101	NA	Site1 - Southern Cross / Starke St - AM Peak - 2025- Mitigation With DVLP
🚦 262	NA	Site2 - Southern Cross / Florey Drive - AM Peak - 2025- Mitigation With DVLP
🚦 103v	NA	Site3 - Southern Cross / Moyes Cr - AM Peak - 2025- Mitigation With DVLP

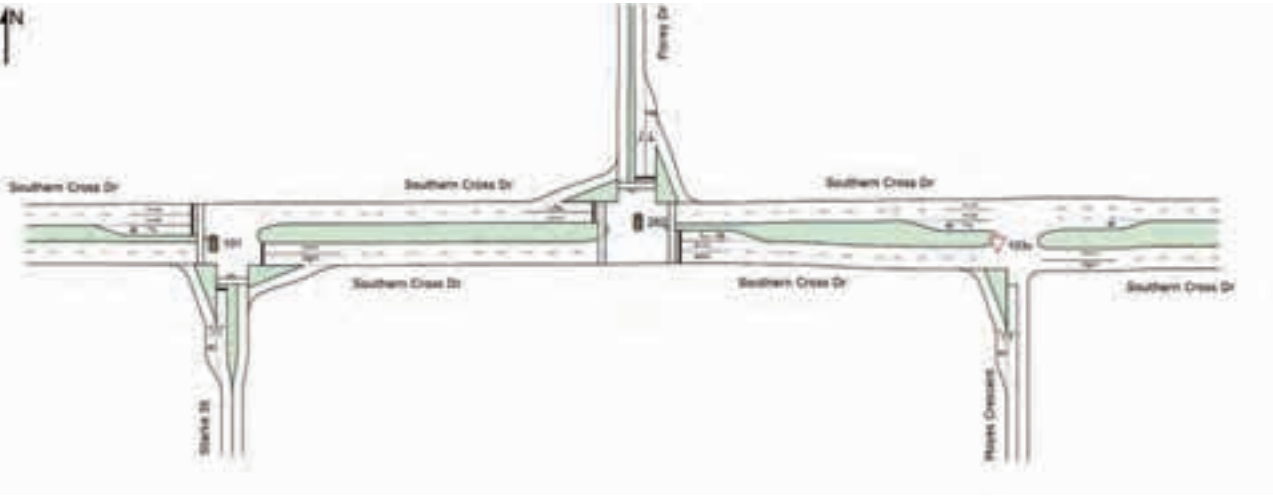
## Network: N101 [Kippax - 2035-Mitigation With DVLP - AM Peak]

SITES IN NETWORK		
Site ID	CCG ID	Site Name
101	NA	Site1 - Southern Cross / Starke St - AM Peak - 2035- Mitigation With DVLP
262	NA	Site2 - Southern Cross / Florey Drive - AM Peak - 2035- Mitigation With DVLP
103v	NA	Site3 - Southern Cross / Moyes Cr - AM Peak - 2035- Mitigation With DVLP

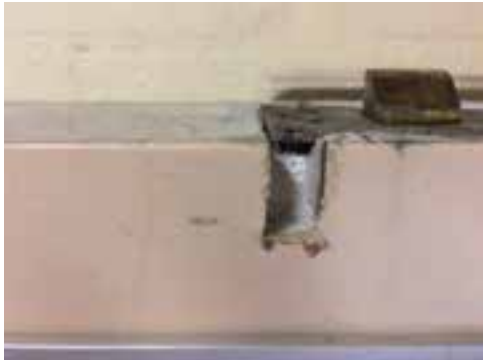
ASBESTOS - Kippax Health Centre				
SAMPLE NO.	TRACKER LOCATION NO.	LOCATIONS	MATERIAL DESCRIPTION	PHOTOGRAPH
2540-19-1	002	Ground floor Corridor - fire doors	Fire door core (Friable)

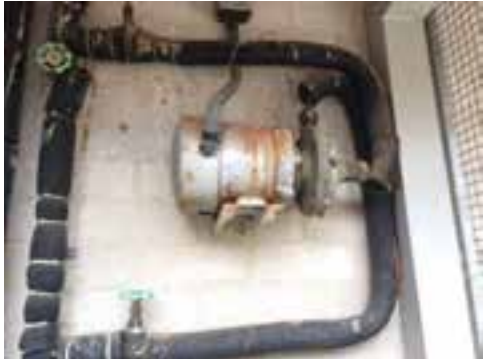
2540-19-10	006	Ground floor Child Health Clinic - to chiller compressor	Gaskets (compressed) (Non-Friable)

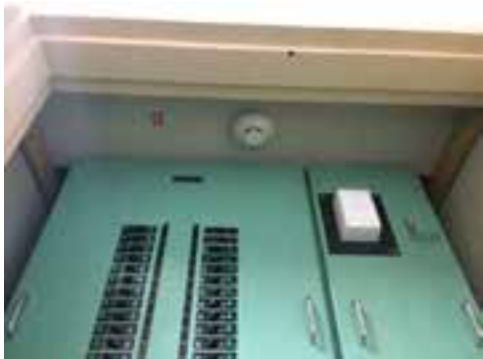
RA 2540- 19-2	002	Ground floor Front Corridor - ceiling to electrical cupboard	Sheet (Non-Friable)

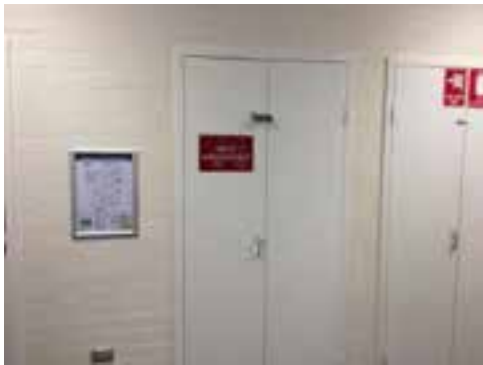
ASBESTOS - Kippax Health Centre				
SAMPLE NO.	TRACKER LOCATION NO.	LOCATIONS	MATERIAL DESCRIPTION	PHOTOGRAPH
RA 2540-19-2	003	Ground floor Rear Corridor - ceiling to electrical cupboard	No Access to Sheet (Non-Friable)

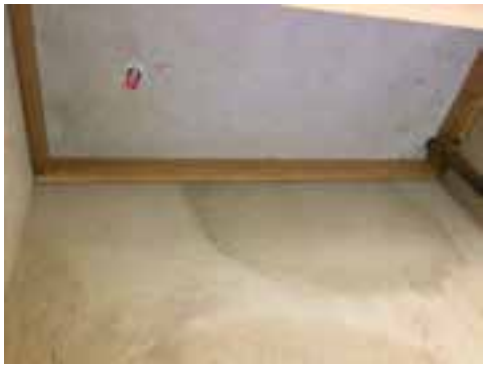
2540-19-2	003	Ground floor Rear Corridor - ceiling to fire hose cupboards	Sheet (Non-Friable)

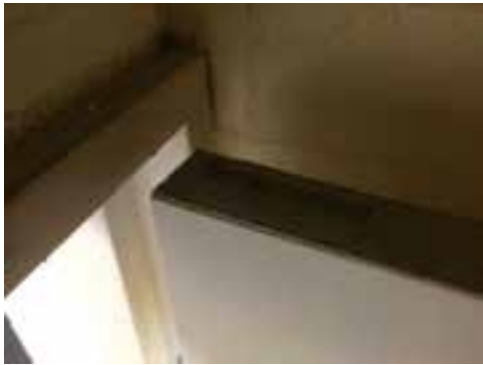
2540-19-4	003	Ground floor Rear Corridor - fire door	Fire door core (Friable)

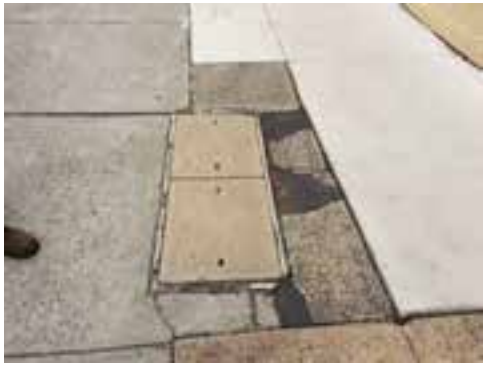
2540-19-7	001	Exterior - PMG pit	Moulded Sheet (Non-Friable)

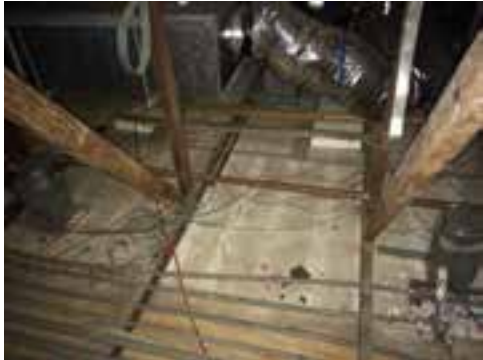
ASBESTOS - Kippax Health Centre				
SAMPLE NO.	TRACKER LOCATION NO.	LOCATIONS	MATERIAL DESCRIPTION	PHOTOGRAPH
2540-19-9	008	Ground floor Ceiling Space - ceilings throughout	Sheet (Non-Friable)

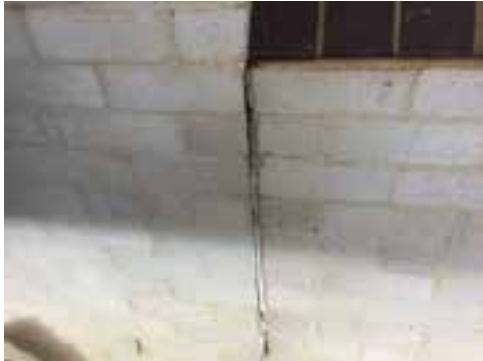
3617-84-A10	001	Exterior - expansion joint to wall	Mastic (Non-Friable)

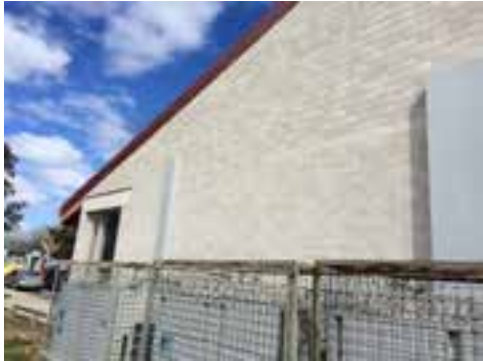
3617-84-A8	001	Exterior - verge under cloaking	Sheet (Non-Friable)

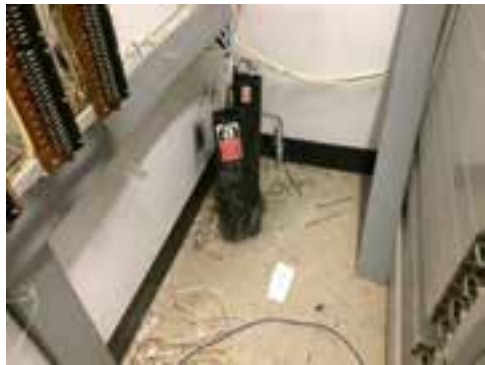
ASBESTOS - Kippax Health Centre				
SAMPLE NO.	TRACKER LOCATION NO.	LOCATIONS	MATERIAL DESCRIPTION	PHOTOGRAPH
M0509	011	Ground floor MDF Room - pipe conduit	Pipe (Non-Friable)

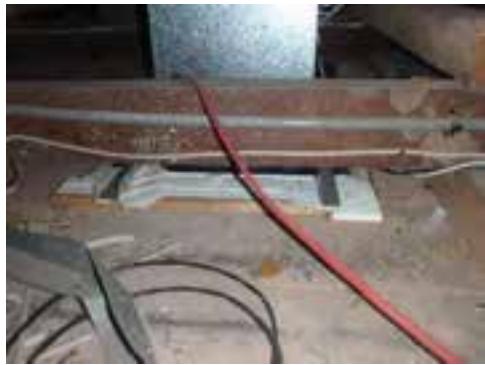
M0511	008	Ground floor Ceiling Space - packers to AC vents	Sheet (Non-Friable)

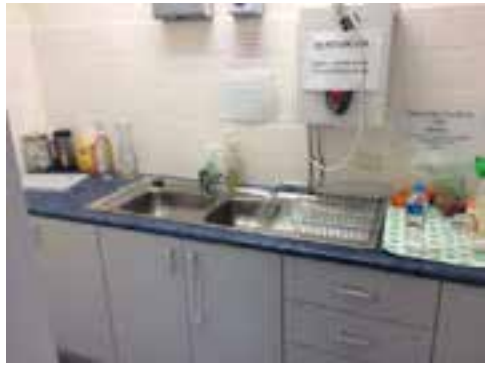
VA1	001	Wet areas - to pipes embedded in masonry walls (throughout building)	Pipe lagging (fibrous) (Presumed Friable)

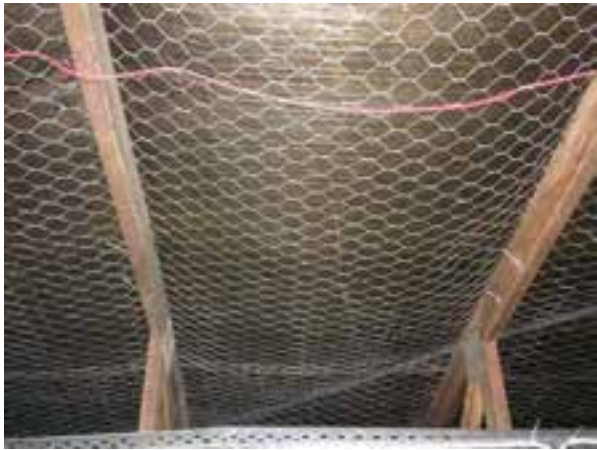
SMF202 7	Ground floor Ceiling Space	foil backed insulation to underside of roof

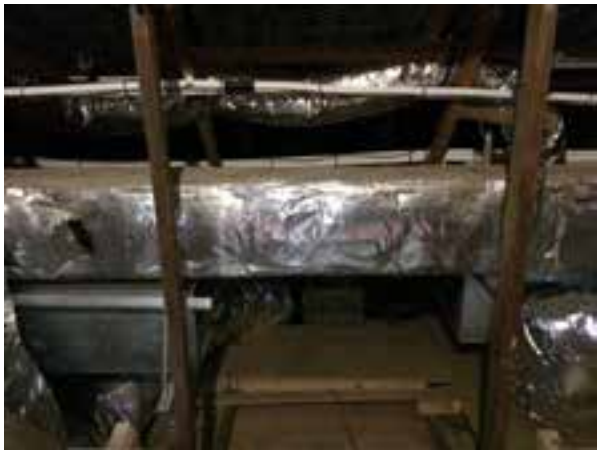
SMF202 8	Throughout	foil backed insulation to ducting

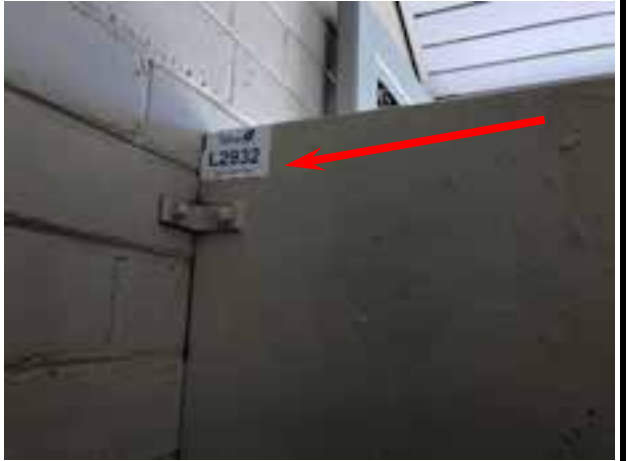
SAMPLE NO	LOCATION	MATERIAL DESCRIPTION	PHOTOGRAPH
L2932	Male toilet wall partition sheeting adjacent entry	Sheet

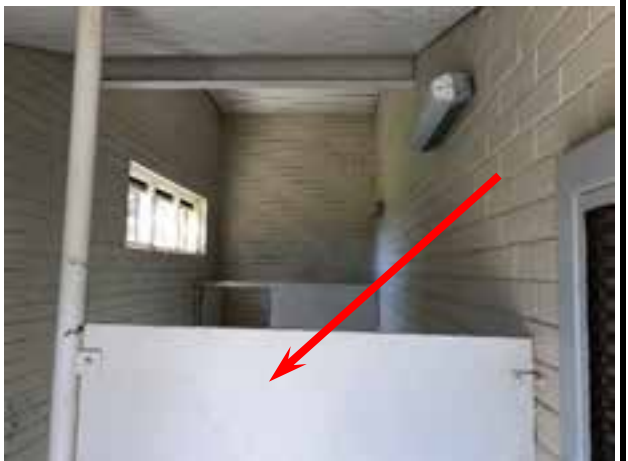
L2932	Male toilet wall partition sheeting adjacent entry	Sheet

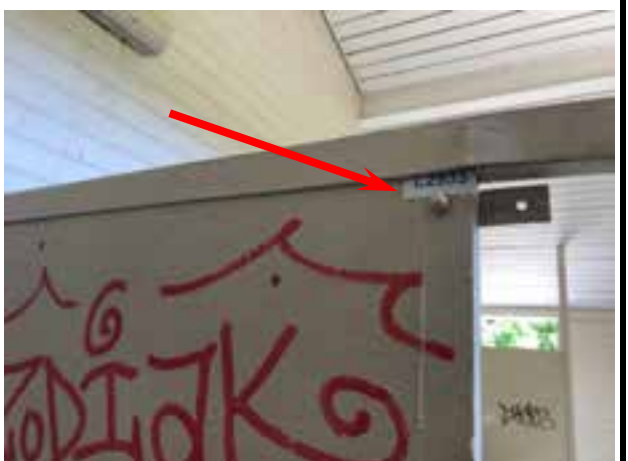
L2933	Male toilet cubicle partition sheeting	Sheet

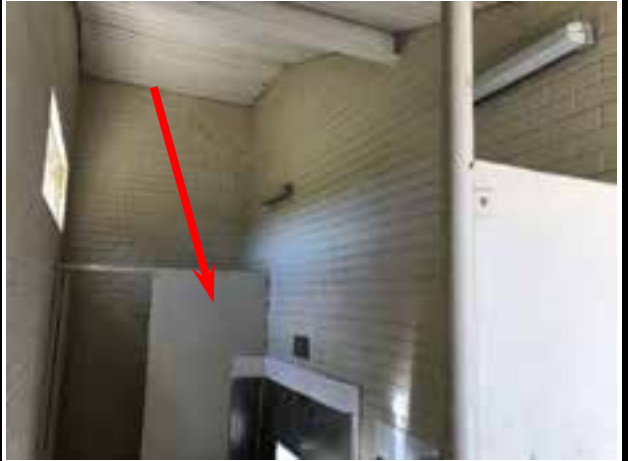
SAMPLE NO	LOCATION	MATERIAL DESCRIPTION	PHOTOGRAPH
L2933	Male toilet cubicle partition sheeting	Sheet

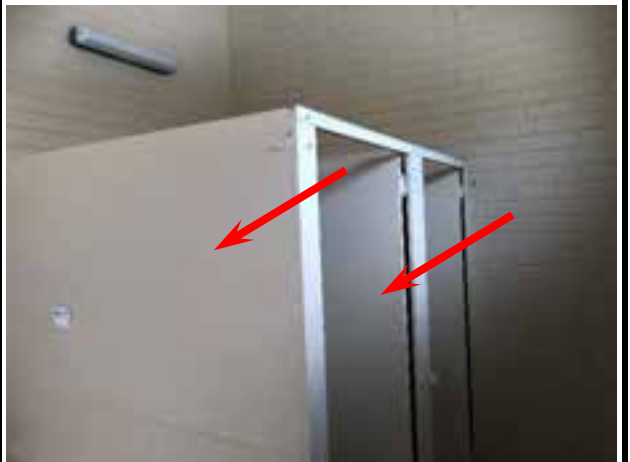
RA - L2932	Female toilet partition (cubicles)	Sheet

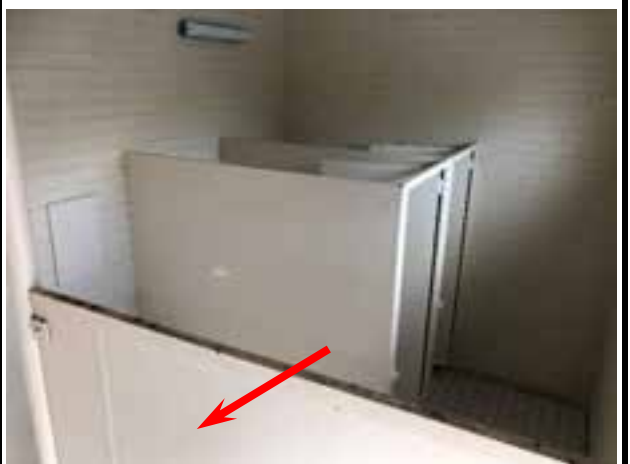
RA - L2932	Female toilet partition (entry)	Sheet

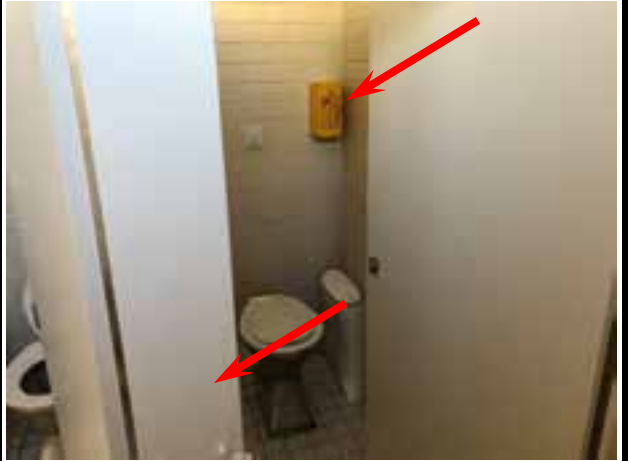
SAMPLE NO	LOCATION	MATERIAL DESCRIPTION	PHOTOGRAPH
RA - L2932	Female toilet cubicle	Sheet and sharps container (yellow)

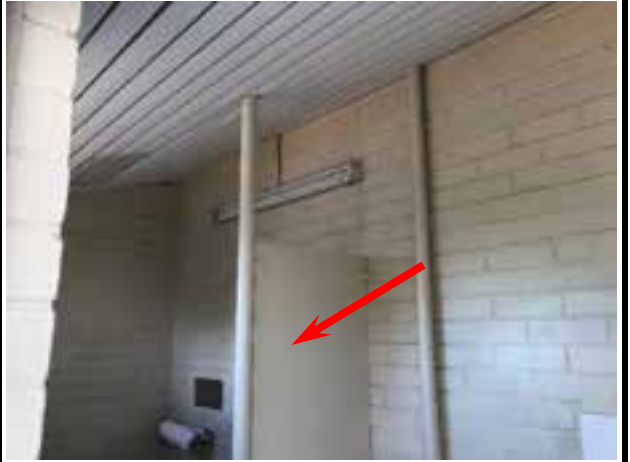
RA - L2932	Disabled toilet partition sheeting	Sheet

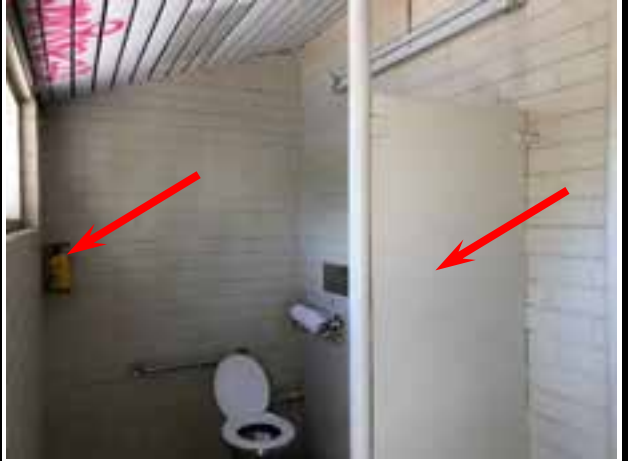
RA - L2932	Disabled toilet cubicle	Sheet and sharps container (yellow)
