OCTOBER 2023

Prepared for **Suburban Land Agency ACT Government**

VOLUME A – CONSERVATION MANAGEMENT PLAN

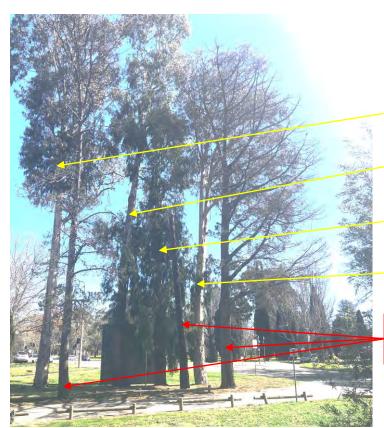
Tree 13 – Regulated Schedule 2 species - Eucalyptus bicostata - Blue Gum, High Quality

Tree 13
Eucalyptus bicostata

Tree 14
Eucalyptus bicostata

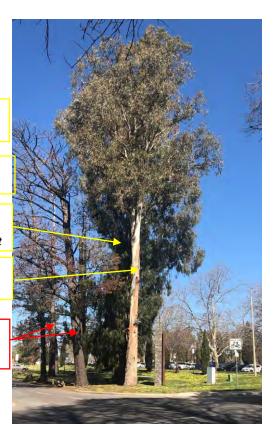
Tree 13, 14,15, & 16 Regulated Schedule 2 species - Eucalyptus bicostata (Blue Gum) and Eucalyptus nicholii (Narrow Leaf Peppermint) are high to medium qualilty trees retain as a group only. Trees 17,18 and 19 in the foreground are the Pinus radiata which are weed species

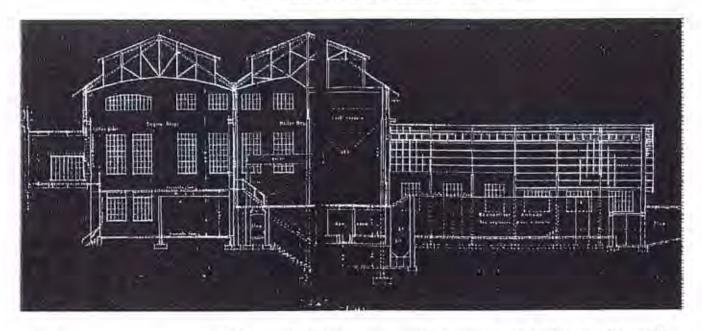
Figure 3 Section of Power House, c1911 National Australian Archives

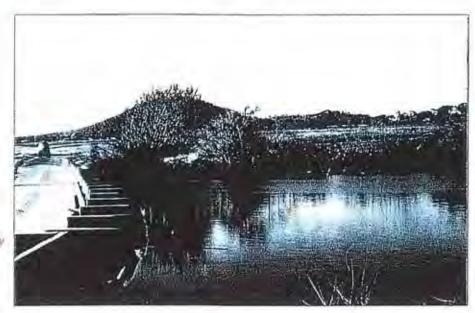
Figure 5
Weir at the Molonglo River originally intended for measuring river flow and later used as water supply for the power station c.1915.
A.F. Minty Collection 1959

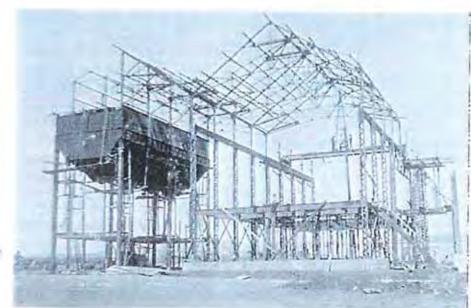
Figure 7
Kingston Power House under construction, c.1912-20, north elevation, showing the installation of the steel frame.

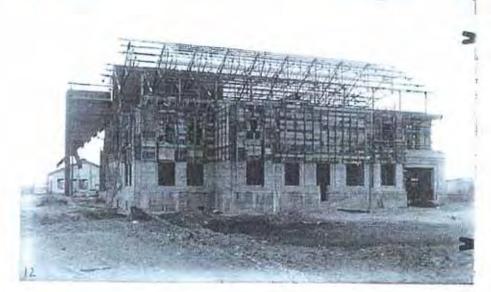
Figure 8
West elevation, showing the lower external walls clad, with the coof substructure in place.
NLA Images No. 23043

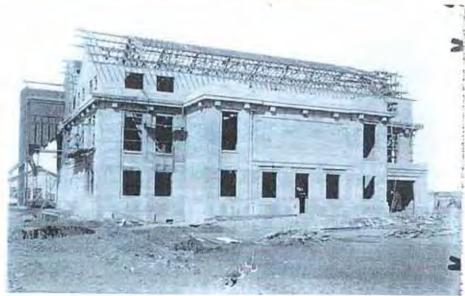
Figure 9
West elevation showing the external concrete walls completed and awaiting roof cladding.
NLA Images No. 23058

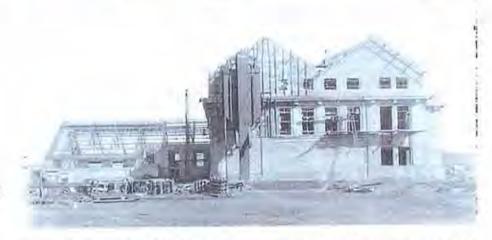
Figure 11
North elevation, showing the completion of the external concrete walls.

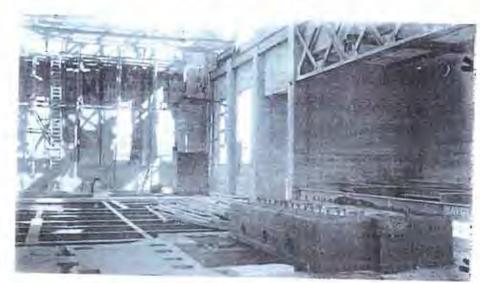
Figure 12 Kingston Power House under construction, c.1912-20. Interior fitout of the Engine Bay. NI.A Images No. 23060

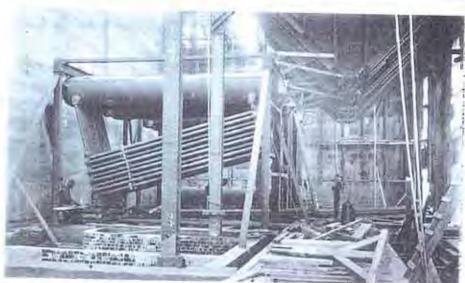
Figure 13 Interior fitout of the Boiler Bay. NLA Images No. 23061

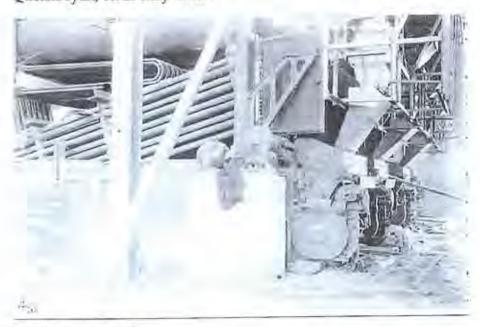
Figure 14
Kingston Power House under construction, c.1912-20.
Detail of Power House boilers.
NLA Images No. 23071

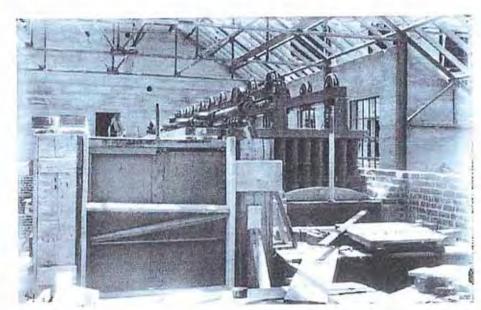
Figure 16 Interior of the Economiser Annexe during construction. NLA Images No. 23072

Interior of Economiser Annexe during construction NLA Images No 23072

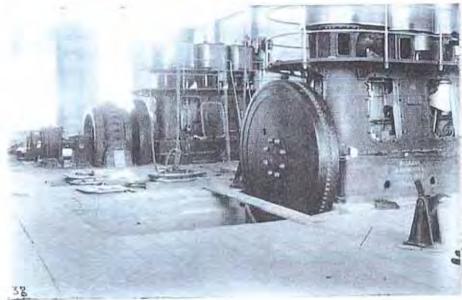
Figure 17 Interior of the Engine Bay showing the engines, one with generator fitted. NLA Images No. 23069

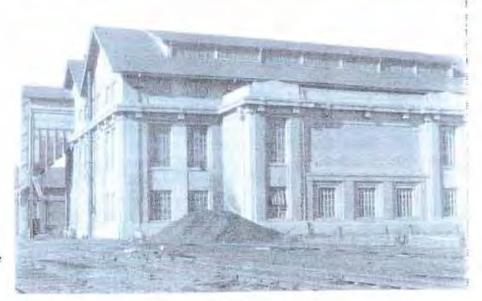
Figure 18
Completed Power House, showing the railway siding running along the north eastern side.

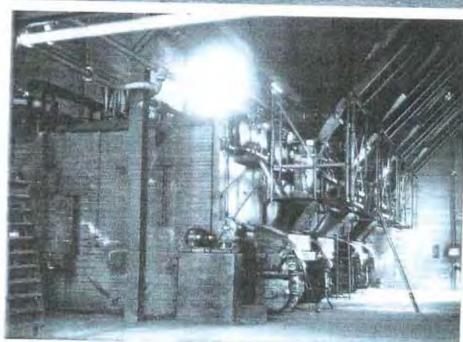
Figure 21
The Boiler Bay interior, showing the original coal-fired Babcock and Wilcox boilers.
NLA Images No., 26738

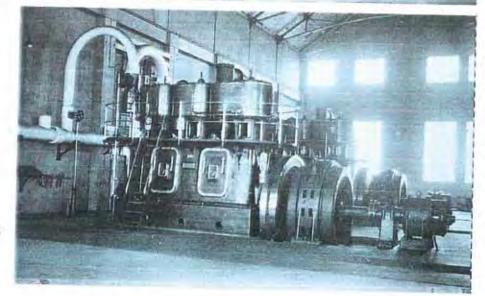
Figure 22
The Engine Room, showing the 1915
Bellis and Morcom triple expansion
steam engine.
NLA Images No.. 26737

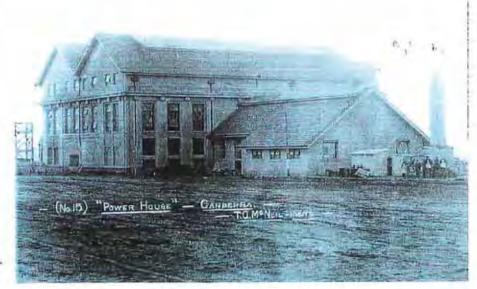
Figure 26 South Elevation of the Power House. T.O. McNeil Collection

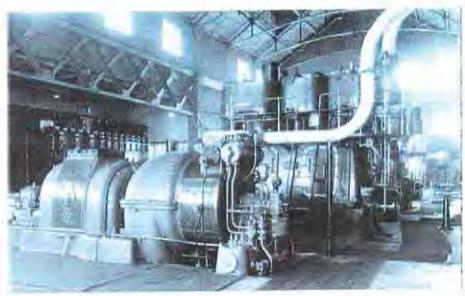
Figure 29 Kingston Power House Engine Room, showing a 1927 BTH turbaalternator in front of a 1915 Bellis and Morcom triple expansion steam engine. NAA A3560 /3588

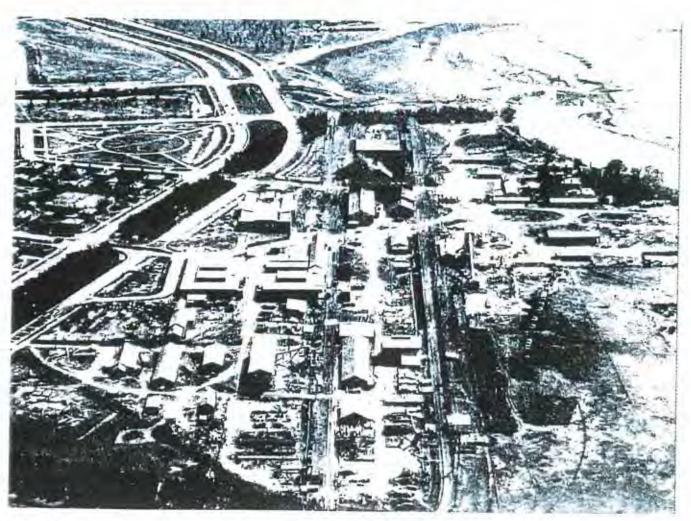
Figure 31
Aerial photograph of the Kingston
Power House, c1950.
Private Collection

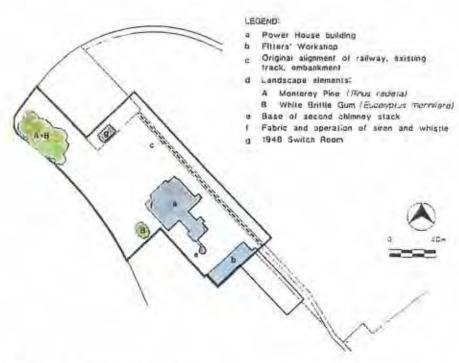
Figure 37 Significant Features within the Precinct PALM Variation 113

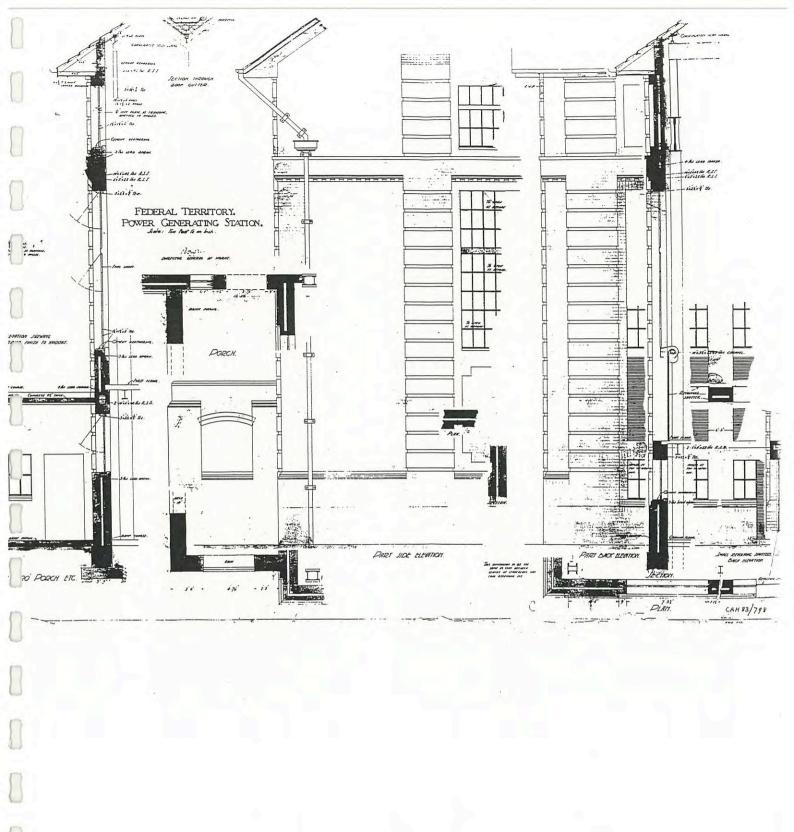
c. 1913 Architectural Details, brickwork. Federal Territory Power Generating Station, signed Percy J. Owen, Director General of Works

Source: Australian Archives CAH 83/799

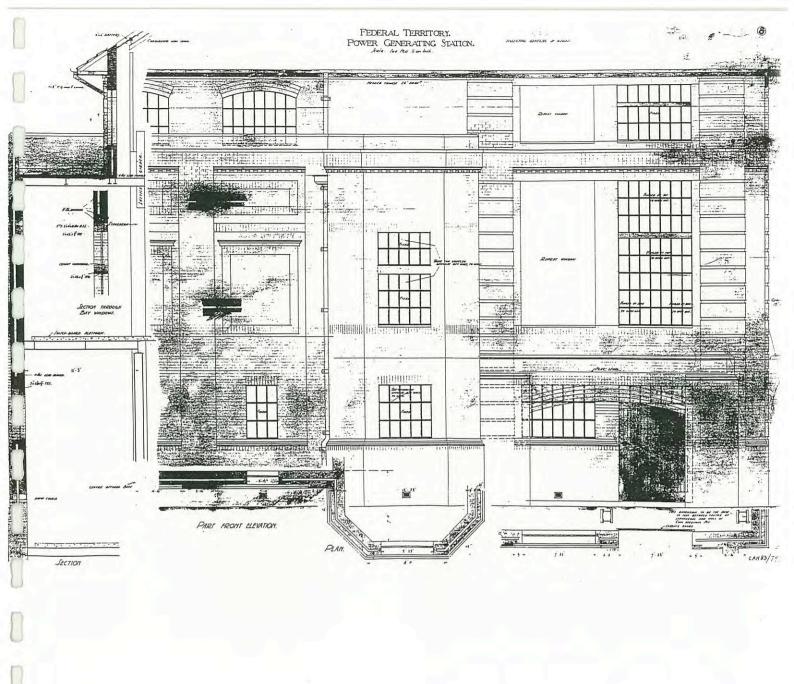
c. 1913 Architectural Details, brickwork. Federal Territory Power Generating Station, signed Percy J. Owen, Director General of Works

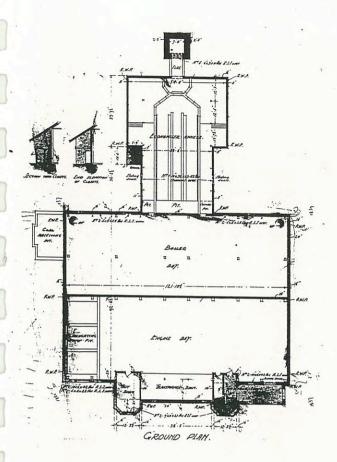
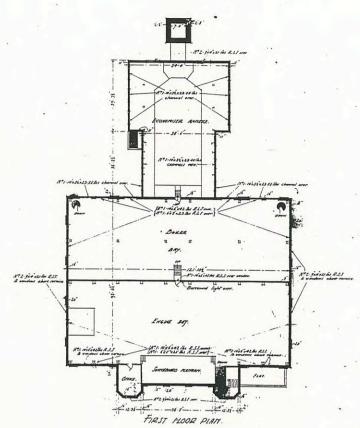
ARCHITECTURAL PLAN NO. 5

1914 Ground & First Floor Plan, Federal Territory Power Generating Station (concrete)

Source: Australian Archives CAH 83/793

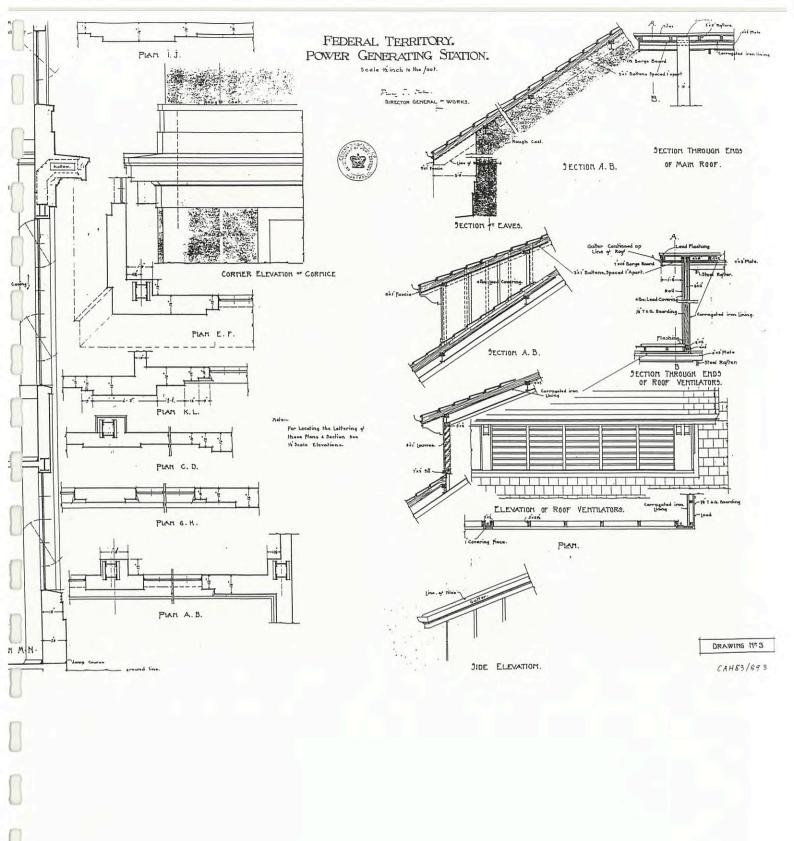
1914 Details, Federal Territory Power Generating Station (concrete)

Australian Archives CAH 83/893

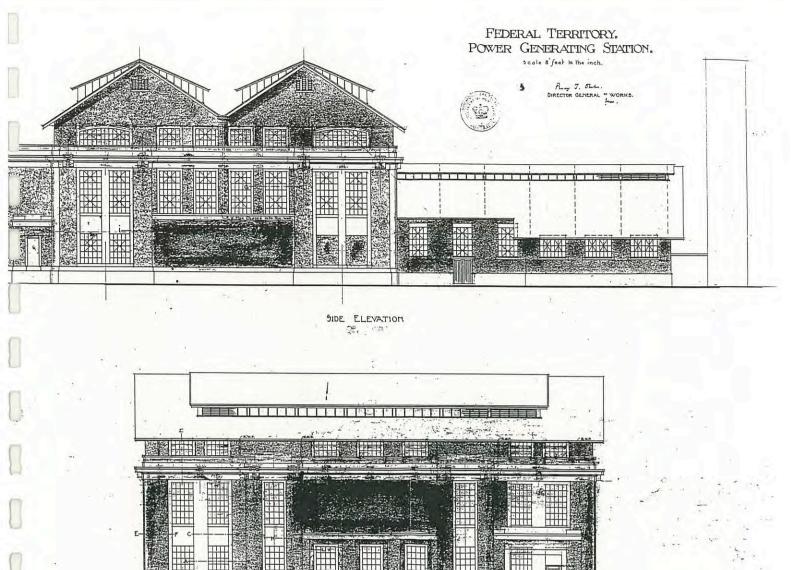
ARCHITECTURAL PLAN NO. 7

FRONT ELEVATION ... DRAWING-Nº4

1914 Side & Front Elevation, Federal Territory Power Generating Station (concrete)

Source: Australian Archives CAH 83/890

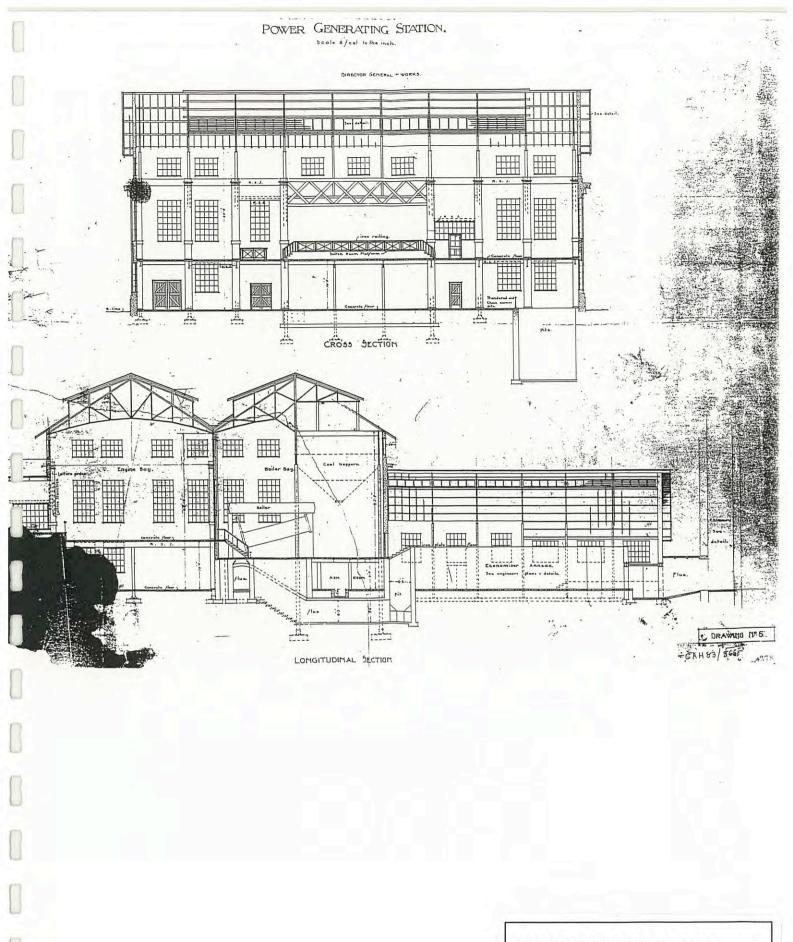
1914 Cross & Longitudinal Section, Federal Territory Power Generating Station (concrete)

Source: Australian Archives CAH 83/866

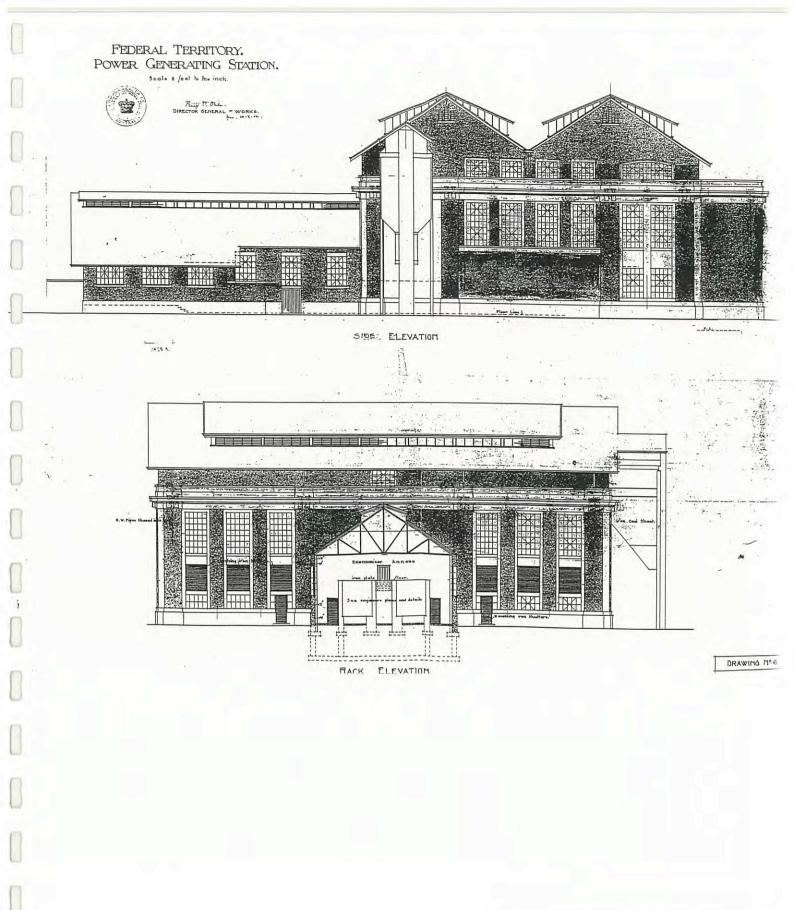
1914 Side & Back Elevation, Federal Territory Power Generating Station (concrete)

Australian Archives CAH 83/793

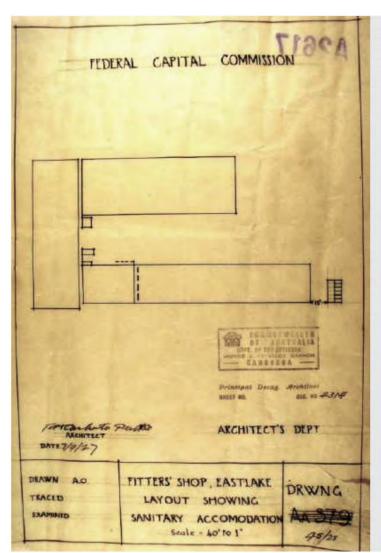
Figure 60. Fitters' Shop, Eastlake, Layout Showing Sanitary Accommodation, 1927

Source: CRS A2617, item Section 167/4314, National Archives of Australia

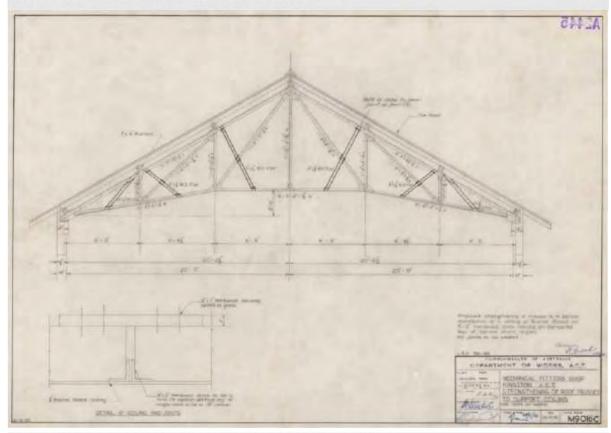
Figure 68. Mechanical Fitters Shop, Kingston, ACT, Strengthening of Roof Trusses to Support Ceiling, 1956
Source: CRS A2445, item M9016C, National Archives of Australia

- 23. New Layout for Welders' Shop, Floor Plan and Sections, 1947, National Archives of Australia
- 24. Mechanical Fitters Shop, Kingston, ACT, Strengthening of Roof Trusses to Support Ceiling, 1956, National Archives of Australia

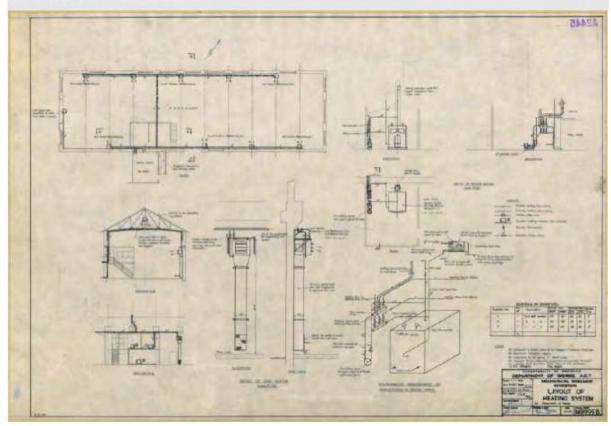
Figure 69. Proposed Heating Layout for Workshop, June 1956 Source: CRS A2445, item M8995B, NAA

- 25. Proposed Heating Layout for Workshop, June 1956, National Archives of Australia

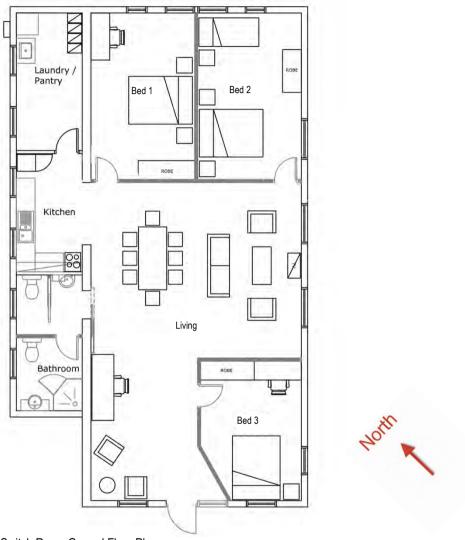
1948 Switch Room Ground Floor Plan

(Source: base plan provided by artsACT and prepared by Spacelift Design Consultancy)

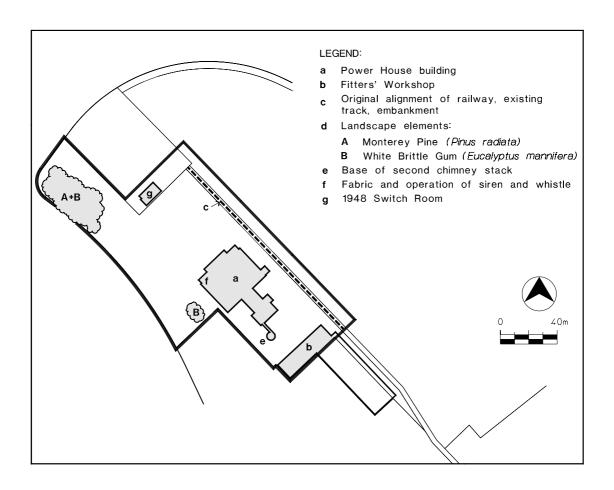
Figure 48a: Kingston Power House Precinct: Significant Features

The Place comprises the following significant features identified on Figure 48a

- a) Power House building, together with significant internal fabric identified at Schedule 1 and Figure 48b;
- b) Fitters' Workshop (Bulk Supply Store);
- c) original alignment of the railway and existing railway track and embankment
- d) landscape elements: Monterey pine (*Pinus radiata-* A), White brittle gum (*Eucalyptus mannifera* B);
- e) base of the second chimney stack;
- f) fabric and operation of the siren and whistle; and
- g) 1948 Switch Room.

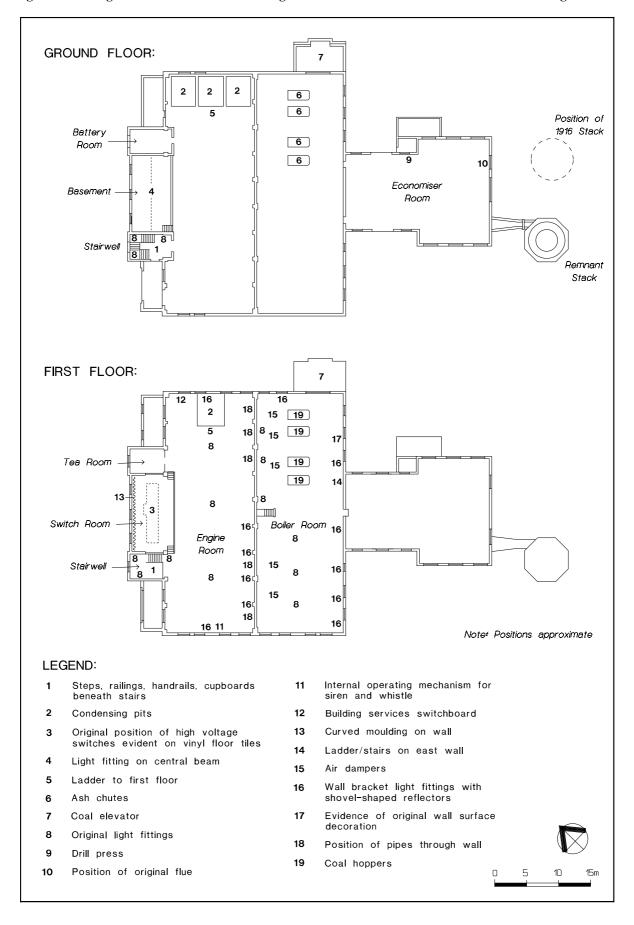
- Walls, ceiling
- Coal hopper (19)
- Coal elevator (7)
- Ladder/stairs on east wall (14)
- Air dampers (15)
- Wall bracket light fittings with shovel shaped reflectors (16)
- Original light fittings (8)
- Evidence on east wall of original wall surface decoration featuring red section from floor finished with a black line below cement washed walls (17)
- Portion of pipes through west wall of Boiler Room into the Engine Room (18)

Figure 48b: Kingston Powerhouse Precinct: Significant Internal Fabric of Power House Building

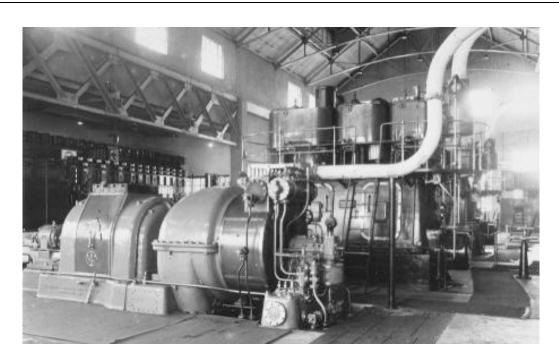
Electricity generating machinery previously operating in this room.

1927 steam turbine in foreground and 1915 reciprocating steam engine at rear.

Example of Interpretive Panel with photos and simple text giving quick impression *Photo NAA A3560 Item3588*

Photographs can be reasonably durable if screen printed or etched on aluminium signs, or mounted under glass, but they are still subject to vandalism. Photographic interpretation would be appropriate in areas such as the generator machine room where plant has been completely removed, or the boiler room, to show how the boilers were located under the coal hoppers and a controlled amount of coal was fed to the chain grate stokers. Examples of this type of interpretation are shown below.

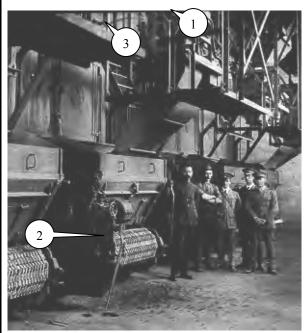
Original Babcock and Wilcox Water-tube Boilers

Coal was fed at a controlled rate from the overhead coal hopper (1) into the bin in front of the boiler, and through to the chain grate stoker (2). The speed of the grate and flow of coal could be controlled to suit the amount of steam needed. The heat from the burning coal, in contact with the steel tubes inside the boiler, turned the water they contained to steam. This steam was superheated under pressure (180 pounds per square inch and 550 degrees Fahrenheit, or1200kPa and 290°C), and collected in the steam drums at the top of the boiler (3). An insulated pipe conveyed the steam through a hole in the wall to the steam engines in the next room. The hot gasses from combustion of the coal were contained in the firebrick casing of the boiler, and passed via a large damper in the floor, through an underfloor chamber to the Economiser Room next door, before passing up the chimney stack. A boiler attendant or fireman looked after the firing rate and pressure in the boiler, with a high degree of automation for 1913 when the boilers were built.

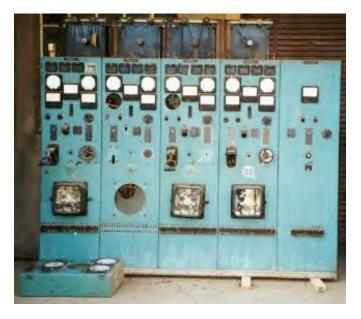
Control and Synchronising Switchboard Salvaged from 1953 Kingston Diesel Auxiliary Station

It is also possible to introduce genuine plant items from elsewhere which serve the same purpose as models in illustrating processes that occurred in the Power House. There is a danger in doing so if visitors become confused in thinking the introduced item is original to the building. However, where the plant item has significance to the site, has high interpretive value, and its origin is clearly identified, such relocation is justified and desirable. The synchronising switchboard from the 1953 Diesel Auxiliary Power Station has been salvaged by the demolition contractor, and donated to Power House conservation project⁶. It would form a useful link in interpreting the changing nature of electricity generation on the site over half a century, and the basic similarity of technology employed in synchronising engine driven alternators, whether the prime mover is steam or diesel powered. It could be adapted if desired to allow visitors to experience a simulated synchronising process, using the synchroscope, lights, governor controls and computerised sound effects.

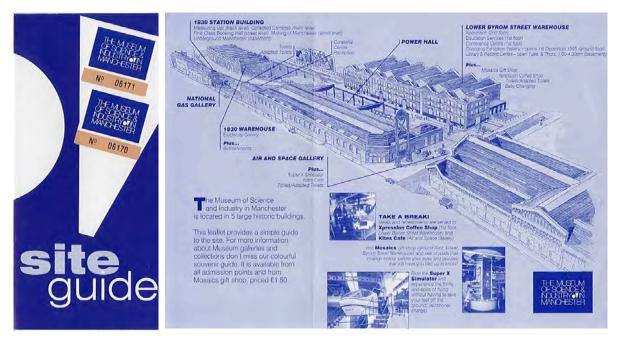
Unfolded sheet showing buildings and display features Manchester Museum of Science and Industry

An important aid for the visitor in understanding the building and its equipment and relationship to the site would be the production of a site guide. This should be easily related to the buildings in a realistic way, and show the entrances for the different parts of the Power House. An example of a folded A4 sheet successfully used with a museum complex using industrial buildings is shown.

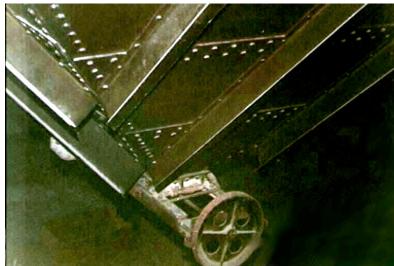
Overhead coal hoppers in the boiler room

- Railway tracks
- External coal filler pit (subject to excavation outside building and examination of pit inside building)
- Coal and ash conveyor system encircling the boiler room
- Overhead coal hoppers in the boiler room
- Overhead ash hopper outside the building
- Air dampers and flue gas chambers below boiler room floor
- Ash chutes between boiler room and ash room
- Base of chimney stack

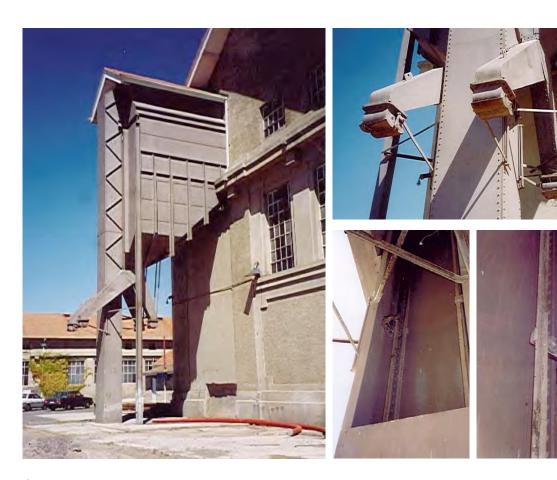
Overhead ash hopper outside the building

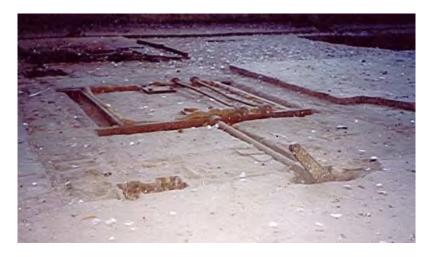
Air dampers to flue gas chambers

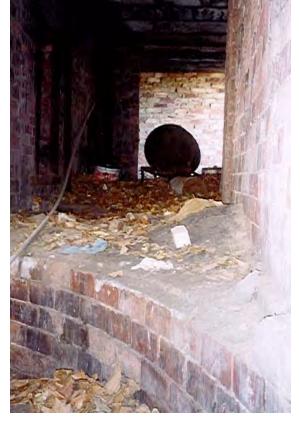
Base of Chimney

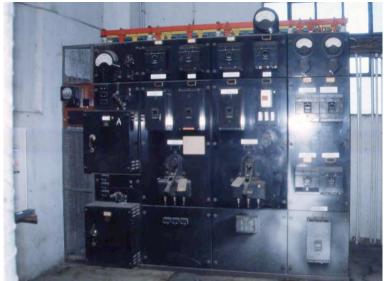
415 Volt building services switchboard

- Overhead Crane in Engine Bay
- 415 Volt building services switchboard feeding building auxiliary equipment
- Cable terminations in cable chamber below high voltage switchroom
- Steam whistle
- Air raid siren

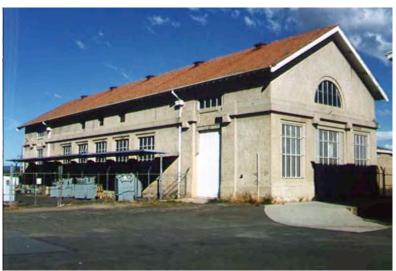
Power House and Bulk Store in early Federal Capital Style

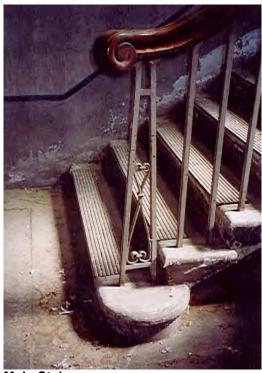
Main Stair

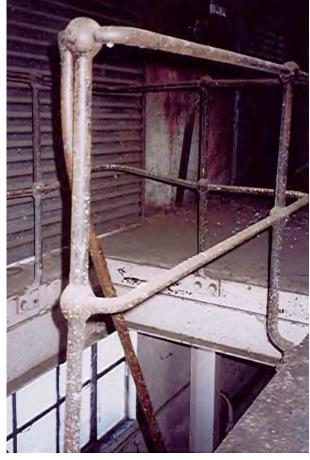
Railings on stairs and floor openings

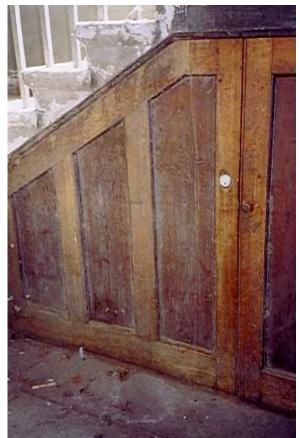
Joinery below main stair

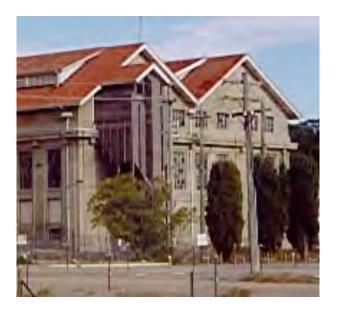
Building Elevation view showing height

- The height of the building determined by the height of boilers, with the coal hoppers above, and the ash handling below
- The same height in the adjacent generating bay being used for massive machine foundations and chambers for cabling and transformers and station batteries below the machine floor level, and provision for lifting the machines over each other by overhead crane, when required for maintenance
- The more economical single storey construction for the economiser room, where less height was required
- The depth of the condenser pit to obtain cooling water from the Molonglo River

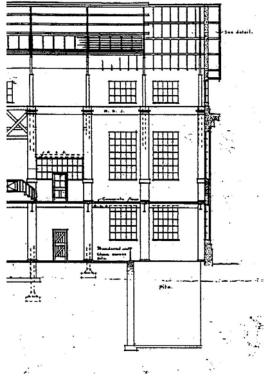
Section showing condenser pits

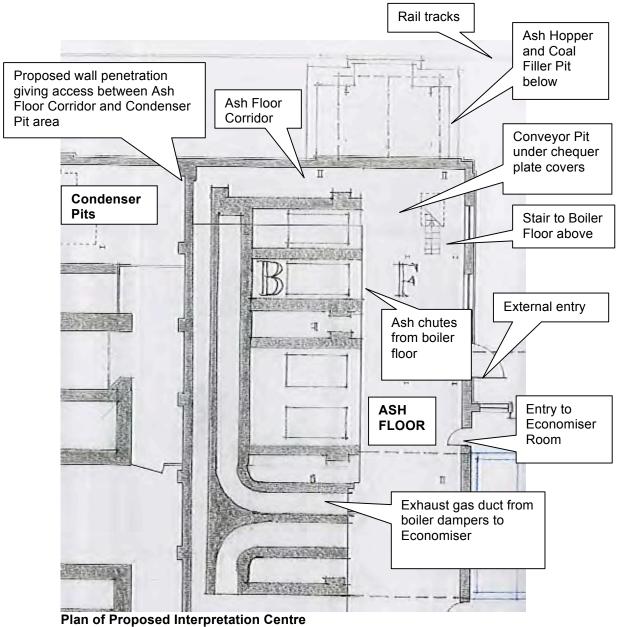
Based on Freeman Vol 2 Adaptive Reuse Ground Plan PF August 2001

- the coal and ash conveyor
- a steel plate covered pit where the coal entered the building
- the location where ash was dispatched on the conveyor to the ash hopper
- a steel access stair to the boiler floor, and
- potential for making a wall penetration via a passage to the basement area below the Engine Bay and into the condenser pit.

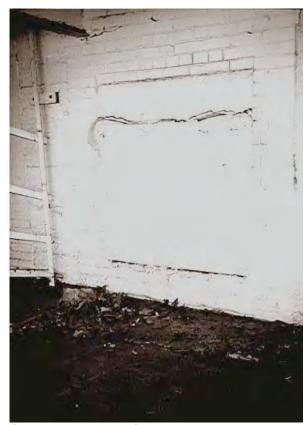
Covered ash chute from boiler above

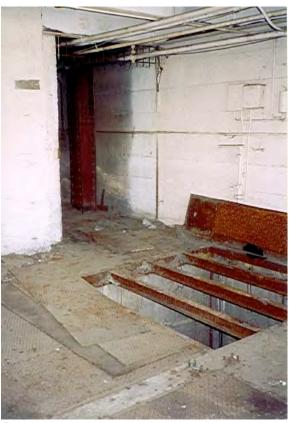
Conveyor pit and corridor to wall adjoining condenser pit

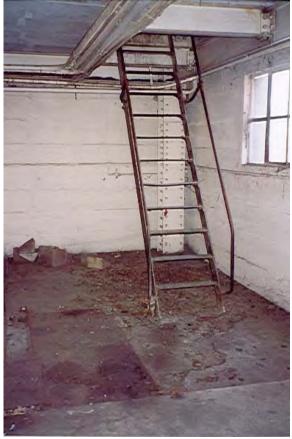
Stair to Boiler Floor

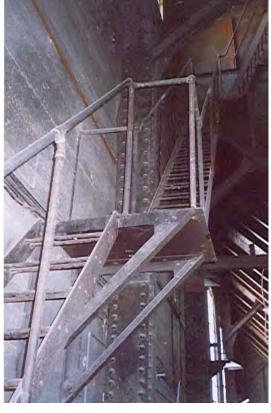
Stair to Catwalk

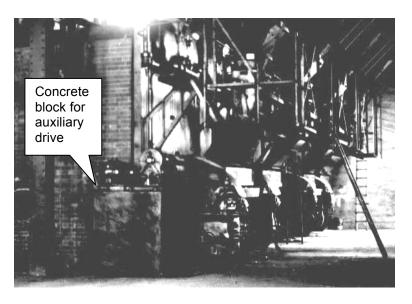
Original boilers with chain grate stoker drive mounted on concrete block NAA A3560 Item 3

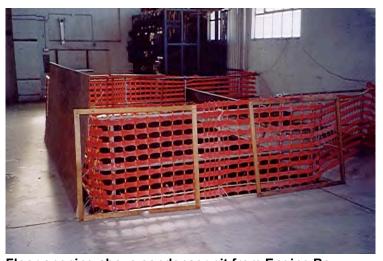
Floor opening above condenser pit from Engine Bay
See also historic photo on page 33 showing condenser equipment adjacent to Roby-Hall engine.

In the Engine Bay, there is a suggestion that the opening in the floor above the Condenser Pit may be infilled and interpreted. This would overcome a safety issue and make more space available for reuse, but it would be more desirable to retain and interpret the opening rather than its former location.

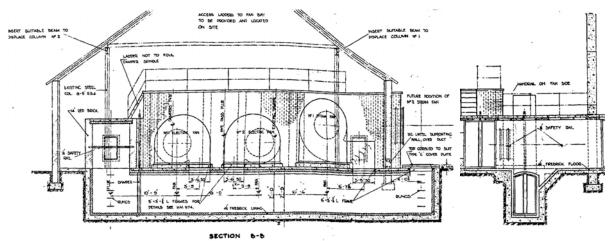
Section through Economiser Annex showing transverse tunnel with fans to new Chimney Actew Microfilm 82217-2050-01

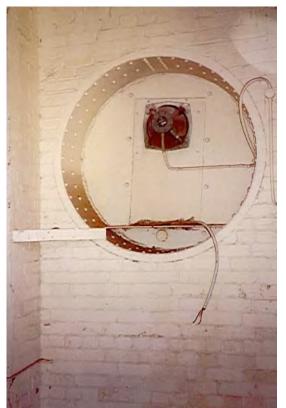
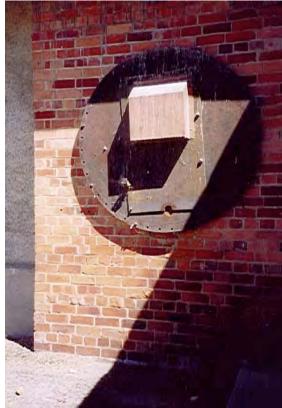
Circular Wall opening in Economiser Annexe, internal and external views

An existing wall penetration in the Economiser Annexe can be interpreted. It is a large circular opening in the eastern external wall. The opening is framed with a steel riveted ring, and sealed with a steel plate through which an exhaust fan has later been fitted. The opening is associated with the work done in the late 1940s when provision was made for a second steam fan to be added to the exhaust duct feeding the new chimney.

The work made use of an existing suction ring, apparently salvaged from the original chimney installation. This opening could add to the story of progressive use, with connection to original fabric.

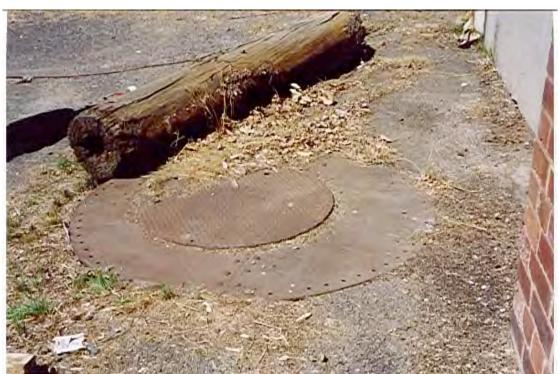
Steel cover plate on ground adjacent to circular opening in Economiser Annexe wall

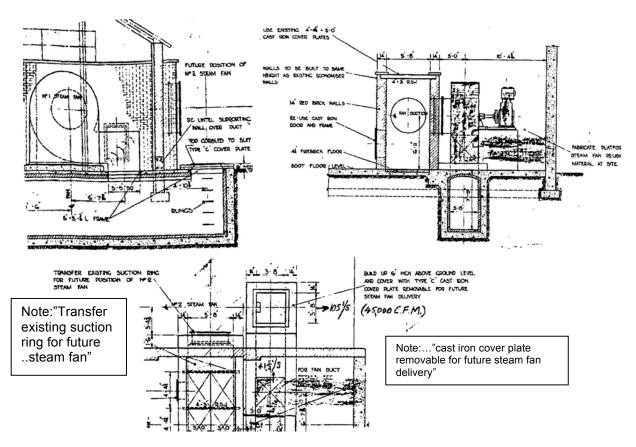
Extracts from drawing showing work associated with new chimney Actew Microfilm 82217-2050-01

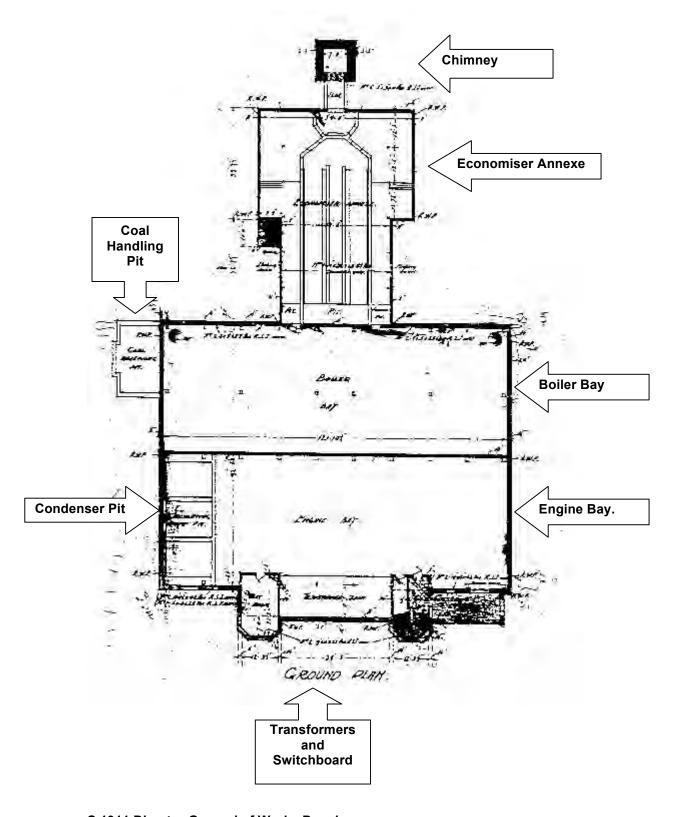
Appendix 1

Original Plan of Power House

C 1911 Director General of Works Drawing National Australian Archives

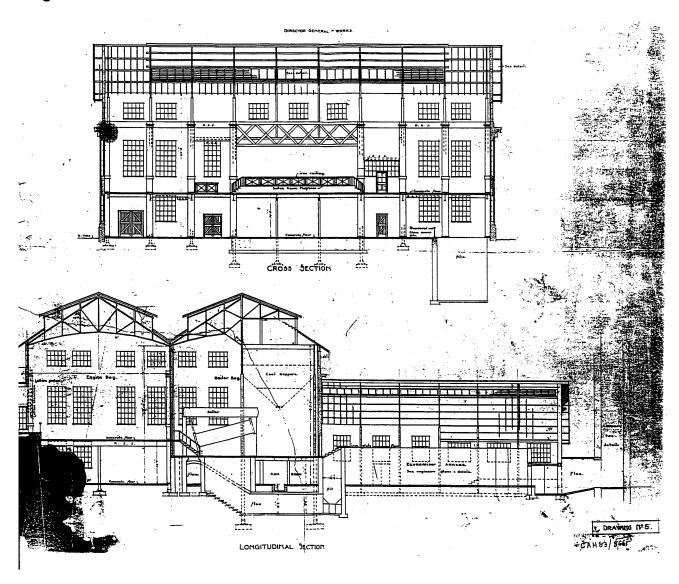
Appendix 2

Original Sections of Power House

C1911 Director General of Works Drawing No5 CAH83/866

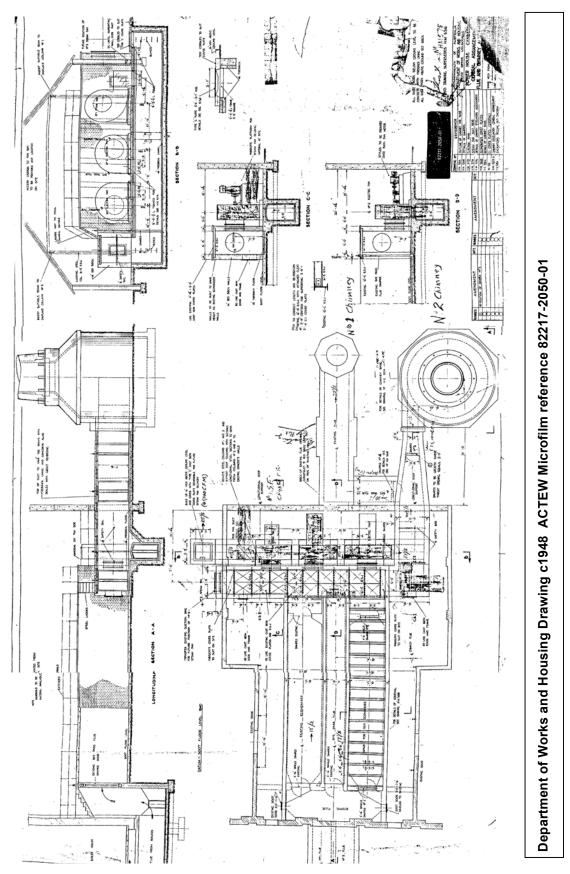
Appendix 3

Plan and Section of Economiser Annexe showing Modifications associated with Replacement Chimney Stack

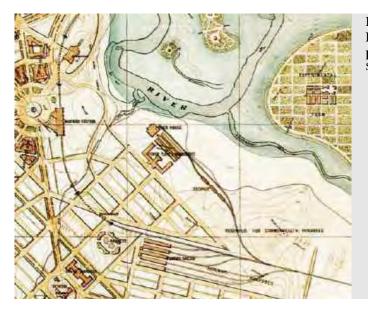
Figure 33. Section of the 1912
Departmental Board Plan showing the planned Kingston industrial area
Source: Detail from Reid 2002, p. 99

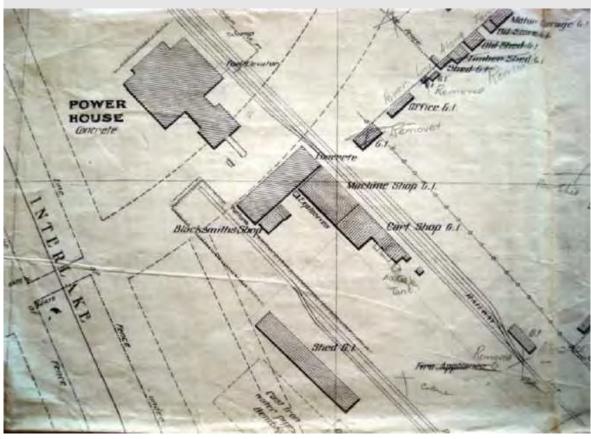
Figure 38. October 1922 Site Plan showing extensions to the Machine Shop, the Explosives Store and the Blacksmiths' Shop with small addition

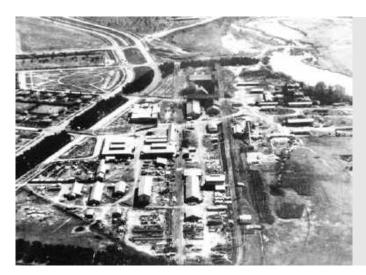
Figure 41. Aerial photograph from about 1928 showing the new double-storey hipped roof extensions to the Fitters' Workshop

The description indicates that extensions were being made to both sets of galvanised iron structures that stood immediately to the southeast of the Fitters' Workshop. Both of them were double-storey. On the northeastern wing, the flat-roofed 1922 Cart Shop was partially or wholly demolished and replaced by a shorter two-storey section with a hipped

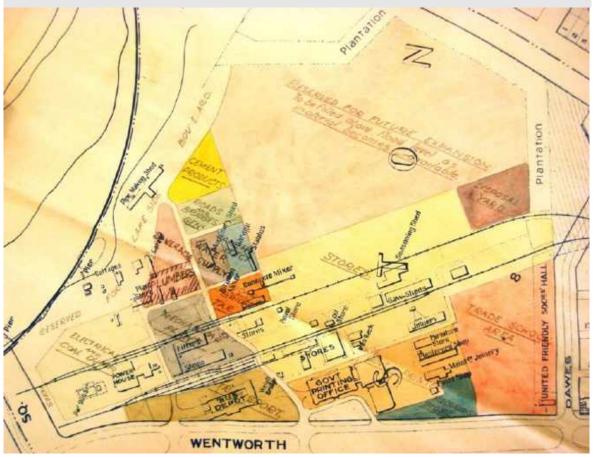
Figure 42. October 1941 Site Plan demonstrating little external change to the size and shape of the Fitters' Workshop and its wings

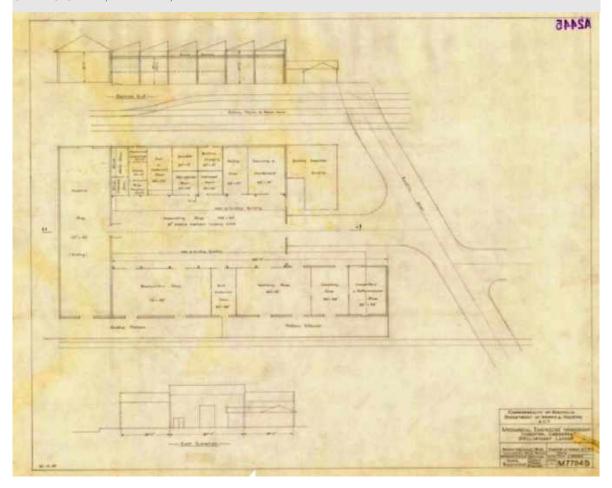
Figure 43. 1946 Preliminary Layout Plan for the Mechanical Engineers' Workshop showing the amenities block at the end of the northeasterly extension from the Fitters' Shop Source: CRS A2445, item M7794B, National Archives of Australia

Simultaneously, the huge replacement extension to the Fitters' Shop that Rolland had proposed was to be used entirely as the Mechanical Workshops. In the end, however, neither scheme would ever be realised. (Extract of Minutes of the 52nd Meeting of the NCPDC, 8-9 August 1946; memorandum, C S Daley to H M Rolland, 'Canberra Power House and Mechanical Workshop', 19 August 1946, both in CRS A3032, item 22/1/1; Drawing no. 17898, 'Proposed Electrical Workshop Kingston Canberra', 6 October 1948, CRS A3032, item 22/1/1A)

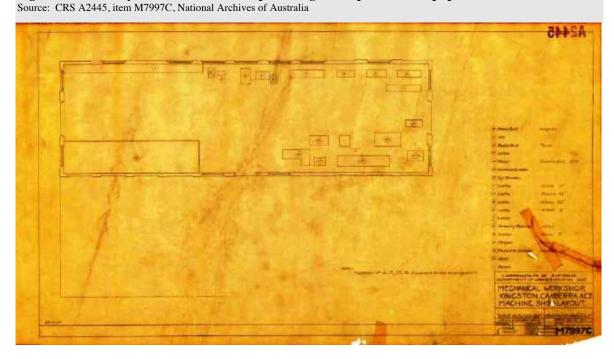
Figure 44. 1947 Layout of the Fitters' Shop showing the disposition of Equipment

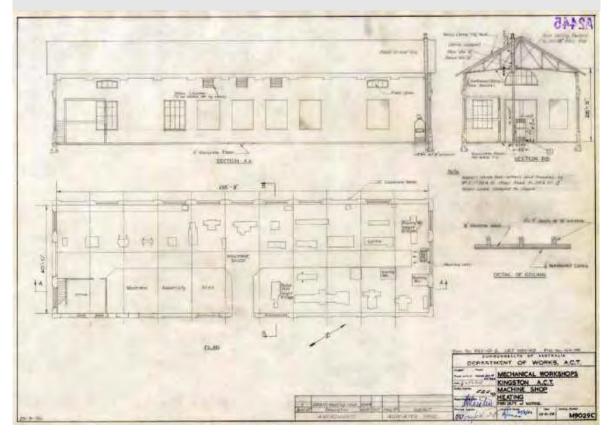
Figure 45. One of the 1956 schemes for heating the Fitters' Shop, showing some of the internal layout at that time

At first, the Committee's recommendations were completely ignored, if not actively undermined. In the same year as the Committee was appointed, the NCPDC revived the scheme it had approved in 1948 to build new Electrical Workshops on a site between the Power House and Wentworth Avenue. Fresh drawings were prepared and the NCPDC averred that it was now necessary to erect the building 'at an early date'. The Electrical Workshops were built later in the 1950s, though not on the preferred site. Rather, they replaced the existing workshop in the northeasterly extension from the Fitters' Shop. About the same time, the Fitters' Shop itself was fitted with a heating system. (Drawings nos. 23200, 23201 and 23202, May 1955; and extract from Minutes of the 145th Meeting of the NCPDC, 7-8 December 1955, all in CRS A3032, item 22/1/1A; ACTEW file G64/14 part 3; CRS A2445, items M8995B and M9029C, 1956)

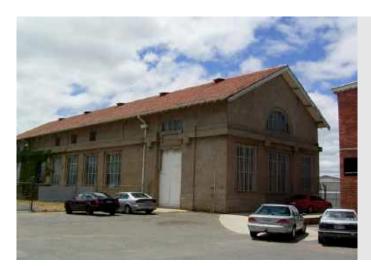
Figure 47. Fitters' Workshop in 2005 Source: Duncan Marshall

Note: There are grilles on the southwest windows and climbing plant on the northwest elevation.
